## Preliminary Information

### PIT5737A Loss of Sirius XM Audio Until XM Channel Change

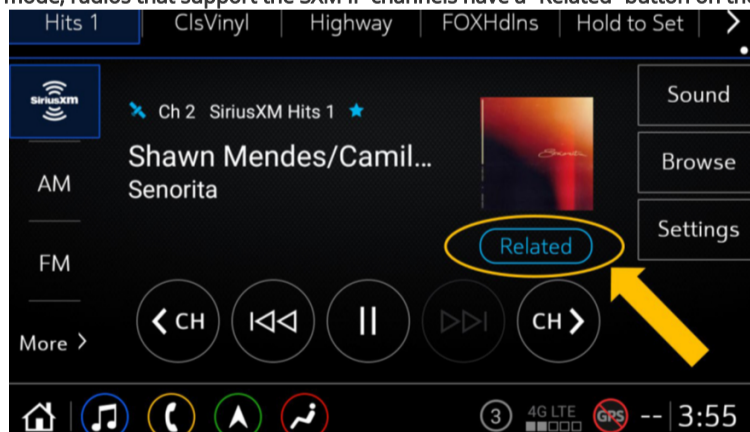
To visually identify if the radio may be involved, switch to the Audio page and select SXM as the Source and look for the "Related" button. When in SXM mode, radios that support the SXM IP channels have a "Related" button on the screen.

1. When changing to SXM from another source (AM, FM, etc.) audio will play for a few seconds and stop. It will not return until the user changes to another SXM channel. This happens 100% of the time when mode changes to SXM are made.
2. Additionally, it was found that if in SXM mode when the vehicle is turned off, on the next power up into SXM mode, the same issue will occur (audio will stop after 2-3 seconds forcing the user to tune away and back).

Specifically, the issues listed are only seen when customers have elected to purchase a SXM service plan that does not include SXM's internet services (example: Mostly Music service plan).

**Note: Do NOT replace parts for these conditions.**

**Sirius XM can assist in resolving the issue. Sirius XM is making a change in their system that can help these affected radios. Please call the SXM Dealer Support team using one of the phone numbers below:**
