Preliminary Information

PIT5499B ABS or ESC MIL on Service Trailer Brake Message or Low Brake Fluid Warning

Brand:	Model:	Model Years:	VIN:		Engine:	Transmissions:
			from	to		
Chevrolet	Colorado	2015 - 2016	All	All	All	All
GMC	Canyon	2015 - 2016	All	All	All	All

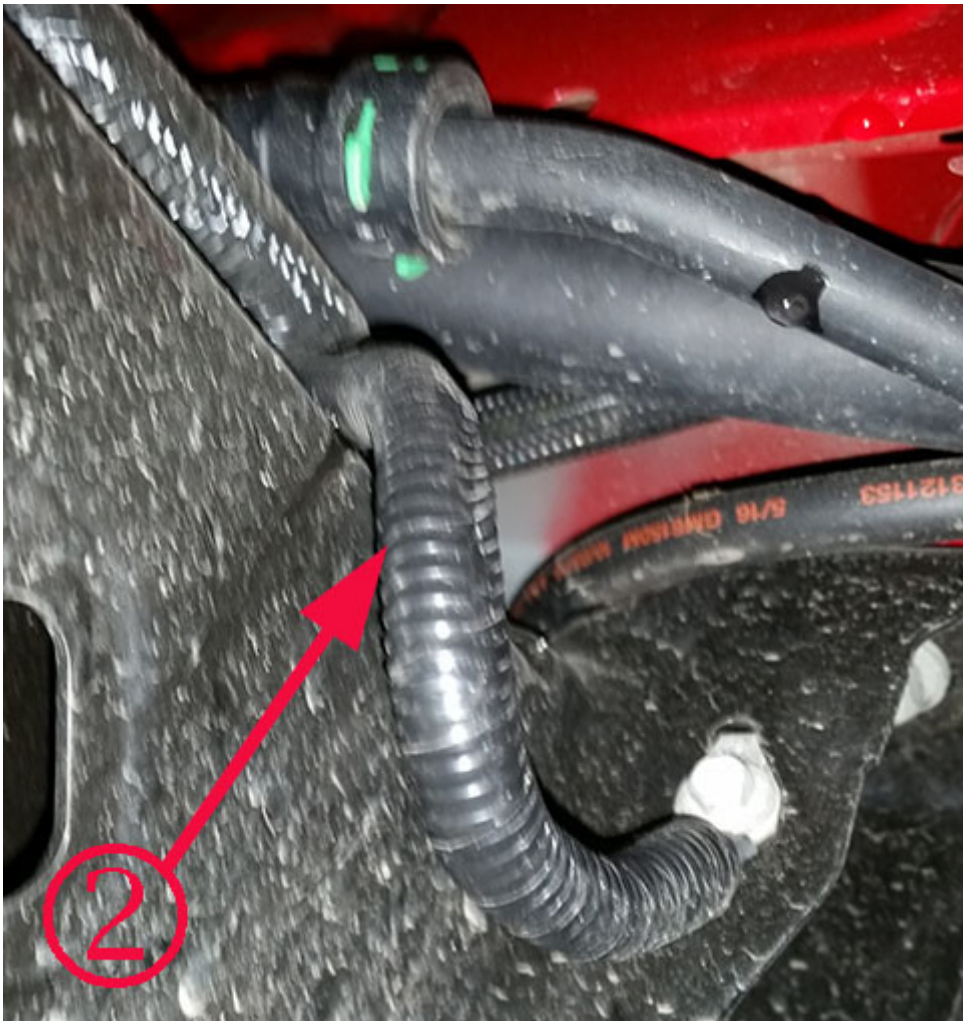
The customer may state the ABS / ESC MIL is on , the Low Brake Fluid lamp on (master cylinder fluid level is full) or a Service Trailer Brake message. The technician may find codes C0035, C0040, C0045, C0050, C0055, C0267, U0121, U0415 or U0420.

Inspect the EBCM connector for water intrusion or terminal corrosion. If either is found, replace the EBCM and replace the effected terminals. Remove the tape from the conduit leading to G400 between the main harness and the ground lug.

If no water intrusion or corrosion is found in the connector, remove the tape from the G400 conduit and continue with published diagnostics. Please note in the repair information if there was water in the conduit.
