## PIT5593B Action Required Steering Assist is Reduced Drive with Care Or Service Power Steering Message And Or Current Power Steering Control Module DTCs

Product Investigation Review Required

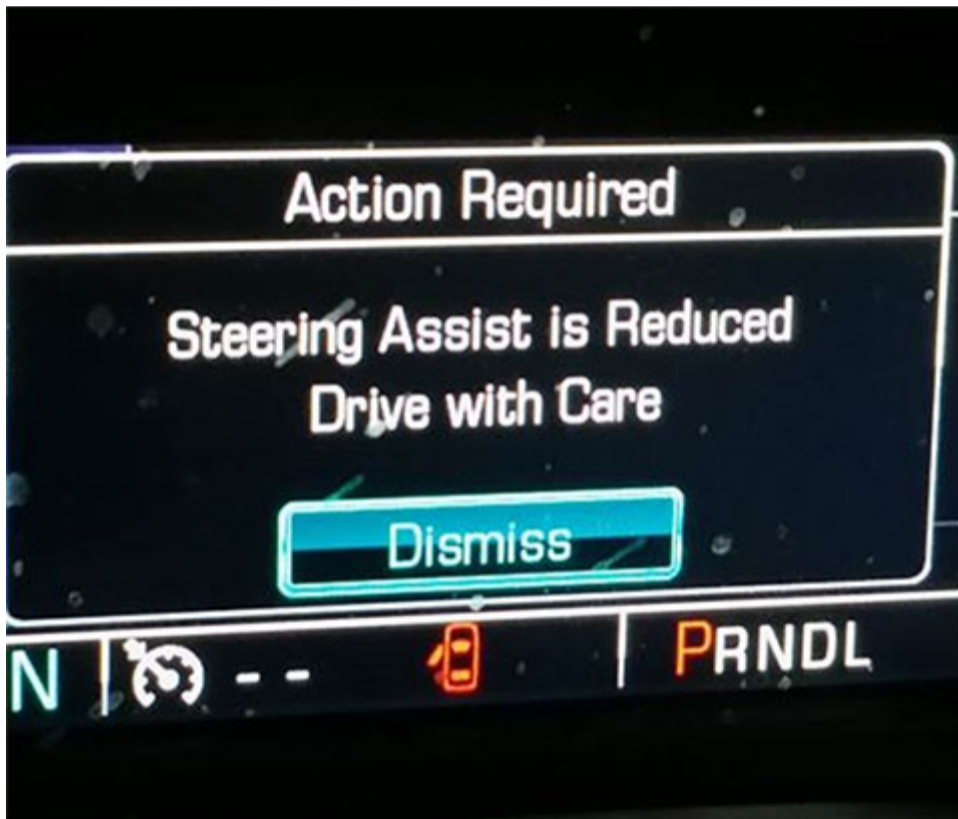
Involved Region or Country	North America
Additional Options (RPO)	Without RPO UHX Lane Keep Assist Without RPO NV8 Variable Assist Power Steering
Condition	<p><b>Note: This PI does NOT apply to 2500/3500 HD Trucks.</b></p> <p>Some customers may comment every time the vehicle is started an "Action Required Steering Assist is Reduced Drive with Care" Or "Service Power Steering" Message is displayed. In most cases, there will be no steering related issues and if the message is dismissed it will remain off the entire ignition cycle.</p> <p>When checking for DTC's the Power Steering Control Module (PSCM) will have current DTC's set. The most common DTC's which may set are C0176, C0544, U0100, U0101, U0140, U0121, U0073, U0126, U0428 71, U0415 and/or U0401.</p>
Cause	A PSCM calibration error has been found, which does not allow its DTC's to transition to history and they stay current. Even when the issue that caused the DTC's to set originally, is no longer present, the PSCM will retain the DTC(s) as current.

- Customer brings the vehicle in for an "Action Required Steering Assist is Reduced Drive with Care" message that is displayed each ignition cycle. See DIC message below.

1. Check and record all DTC's in all modules.
2. Clear all DTC's. If all DTC's can be cleared, go to step 3. If DTC's will not clear, the vehicle is experiencing a current fault, which will need to be diagnosed and repaired before continuing to step 3.
3. Reprogram the PSCM with the latest calibrations currently available in TIS2WEB, and clear any DTC's which may have set during the programming event.
4. Let the vehicle go to sleep, then restart the engine and check for DTC's. If any DTC's reset, perform normal diagnosis and repair as necessary.
5. If no DTC's reset, it will be necessary to look at all recorded DTC's in step 1 to help determine the original root cause. See additional information/example below.
