L636-A.04.20

Gearbox harness replacement

Urus

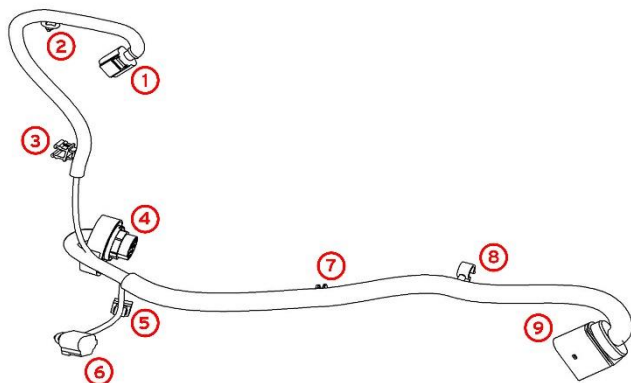
The wiring is fitted with 4 connectors and 5 fasteners.

2. Open the three buttons and free the thermal sleeving, positioning it out of the way.
