SIB 01 01 19

2020-05-21

## FRT GRILLE UPPER/LOWER AIR FLAPS: LTD WTY EXT TO 10 YRS/120,000 MILES

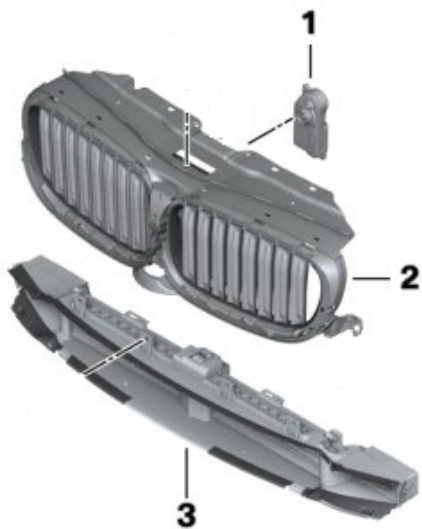
- Air flap control (drive), active, upper
- Air flaps, upper (assembly)
- Air flaps, lower (assembly)
