SIB 13 04 20

2020-05-11

TANK VENTILATION AND MIXTURE CONTROL FAULTS STORED IN THE DME

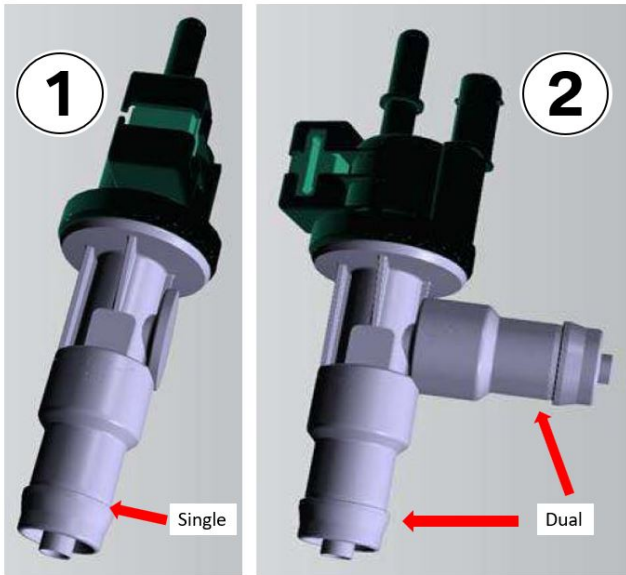
This procedure affects tank ventilation valves with **single** and **dual** discharge points.

Single (1)

Dual (2)

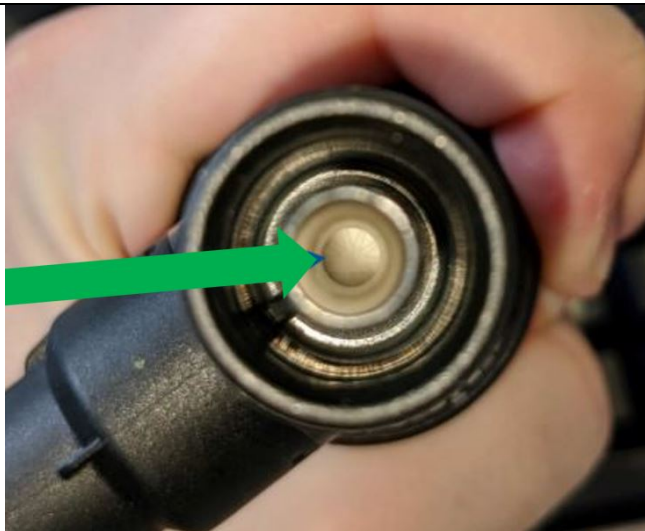
The reed valve dimple should be centered in the discharge port.

Note the **GREEN** arrow.

The reed valve in this photo is **good**.

Do not replace the valve.

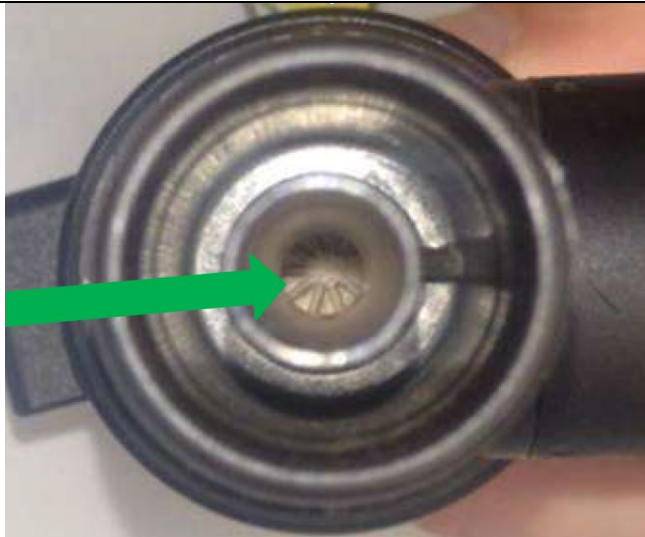
The reed valve center with vanes should be centered in the discharge port.

Note the **GREEN** arrow.

The reed valve in this photo is **good**.

Do not replace the valve.

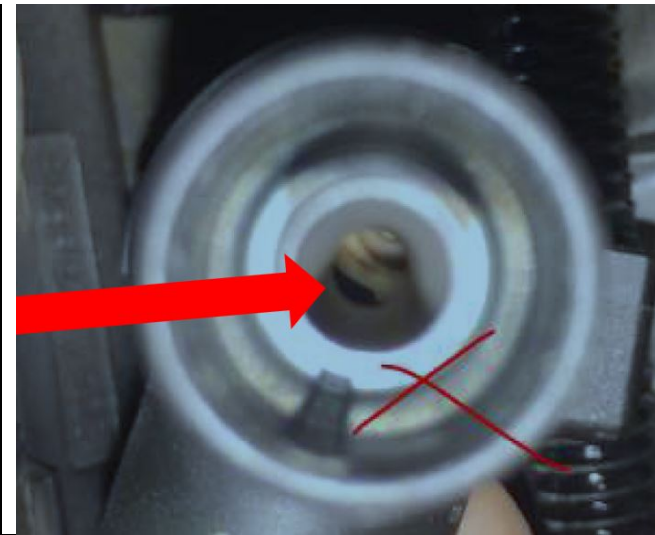
Internal mechanical defect in the tank ventilation valve.

The edges of the reed valve can be ripped or torn apart.

It is very important to inspect the valve very closely using a borescope so that any damage is not overlooked.

Note the **RED** arrow.

The valve must be replaced.
