SIB 17 01 20

## SERVICE ACTION: ADD SILICONE BOOSTER TO LOW TEMP COOLING SYSTEM

| G05 (X5 Sports Activity Vehicle) | G06 (X6 Sports Activity Coupe) | G07 (X7 Sports Activity Vehicle) | All with the N63B or N63M engine |

The coolant in the low temperature cooling system may not have sufficient coolant corrosion protection.

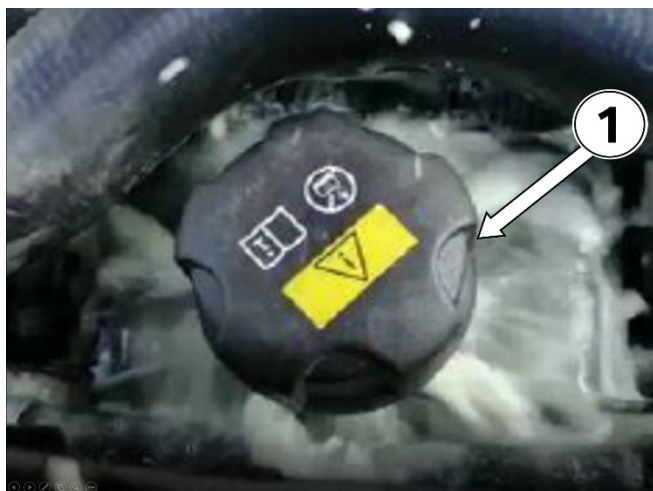
Was pressure released (1)?

- Yes: Continue to Step Two.
- No: Continue to Step Three.

Step Two: Do not add the silicon booster if there is significant pressure released from the low temp cooling system. Follow [SI B17 06 17](#) to properly repair the vehicle.
