SIB 51 05 20 FUEL FILLER DOOR STICKING

This Service Information Bulletin (Revision 1) replaces SI B51 05 20 **dated February 2020**.

E-Series	Model Description
G06	X6 Sports Activity Coupe
G07	X7 Sports Activity Vehicle

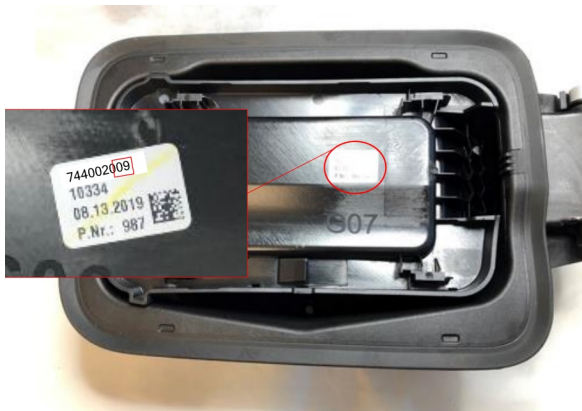
1. Open the fuel filler door to inspect the orientation of the fuel filler door ejector.

Ensure the ejector is positioned straight up and down as shown to the left.

No: Replace the complete insert (aka cover pot) and continue to step 3.

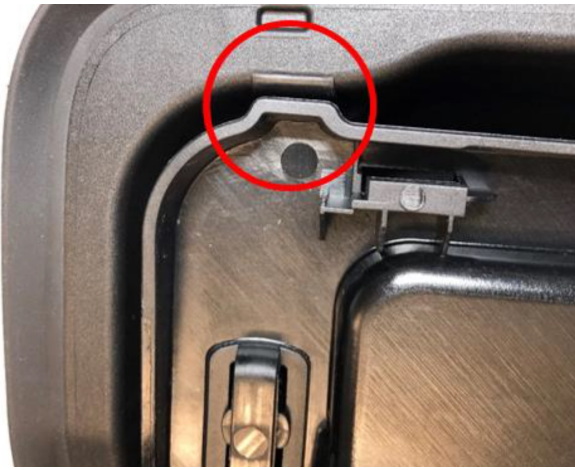
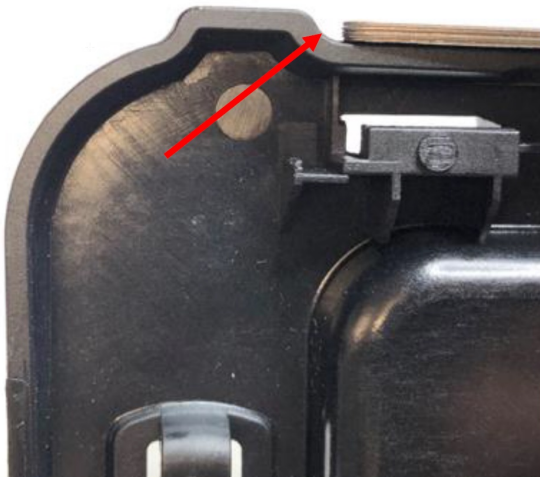
2. This is the area which will be modified (circled). **Do not modify the lower tab, only the upper.**

3. Remove 0.7 mm from the upper tab (arrow) using a file. A feeler gauge can be used (shown lying flat along top edge) to assist with measuring.
