SIB 51 17 20

FUEL FILLER FLAP MISALIGNED OR STICKING

E-Series	Model Description
G05	X5 Sports Activity Vehicle

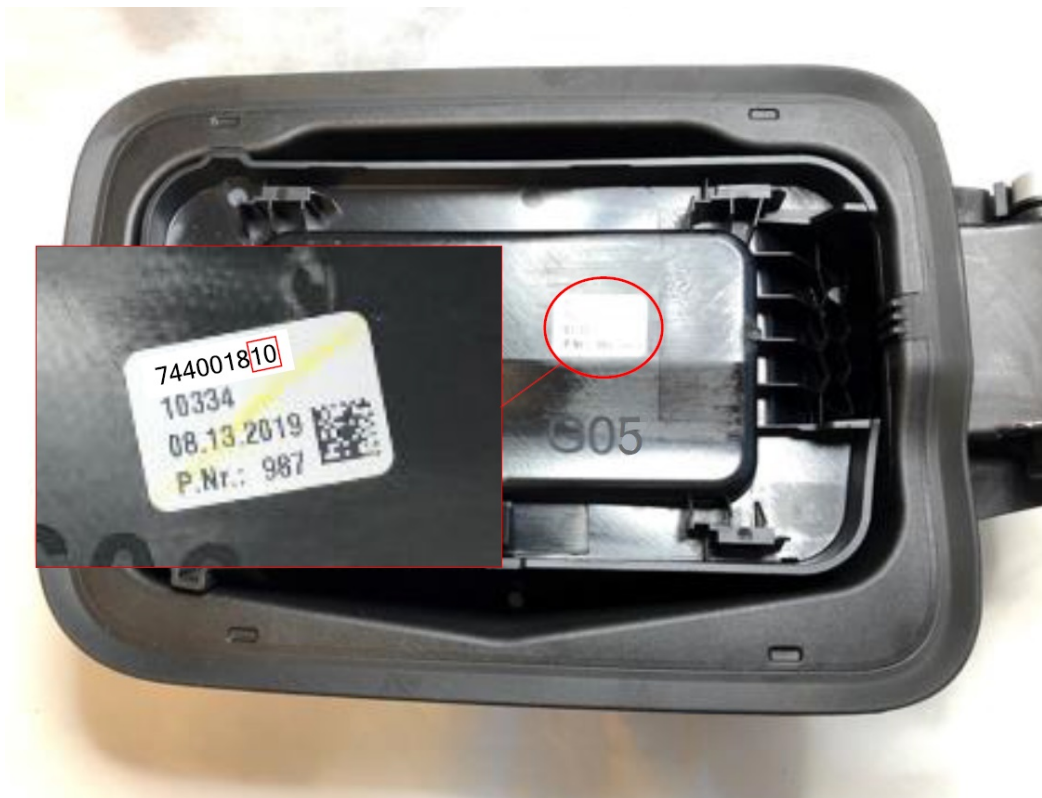
The arm for the fuel filler flap absorbs water and may become deformed. The complaint may be intermittent, as the plastic will return to its normal shape as it dries.

1. Remove the fuel tank filler flap following repair instructions **REP 41 63 000 “Removing and installing the fuel filler flap”**.
2. Inspect the white identification label shown below to find the part number and index.

Inspect and replace the fuel filler flap (aka cover pot, or cover bowl) if necessary.

3. Use the P/N and index to determine if replacement is required:

P/N 7440018 with an index below 11 requires replacement

P/N 7440024 with an index below 9 requires replacement
