**SIB 51 18 15**

A Check Control Message is displayed for the Tailgate Lock Open

E-Series	Model Description
I01	i3

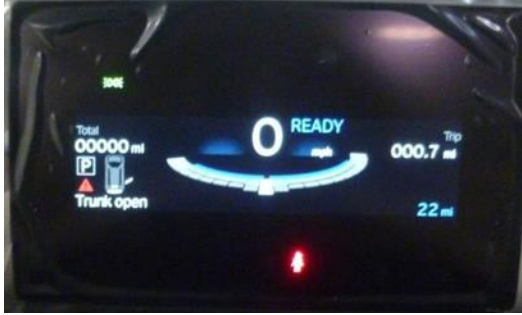
<p>The customer states that the trunk open warning is displayed, even though the trunk is mechanically closed.</p>

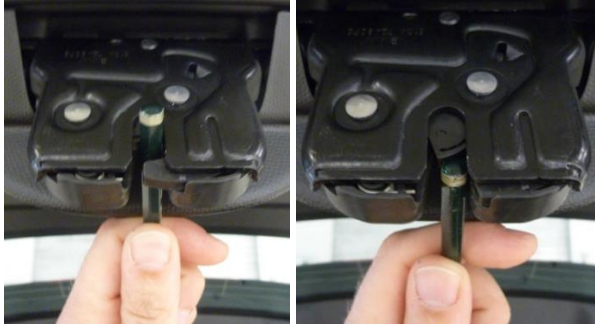
<p>Check the movement of the tailgate lock in both detent positions with a pencil or similar object.</p> <p>If the movement is not smooth and the lock binds, replace the tailgate lock. Compare to a known good vehicle for reference.</p>

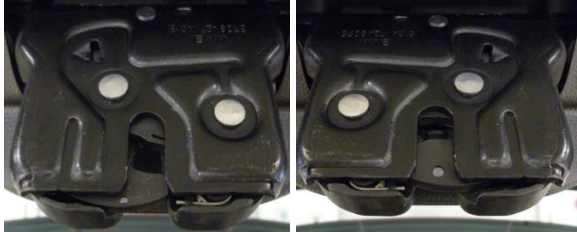
<div style="display: flex; justify-content: space-around; margin-top: 10px;"> <div style="border: 1px solid black; padding: 2px 5px;">A</div> <div style="border: 1px solid black; padding: 2px 5px;">B</div> </div>	<p>The two detent positions are shown and will be referred to in the following measurements.</p> <p>A: Detent position 1</p> <p>B: Detent position 2</p>

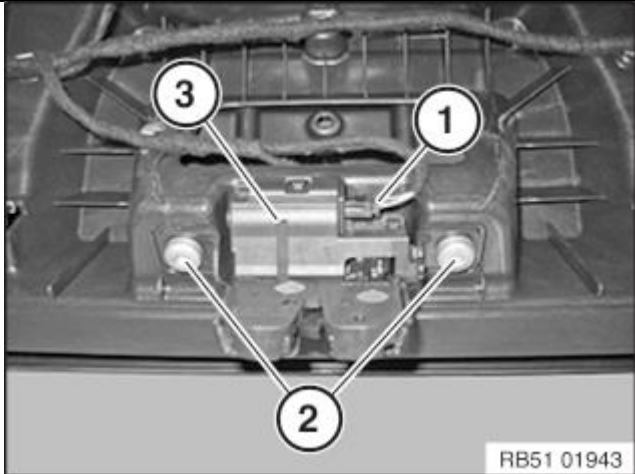
<p style="text-align: right; font-size: small;">RB51 01943</p>	<p>Remove the connector S30*1B (1) from the tailgate lock.</p> <p>The following measurements are taken on the tailgate lock itself.</p>

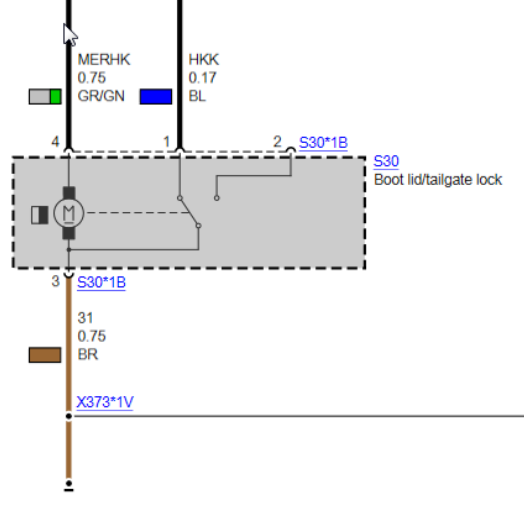
<p>1. Measure between PIN 3 and 4 (the resistance of the motor is measured)</p> <p>1<sup>st</sup> detent position: Approx. 3-4 Ohm 2<sup>nd</sup> detent position: Approx. 3-4 Ohm</p> <p>2. Measure between PIN 2 and 3 (the switch position is checked)</p> <p>Lock open: Approx. 0.8 Ohm 1<sup>st</sup> detent position: Approx. 0.8 Ohm 2<sup>nd</sup> detent position: Approx. OL or "open"</p> <p>3. Measure between PIN 1 and 3 (the switch position is checked)</p> <p>Lock open: Approx. 0 Ohm 1<sup>st</sup> detent position: Approx. 0 Ohm 2<sup>nd</sup> detent position: Approx. 0.8 Ohm</p> <p>If any measurements are not correct, replace the tailgate lock.</p> <p>If all measurements are correct, check the closing comfort of the tailgate and adjust the tailgate lock as per the Repair Instructions "51 24 004 Adjust rear lid lock".</p>
---	--
