**SIB 51 21 19**

2020-05-18

ACTIVE AIR FLAP FAULT DIAGNOSIS AND REPAIR

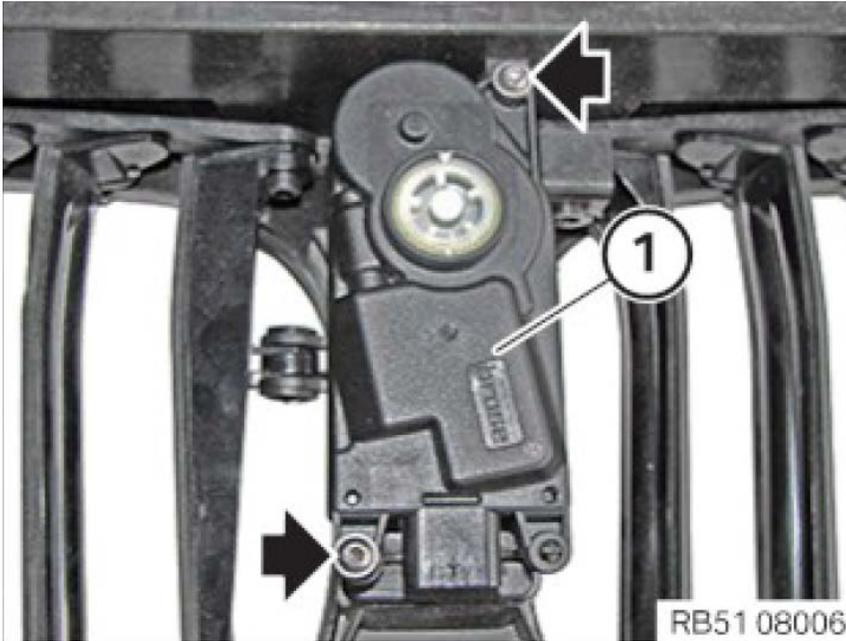
1. Remove the upper active air flap, following the repair instructions within ISTA for the specific vehicle by VIN.
2. Remove screws (see arrows) from upper active air flap actuator (1) as shown below:

3. With the active air flap actuator removed, manually open the flaps.
4. Install the replacement active air flap actuator.
5. Install screws, tightening to the following specifications:
G01/G02-3nm
G12, G30, G32- 2nm
6. Reinstall the upper air flap following ISTA repair instructions.
