SIB 54 11 19 SUNROOF WATER LEAK DIAGNOSIS

This Service Information Bulletin (Revision 1) replaces SI B51 11 19 **dated September 2019**.

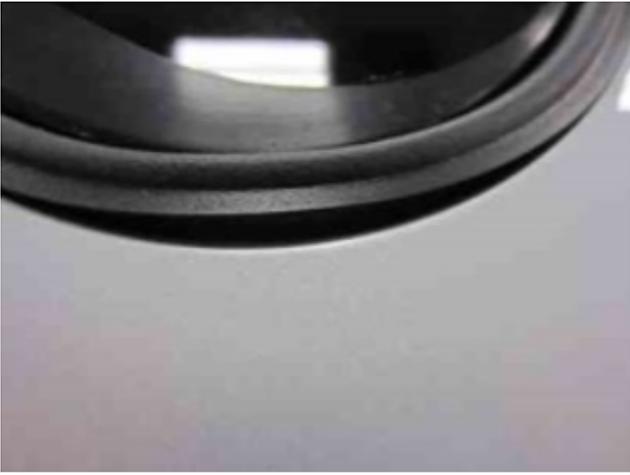
Damage to the sunroof perimeter seal mounted to the roof

This typically occurs in the corners.

Additional damage may include indentation or deformity at any point of the perimeter seal.

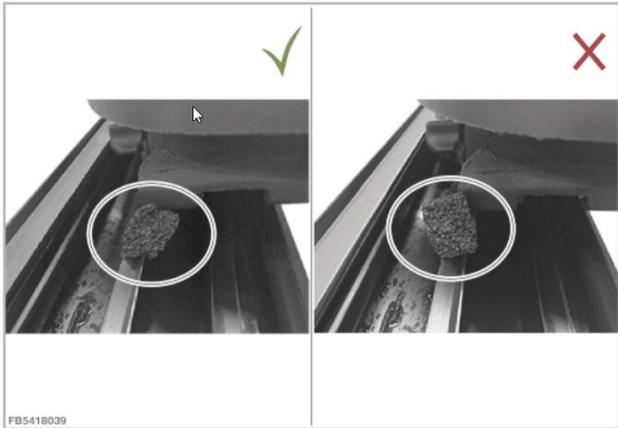
Misplaced or damaged support foam for the center drip tray.

Photo shows correct (green) vs incorrect (red).

If the foam has become misplaced:

- Correctly position support foam, operate sunroof 5 times, and check to ensure proper position remains.
- Replace foam if found out of place after operation.

If the foam is missing or damaged:

- Replace support foam, ensuring proper installation as shown to the left.

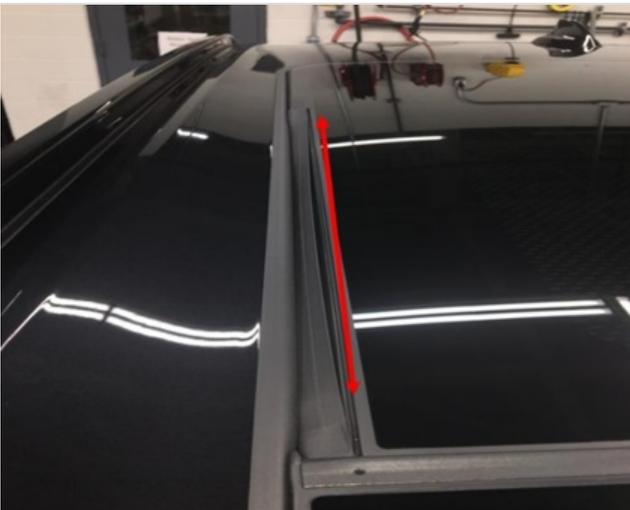
Damaged side seals of the rear sunroof glass panel

Note the gap and incomplete installation of the side seal (long arrow; passenger side shown, looking rearward).

If the seal is incorrectly installed:

- Replace the glass panel side seals.

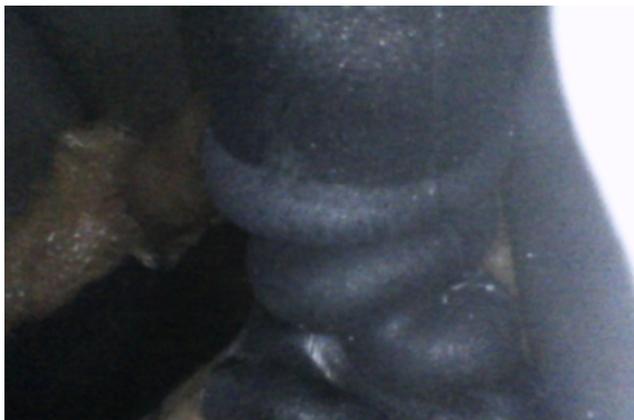
Improperly installed, clogged, or kinked panoramic sunroof drain(s).

- Position the vehicle on a flat surface
- Familiarize yourself with which sunroof "track" is used for water management. Ensure water is ONLY introduced to the water management track of the sunroof.

- Introduce approximately 300ml of water to each drain tube and compare drainage speed at all the tubes.

If water enters the vehicle during testing, or one drain tube is slower than the others, remove the corresponding interior trim as needed to investigate causes of potential blockages.
