SIB 11 01 20

## REPLACING TIMING CHAIN REAR GUIDE AXLE

2020-05-20

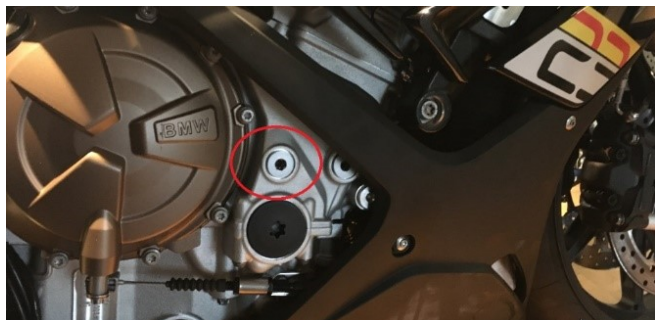
BMW Motorrad has ascertained that the engine installed in the affected vehicles may have a burr present in the guide bore for the oil supply of the timing chain. The burr can dislodge over time due to vibrations and oil pressure fluctuations (incl. temperature influences). This can cause a narrowing or restriction of an oil duct or oil spray nozzle. A lack of lubrication (e.g. the timing chain) or insufficient cooling (e.g. the piston) can be the result.

Note: The front chain guide axle (pivot bolt) is not affected. Only the rear one involves the oil circuit.

In the vehicles concerned, the timing chain rear guide axle (aka pivot bolt; circled) - when viewed in the direction of travel – must be replaced.

The chain guide axle can be replaced without additional preparatory work. A new gasket ring must be used when installing the new axle.
