Technical Service Bulletin

48 Intermediate steering shaft boot is not properly sealing the engine, exhaust noises are heard

48 20 88 2059704/1 June 8, 2020.

Model(s)	Year	VIN Range	Vehicle-Specific Equipment
Q7	2017 - 2018	All	Not Applicable

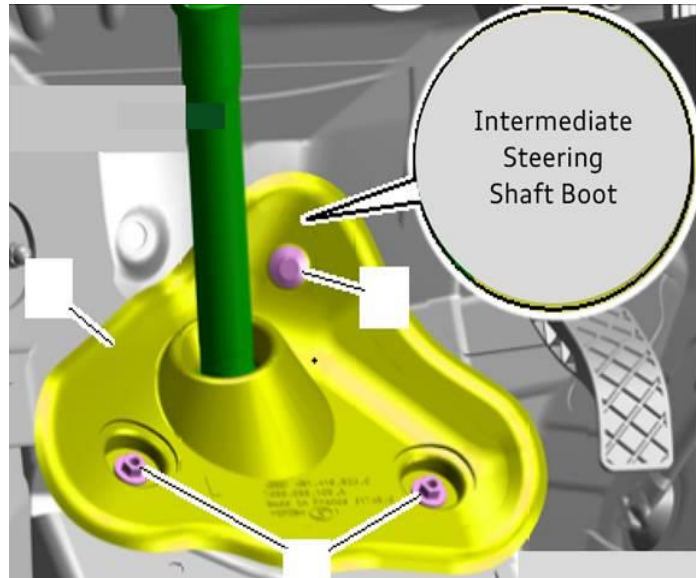
- The rubber boot from the intermediate steering shaft is not properly sealing the firewall.

Figure 1. Intermediate steering shaft boot.

1. From inside the vehicle place a shop rag/towel around the intermediate steering shaft in the area where it passes through the boot, also covering the entire boot (Figure 1).

2. If the noise is reduced or is no longer present, the intermediate steering shaft should be replaced according to Elsa at Repair Manual, Elsa at Repair Manual, *Chassis >> Suspension, Wheels, Steering >> 48 Steering >> Steering Column >> Steering Intermediate Shaft; Removing and Installing.*
3. If the noise is unchanged, continue with normal diagnosis including inspecting for other body sealing issues (e.g. loose or missing harness grommet).
