91 Audi connect myAudi pin not saved for stored online destinations

91 20 74 2047433/5 June 4, 2020. Supersedes Technical Service Bulletin Group 91 number 19-07 dated October 30, 2019 for reasons listed below.

Model(s)	Year	VIN Range	Vehicle-Specific Equipment
A6, A7	2016 – 2017	All	MIB2 High

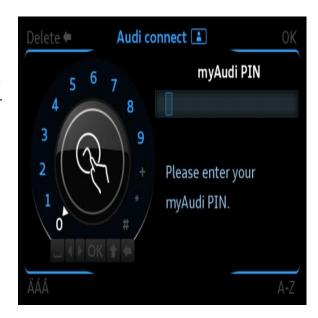
- When retrieving the stored myAudi online destinations, the myAudi PIN (Figure 1) is not saved and must be entered each time after the vehicle has been switched off for a long period.
- The vehicle is a MY2016 or MY2017 A6, A7, S6, S7, or RS7 and is equipped with MMI Navigation plus (MIB2 High; PR code 7UG).

Figure 1. myAudi Pin entry screen.

The condition is the result of an MMI software bug and can be fixed by updating the MMI software. The software bug only prevents the myAudi PIN from being stored in the navigation area of the MMI menu. The myAudi pin is saved in the Audi connect menu for accessing custom news feeds.

The service solution is to update the MMI software to SW1062 for MY16 and SW0924 for MY17 to fix the myAudi PIN issue.

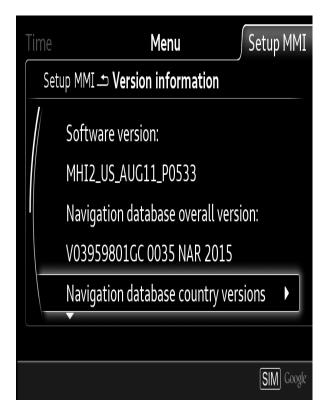
Figure 2. MMI Version Information.

1. Verify that the customer's MMI requires the software update by going to the *Main Menu >> Setup MMI >> Version Information* (Figure 2).
