97 Fuel gauge does not work

97 20 75 2056234/3 June 12, 2020. Supersedes Technical Service Bulletin Group 97 number 19-67 dated November 19, 2019 for reasons listed below.

Model(s)	Year	VIN Range	Vehicle-Specific Equipment
A8	2018 - 2020	All	Not Applicable

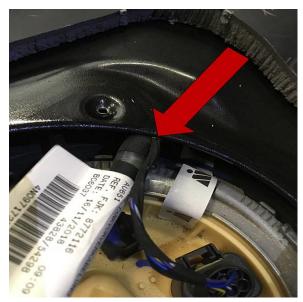
The wiring of the fuel tank senders can rub through on the service opening for the fuel tank.

Figure 1. Location to inspect for rub through.

If any of the above faults are stored the fuel tank harness will need to be inspected:

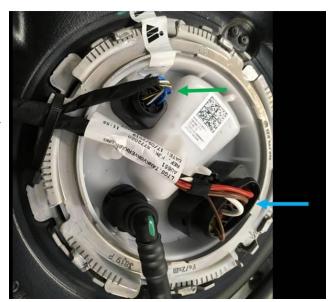
Figure 2. Fuel tank harness connectors to be removed.

- 2. Unplug both connectors on the fuel pump flange.
 - Tools required for the unplugging:
 - Small plug (tank unit) green arrow (Figure 2).
 - Use VAS1978/16 to release the primary lock
 - Use VAS1978/17 to release the secondary lock.
 - Large plug (fuel pump) blue arrow (Figure 2).
 - Use VAS1978/18 to release the primary lock.

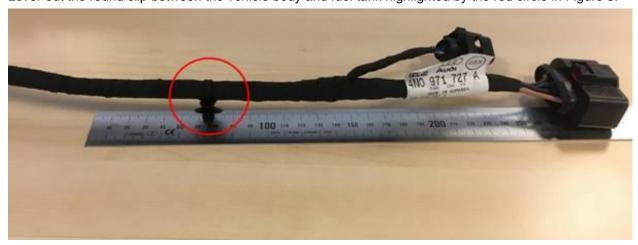
Figure 3. Clip to be removed from the old or new harness.

- 3. Attach a fish tape, mechanics wire or similar to the old wiring harness.
- 4. Lever out the round clip between the vehicle body and fuel tank highlighted by the red circle in Figure 3.

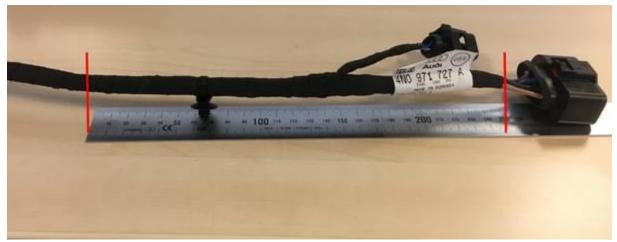
Figure 4. Add additional wrapping between the two red lines, approximately 250mm.

- 8. If any damage is found on the harness, replace the wiring harness and continue with the remaining steps to re-route the new harness.
- 9. If there is no damage found, perform the remaining steps using the existing harness and continue with standard diagnosis.
- 10. Remove the round clip from the wiring harness (red circle in Figure 3.)
- 11. Add an additional wrap to the harness using textile tape **N 105 920 02** between the indicated lines in Figure 4 (approximately 250 mm).

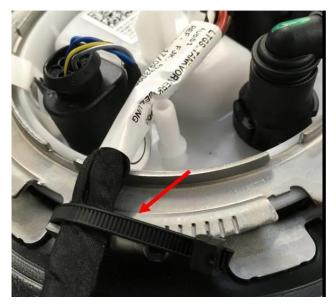
Figure 5. Harness shown secured to tank.

13. Secure the wiring harness with a cable tie to the retaining ring for the tank unit (Figure 5).
