Technical Service Bulletin

97 Car jerks/bucks or hesitates while driving DTCs P023400, P023500, P023600, P023700, and P023800 are stored in the ECM

97 20 76 2058976/3 June 12, 2020. Supersedes Technical Service Bulletin Group 97 number 20-73 dated April 10, 2020 for reasons listed below.

Model(s)	Year	VIN Range	Vehicle-Specific Equipment
Q5	2018 - 2020	All	2.0 liter

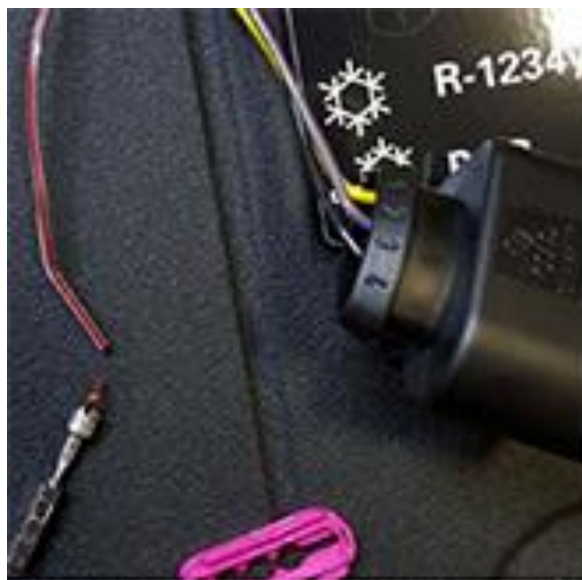
One of the pins or wires at the boost pressure sensor (G31) connector T4e may be backed out or broken due to the routing concept of the engine harness. When inspected, the harness is found to be too tight in the area of the sensor.

Figure 1. T4e with damaged wire.

If there is damage to the pins or wire, repair the harness as needed (Figure 1). Ensure there is sufficient slack in the harness to prevent future issues.
