# Technical Service Bulletin

## 91 Multiple vehicle features (ACC, Nav, DriveSelect, etc.) are not available, DTC P164700 stored in the ECM

91 20 76 2042506/10 June 5, 2020. Supersedes Technical Service Bulletin Group 91 number 20-34 dated February 6, 2020 for reasons listed below.

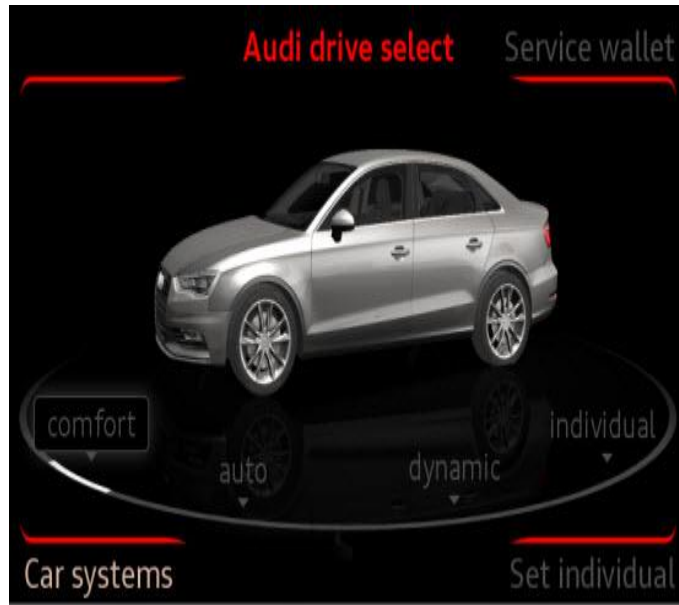
- Audi drive select functions cannot be selected (Figure 1).
- Cruise control does not work (except for A6 and A7) and **DTC P164700** (ECM incorrect coding) is stored in the engine control module (address word 0001 (ECM), etc.).
- Navigation is not activated (Figure 2 and Figure 3).
- Bluetooth is unavailable.
- Audi smartphone interface, including CarPlay or Android Auto, is not available.
- Voice recognition is unavailable (in all cars except A3 Cabriolet. For A3 Cabriolet, see TSB 2038136: 91 Voice recognition is not available or not enabled).

**Figure 1.** Audi drive select functions unavailable and greyed out.

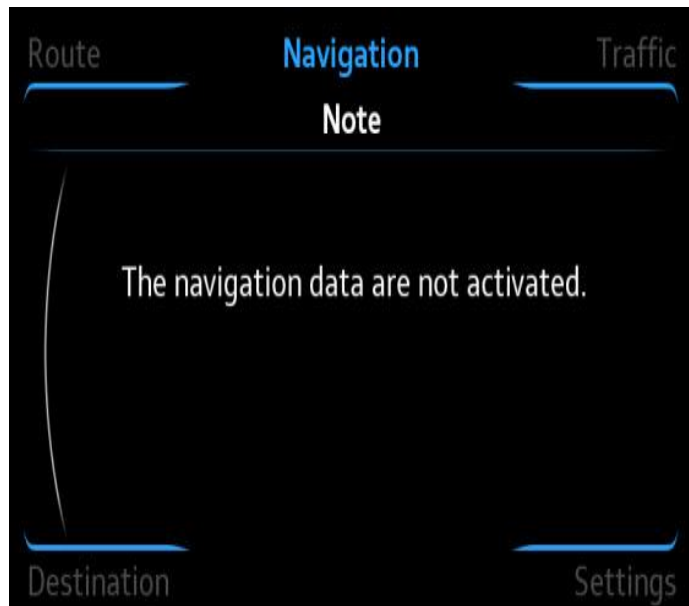
**Figure 2.** Navigation not activated message (Original MIB HMI).

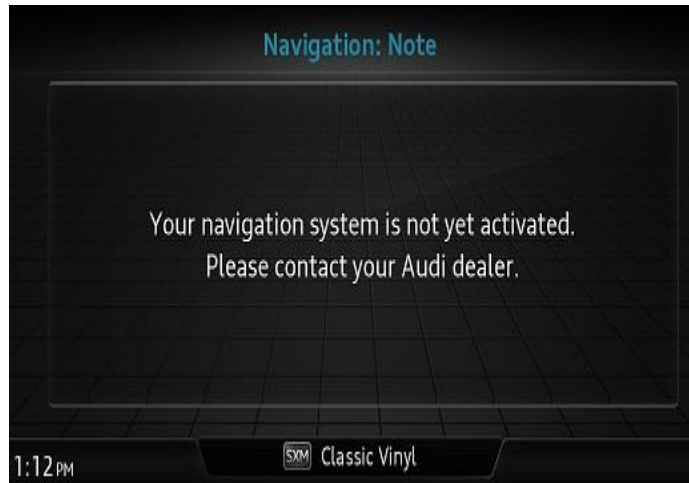
**Figure 3.** Navigation not activated message (New MIB2 HMI).

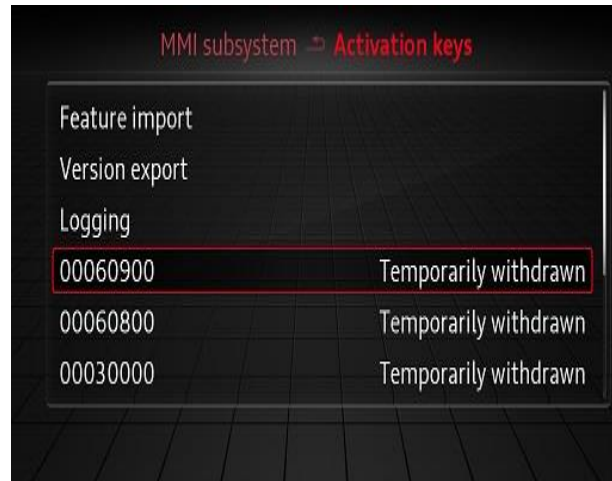
**Temporarily withdrawn or Temp illegal** = This indicates that the SVM activation test plan was not completed (Figure 4). This status is normal for all parts that have been swapped from a different vehicle. Perform the SVM Activations test plan as indicated below, under *Repair Procedure*.

**Figure 4.** Activation keys showing “Temporarily withdrawn”.

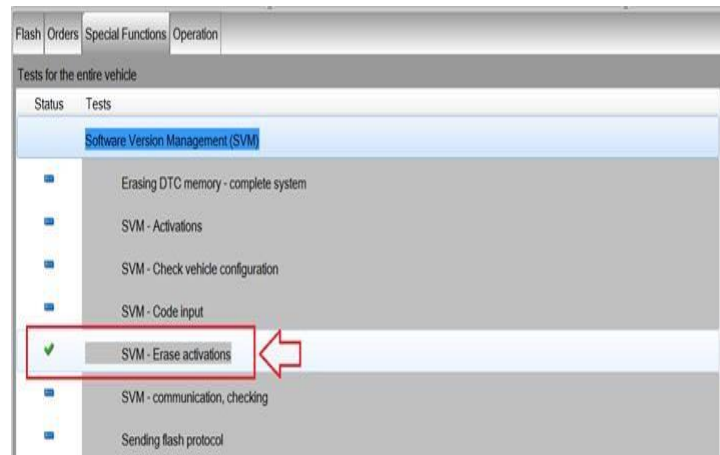
**Figure 5.** SVM – Erase activations.

1. There is a known issue with the activations keys stored in the MMI where they can become corrupt, thus the first step will be to delete the activation keys in the MMI. Delete the activations of the affected system using the ODIS test plan *DIAGNOSIS >> START DIAGNOSIS >> SPECIAL FUNCTIONS >> “SVM – Erase activations”* (Figure 5).

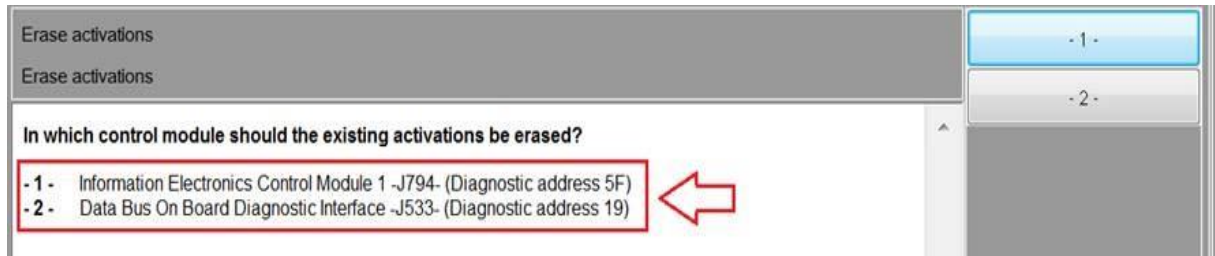
**Figure 6.** MMI (Information Electronics Control Module 1); Gateway (Data Bus On Board Diagnostic Interface).

2. When prompted choose the appropriate system to delete activations based on the customer’s concern:
  - For concerns with Navigation, Bluetooth, Audi smartphone interface, or voice recognition, select option -1- for the MMI (Information Electronics Control Module 1).
  - For concerns with Audi drive select, adaptive and regular cruise control, select option -2- for the Gateway (Data Bus On Board Diagnostic Interface) (Figure 6).

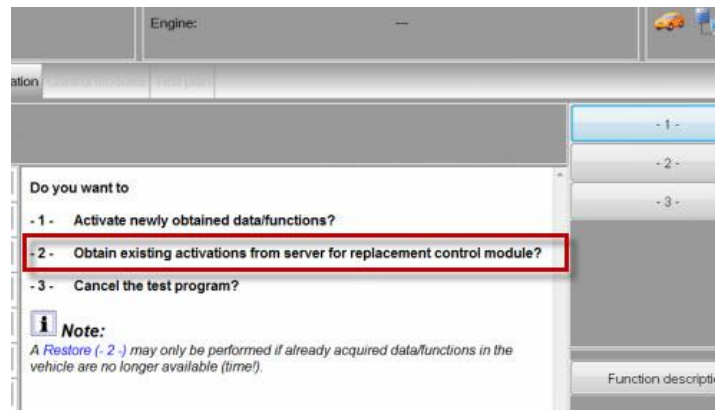
**Figure 7.** Obtain existing activations.

5. When prompted, select “obtain existing activations” (Figure 7).
