ENTRANCE DOOR AIR NOISE DIAGNOSTIC AND REPAIR.

Bulletin Type:	INC	Publication Date:	June 2020
Bulletin #(s):	20-016	Make(s):	ENTEGR A COACH
Model Year(s):	ALL	Model(s):	CORNERSTONE, ANTHEM ASPIRE, INSIGNIA, REATTA

Incident:	Steps to find and correct air noise from or around the entrance door.
Affected Units:	All units with PTL entrance doors.

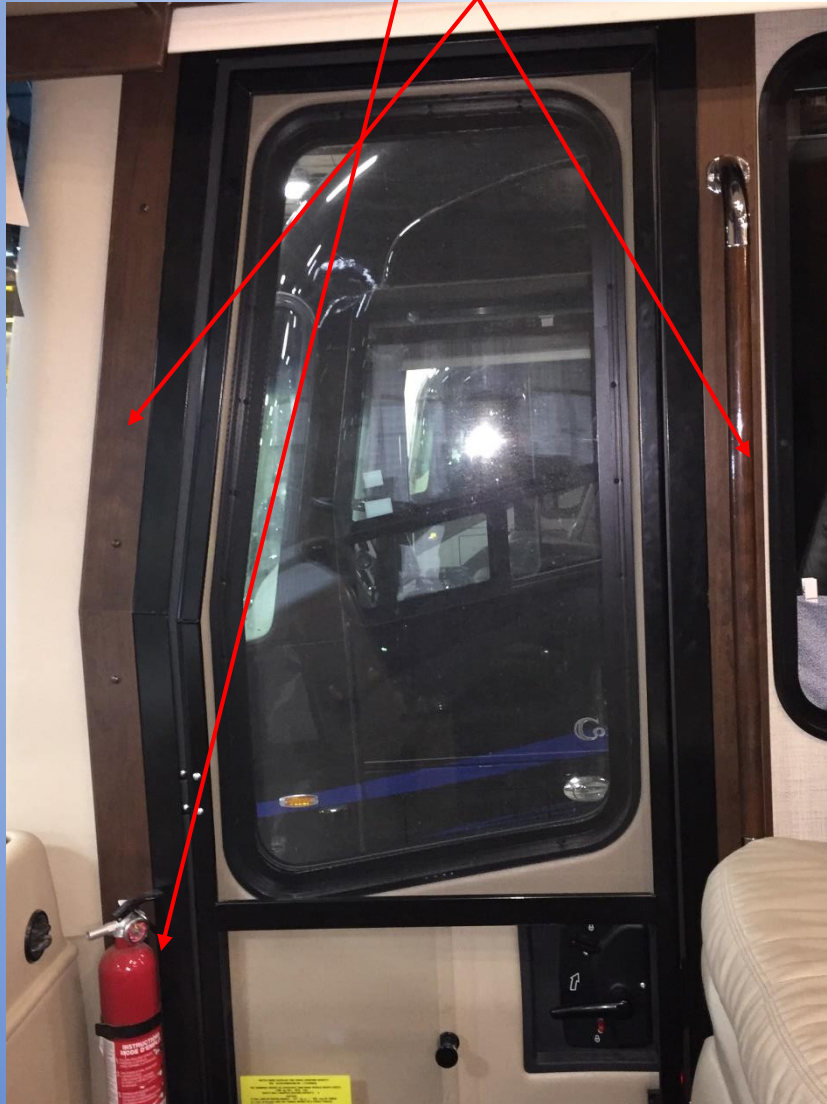
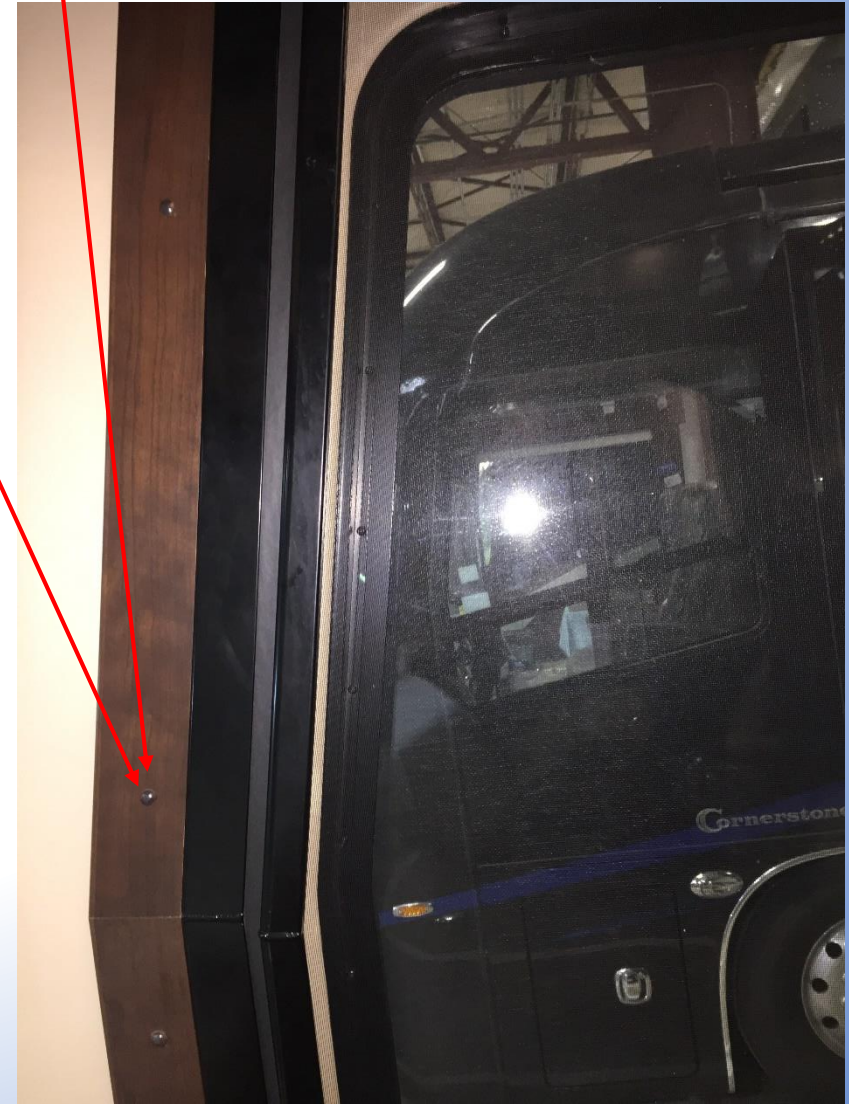
C: ENTRANCE DOOR HAS EXCESSIVE AIR NOISE OR DOES NOT FUNCTION CORRECTLY.

C: THE FRAME IS NOT SQUARE AND EVEN WITH THE DOOR.

REMOVE THE WOOD TRIM FRAME FROM INTERIOR OF THE DOOR.
REMOVE ALL COMPONENTS FROM THE WOOD TRIM; FIRE EXTINGWISHER AND GRAB HANDLE.
REMOVE WOODEN PLUGS AND SCREWS HOLDING TRIM IN PLACE.

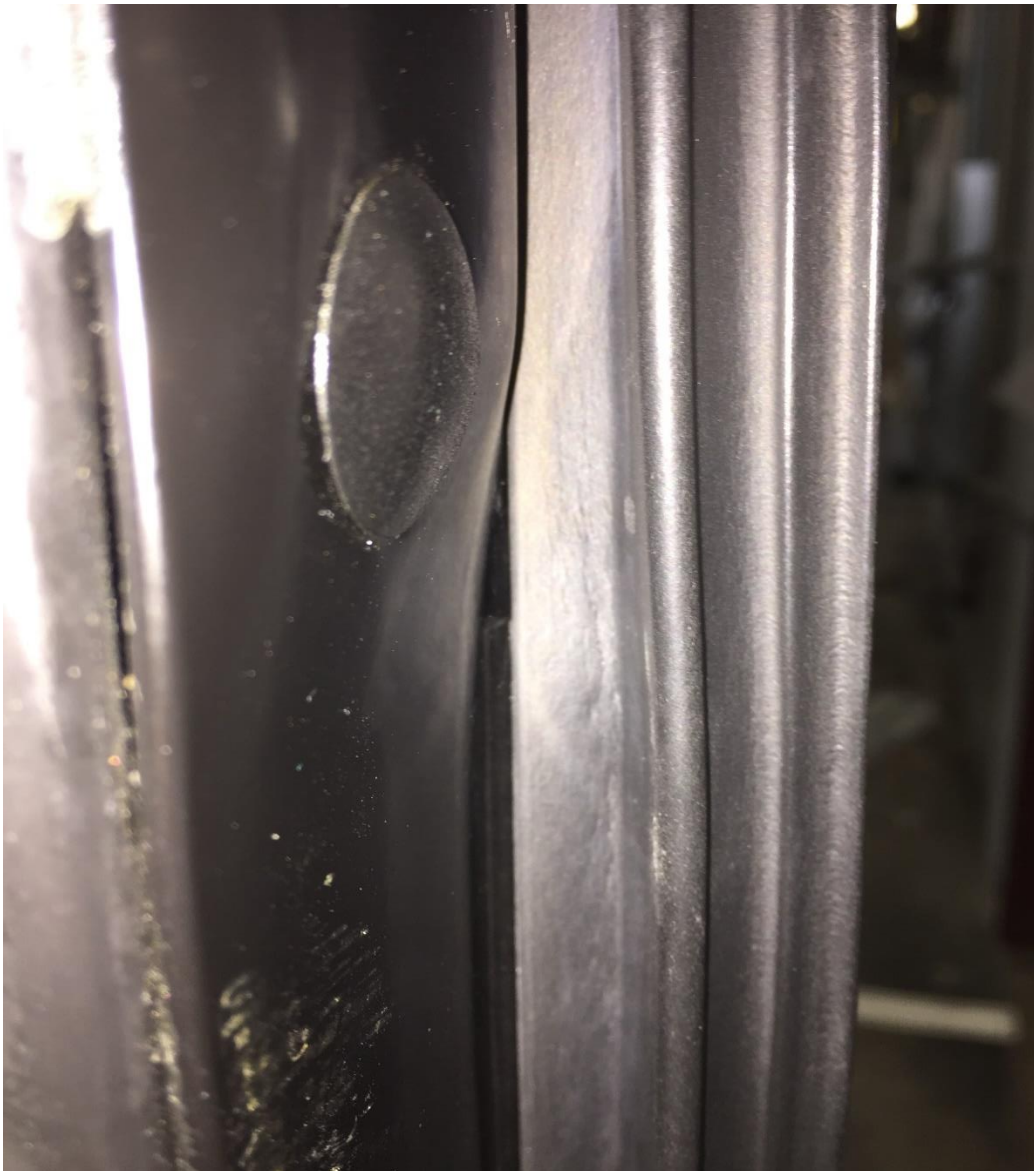
The rubber seal on the door may not be mounted in the proper location for the best seal of the door and may need to be repositioned outward.

- The gap should be checked and frame adjusted before the seal is moved.
 - Older rubber may need to be replaced if it cannot be removed without damage.
- Rubber door flex seal (EC PART #0224320 FLEX SEAL FROM PTL).

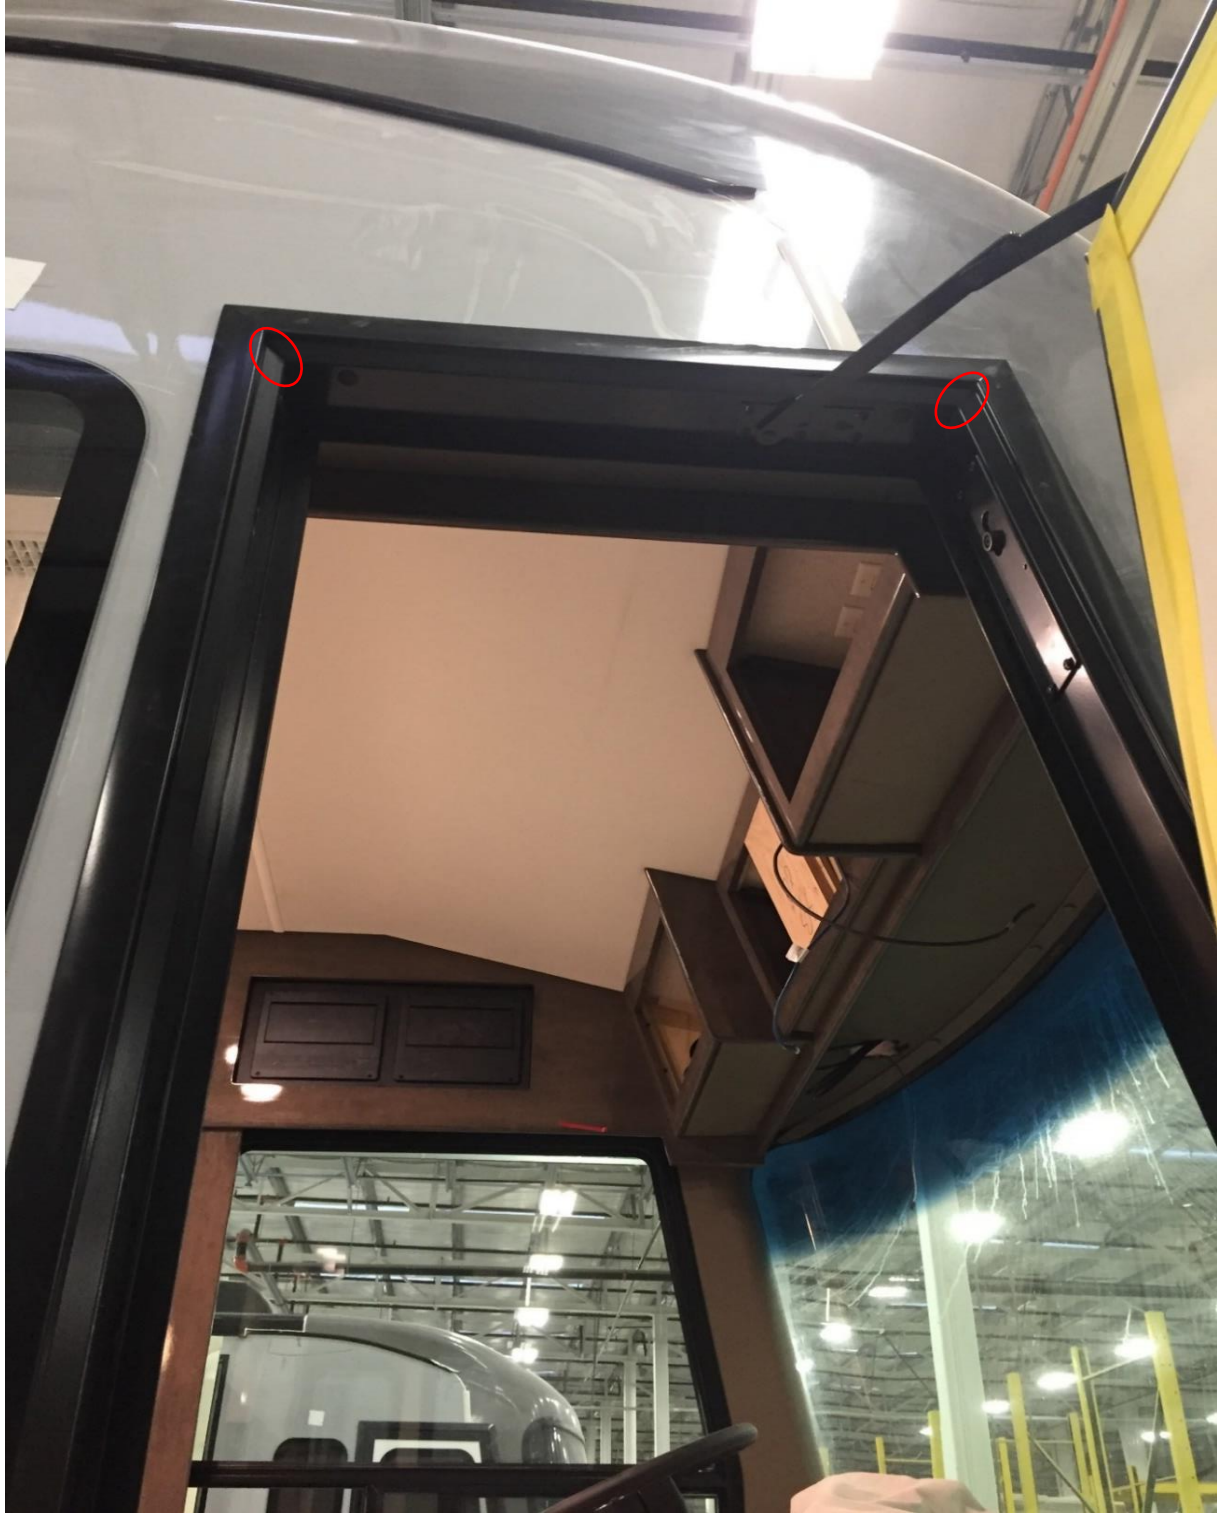
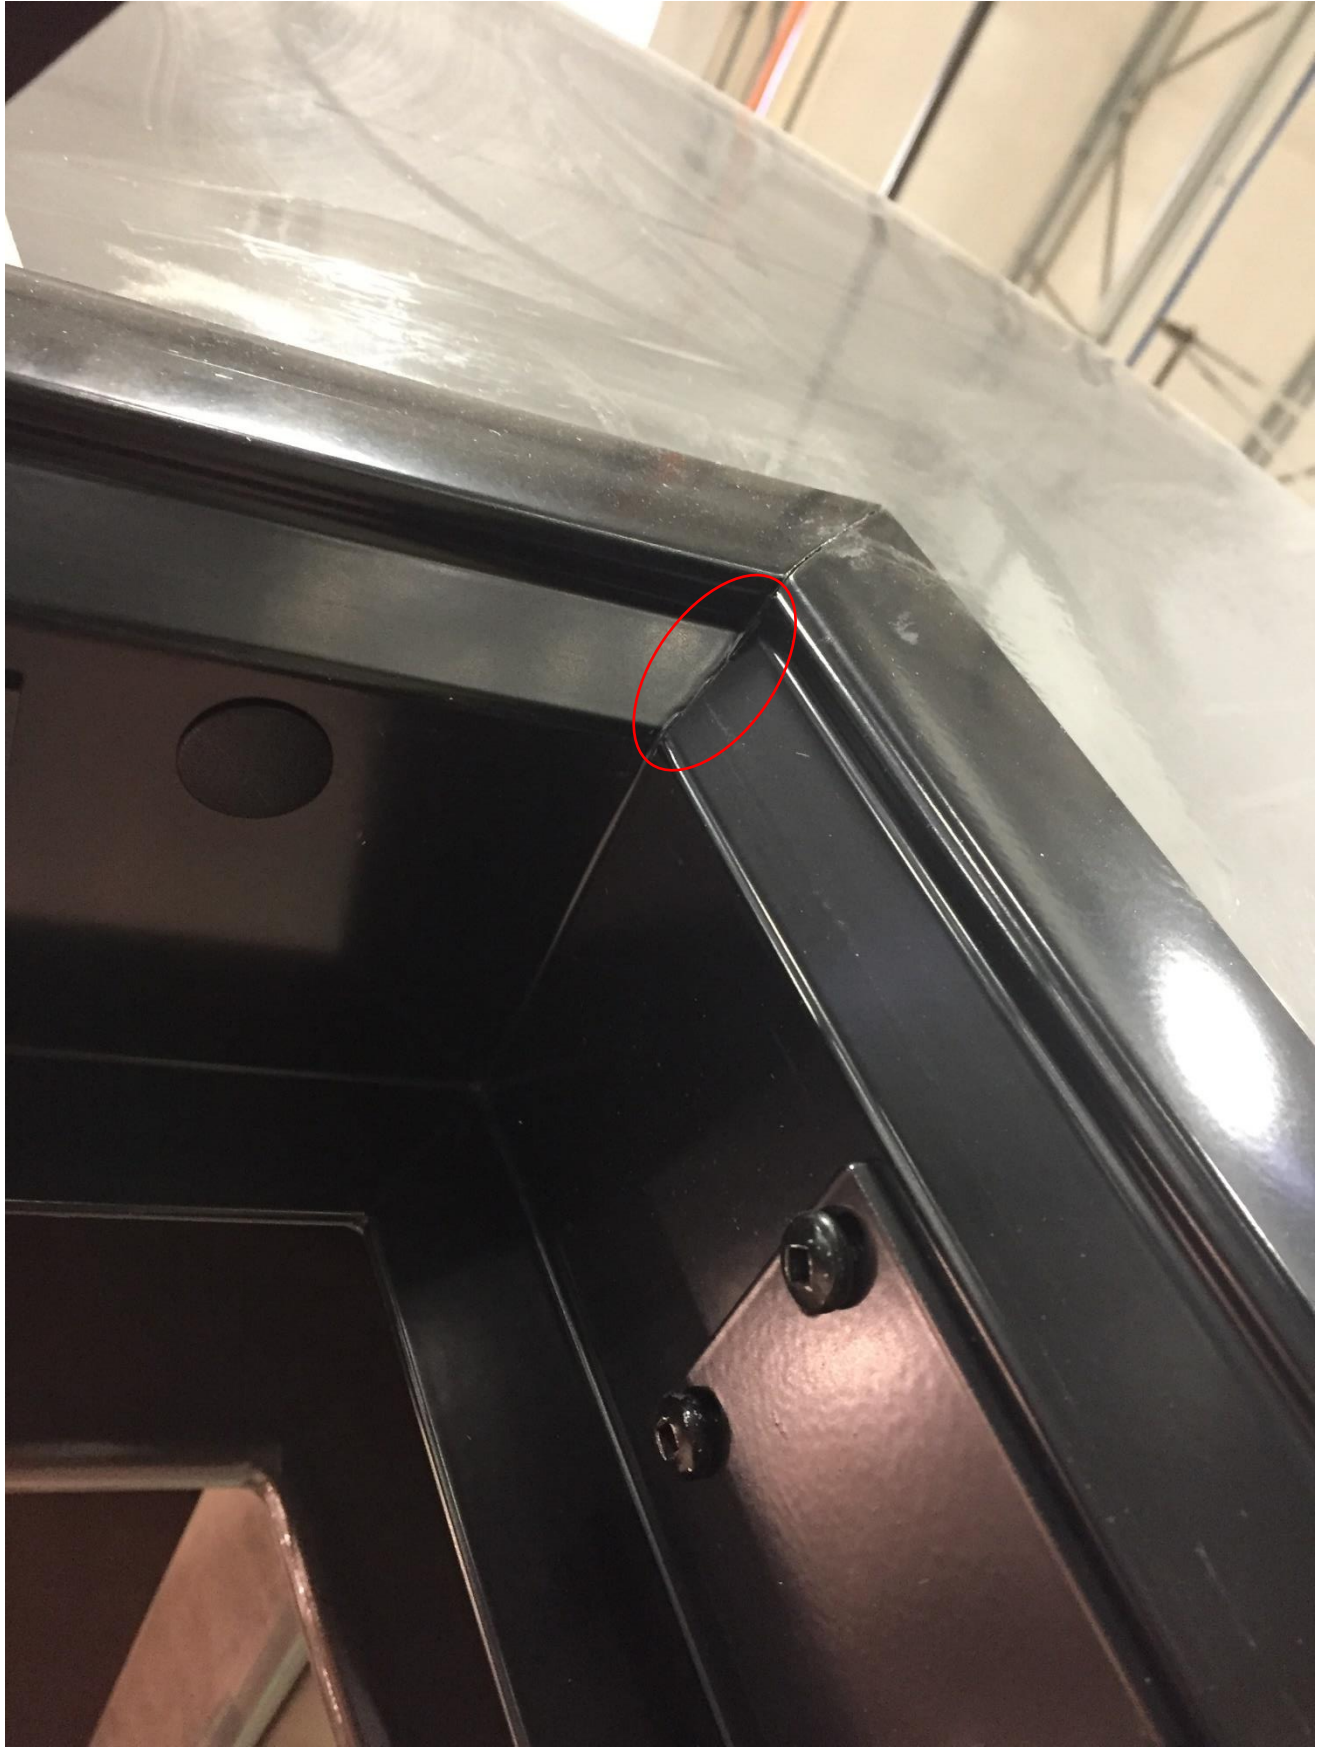
AIR NOISE; 45* SEAM AT FRONT TOP:

There are seams welded from the inside at the top of the door that may leak from lack of weld (back side). PTL recommends E6000 black sealant or something similar to seal them on the front side to seal and stop the air noise.

8. Inspect the 45* seams at the top of the frame where the rubber seal on the door contact the frame. Sealing the gaps with a seal adhesive will stop the wind noise.
E6000 2-fl oz. Bonding Clear Multipurpose Adhesive, Item #556902 Model #237032.
Refer to "AIR NOISE; 45 SEAM AT FRONT TOP" document.
