Service Action

Code: 97DZ

Audi

Subject	Transmission Wiring Harness																												
Release Date	June 12, 2020																												
REVISION SUMMARY	Updated claiming quantity for tape part number N 10592002.																												
Affected Vehicles

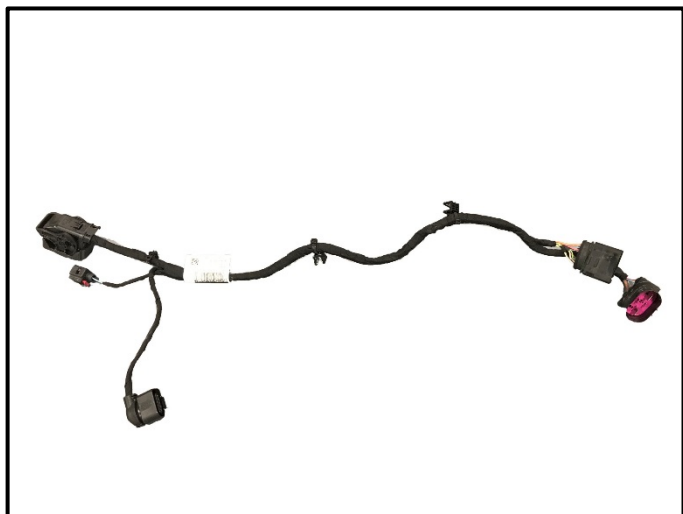
- Modify transmission wiring harness.
- Repair wiring if necessary.

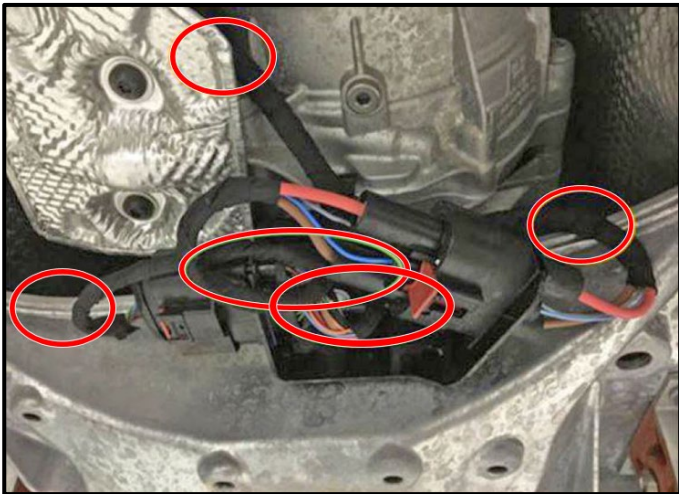
Inspect transmission wiring harness for damage:

- Thoroughly inspect the transmission and body side wiring harness and routing near the areas shown.

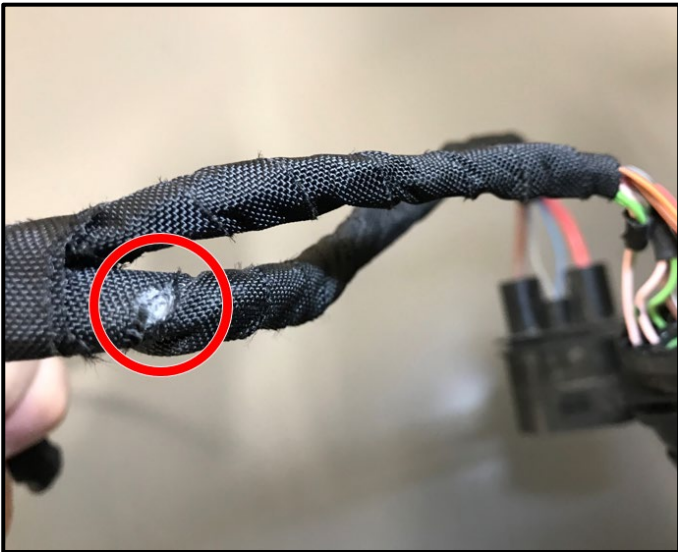
- Pay very close attention to all areas making contact with any bracket or mount. Harness damage may be very subtle and even a light chaffing could lead to faults.
- Repair wiring as needed per the repair manual.
 - See ELSA Repair Manual: *Repair manual > Electrical System > Electrical Equipment General Information > 97 Wiring > Wiring Harness and Connector Repairs*
- Ensure the repairs are staggered as needed to:
 1. Avoid large bunches of repairs in the harness.
 2. Avoid a repair at a critical flex point, e.g. over the transmission cross brace.

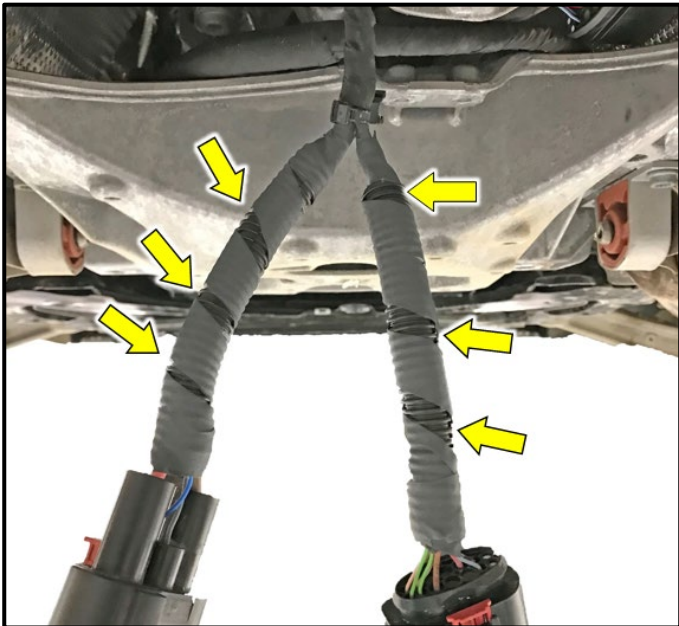
The gaps in the tape are necessary to allow water to flow out of the wiring harness.

- Wrap corrugated tube with fabric tape.

- Ensure there is gap between the tape windings <arrows>.
- Ensure the corrugated tube is secured to the wiring harness with the fabric tape to prevent the harness from sliding inside the corrugated tube.
