# TECHNICAL SERVICE BULLETIN

## Technical Service Bulletin: 40-1176

Forest River is alerting you to an issue involving certain 2020 through 2021 – Berkshire - BEA34QS-360, BEA37A-380, BEA39A-360, BEA40C-380, BEA40D-380, BEA40E-380, BEA45A-450, BEA45B-450, BEA45CA-450 and BEA45SL-450 Class A Motor Home Recreational Vehicles. Please see the information below, which describes the issue and provides you with details on the steps you should take to have your vehicle repaired.

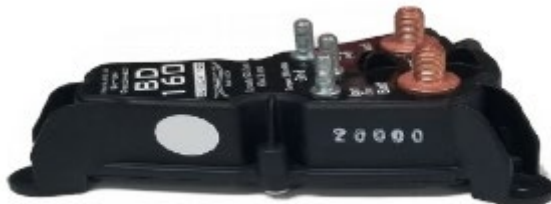
Coach battery disconnect turning off on its own. PCI Part # 00-10041-100. Parts with the date code 19127 – 19325 (Stamped in white ink on the rear of the battery disconnect) will need to be replaced.

- 1.) Battery Disconnect 00-10041-100 Date Code 20000 or greater that is stamped in white on the side of the part.

- 1.) Turn off the manual battery disconnect switch, use a volt meter to insure power has been removed from the battery disconnect;
- 2.) Use the tape and marker to label each cable, then use the socket wrench to remove the nuts from Ground, Ignition, Battery and Load, then remove the cables;
- 3.) Remove the three mounting screws from the battery disconnect, then install the new battery disconnect using the three mounting screws;
- 4.) Put all of the cables back to the correct position and hand tighten the nuts. Remove the tape from the wires;
- 5.) Using a torque wrench tighten Ground and Ignition to 20 in-lbs., then tighten the Battery and the Load cables to 50 in-lbs.;
- 6.) Turn the manual battery disconnect back to the on position.
