Tech Tip T-TT-0609-20

Headlamp DRL Function Issue Identification

2019-2020 Avalon

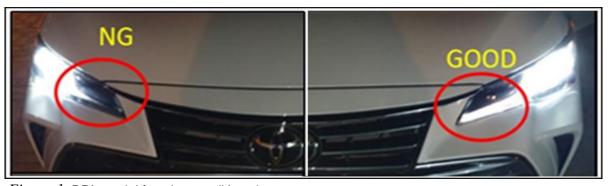
Some 2019 & 2020 model year Avalon & Avalon HV may exhibit abnormal, partial or 100% inoperative function of either the passenger side, driver side, or both LED¹ Headlamp Day Time Running Lights (DRL). This may be caused by an internal fault in the headlamp assembly or DRL logic issue.

Figure 1. DRL partial function condition shown.

- In the event the Headlamp LED-DRL is exhibiting abnormal, partial or 100% no function of either passenger side, driver side or both LED-DRLs use the flowchart on the next page titled "19-20MY Avalon Headlamp DRL Function Issue Identification Flow" to judge between headlamp assembly internal fault or LED-DRL logic issues.
