Vibration and noise with light brake application - rear axle runout

2016-2019 Tundra

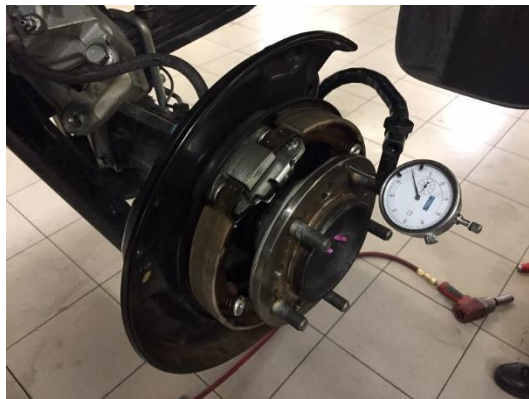
Some 2016-2019 model year Tundra vehicles may experience vibration and noise with light brake application. Rear axle runout may not meet the specification of 0.05 mm (0.00197 in.)

1. Confirm there is vibration and/or noise from the rear brakes during light brake application at low (parking lot) speeds.
2. Measure axle flange runout.

3. If out of specification (0.05 mm (0.00197 in.)), please create a TAS case and contact TAS for instruction prior to diagnosing or repairing of the vehicle. If it is a weekend or holiday, continue with diagnosis and repair. Please save all parts and/or details and contact TAS on the next available work day. If within specification, please continue to diagnose using the applicable Repair Manual.
