Subject Headlamp DRL Function Issue Identification		Market USA
Service Category Vehicle Exterior	Section Lighting (ext)	
Applicability 2019-2020 Avalon And Avalon HV

Headlamp DRL Function Issue Identification

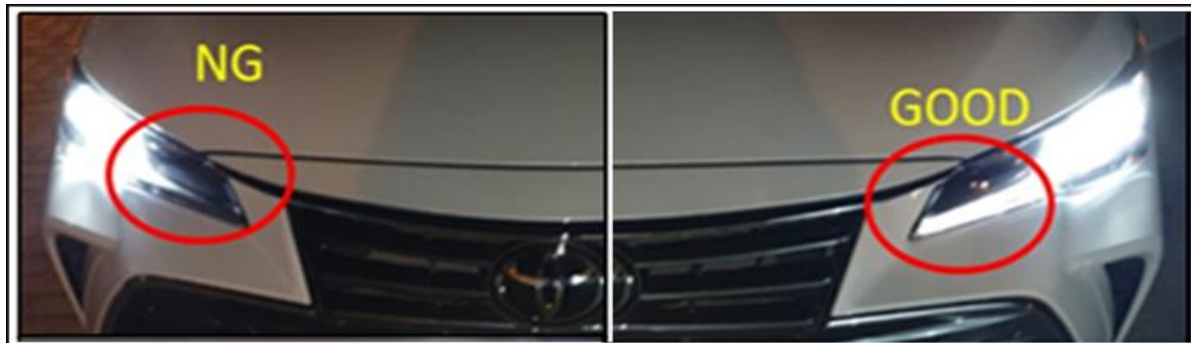
Some 2019 and 2020 model year Avalon and Avalon HV may exhibit abnormal, partial or 100% inoperative function of either the passenger side, driver side, or both LED¹ Headlamp Day Time Running Lights (DRL). This may be caused by an internal fault in the headlamp assembly or DRL logic issue.

Figure 1. DRL partial function condition shown.

1. In the event the Headlamp LED-DRL is exhibiting abnormal, partial or 100% no function of either passenger side, driver side or both LED-DRLs use the flowchart on the next page titled **“19-20MY Avalon Headlamp DRL Function Issue Identification Flow”** to judge between headlamp assembly internal fault or LED-DRL logic issues.

2. In the case where headlamp assembly internal fault is identified per DRL Function Issue Identification Flow Chart in the next page, or if is not an internal fault, then:

- Continue diagnosis using the applicable Repair Manual.
3. In the case where logic issue is identified:
 - Submit a Dealer Product Report on TIS including pictures and details of the condition.

- Inform the customer that this issue is currently under investigation and that the issue only affects the headlamp DRL function when the vehicle is in reverse and the headlamps are turned on. Recommend turning on their headlamps when their shifter is in the Park or Drive positions.
