STAR ONLINE PUBLICATION

Case Number: S1923000027

Symptom/Vehicle Issue: Tail Light Too Close To Tailgate

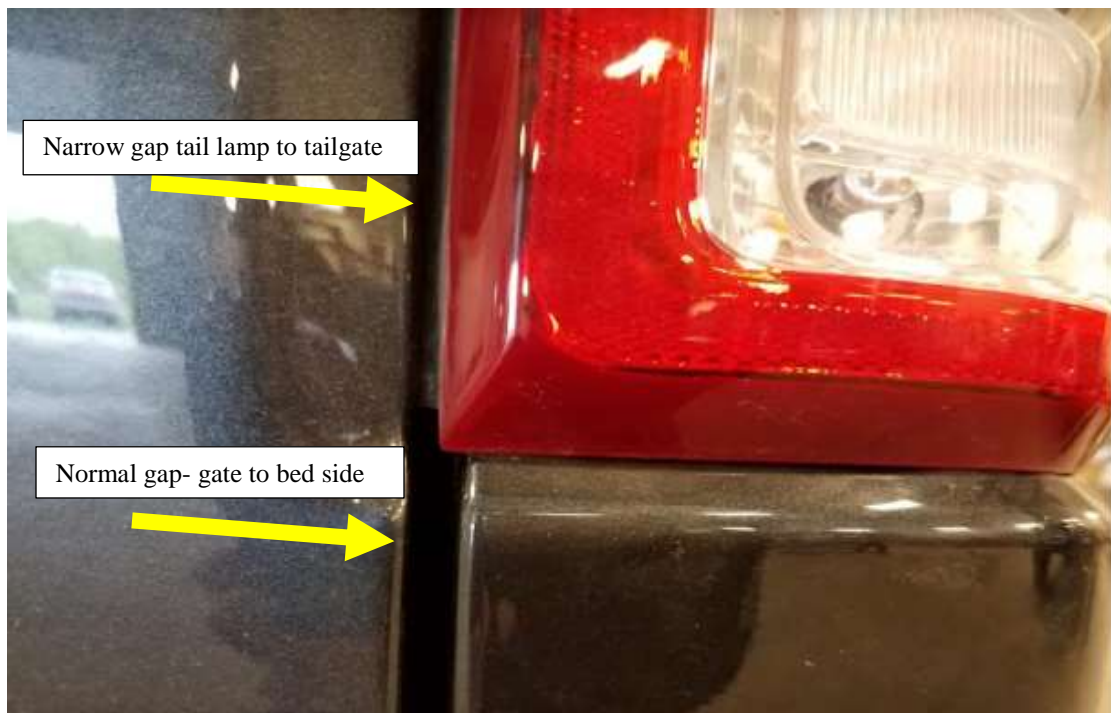
Discussion: If an owner has a complaint of tail light fit appearance slight fitment issues can be improved with adding a shim to the tail lamp. Shimming can improve a lamp too close to the gate. See below image.

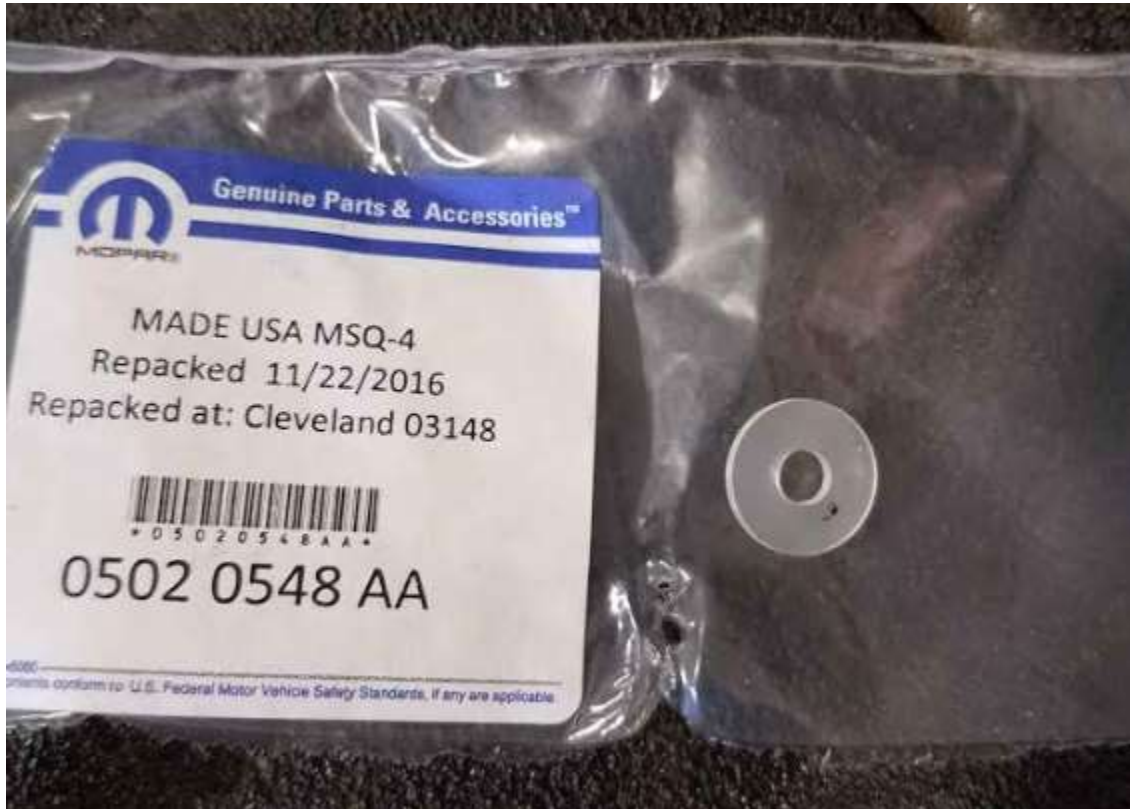
Use the butyl or RTV in a small quantity to temporarily adhere the washer to the lamp housing at the screw location requiring shimming. In the first figure the bottom of the lamp required shimming. Only apply 1 shim to the screw location requiring shimming.

To shim the lamp, remove the assembly 08 - Electrical/8L - Lamps and Lighting/Lamps/Lighting - Exterior/LAMP, Tail Stop Turn/Removal and Installation.

Obtain 05020548AA- package of 4 clear plastic washers and some butyl or RTV

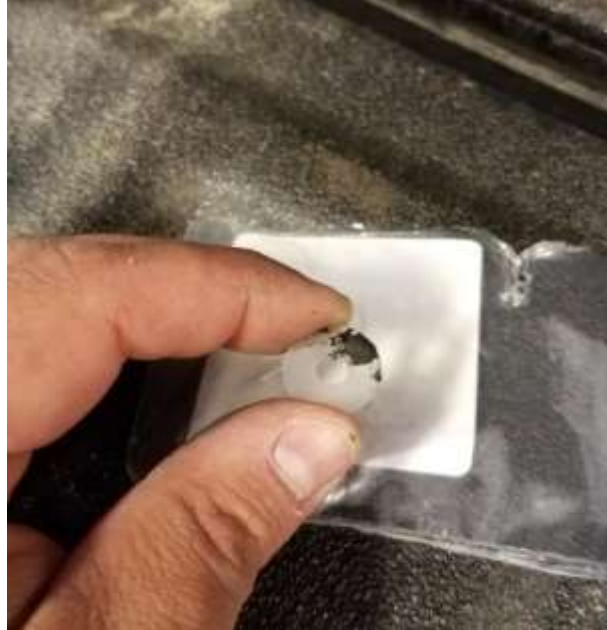
Butyl or RTV on washer to hold it in place for assembly

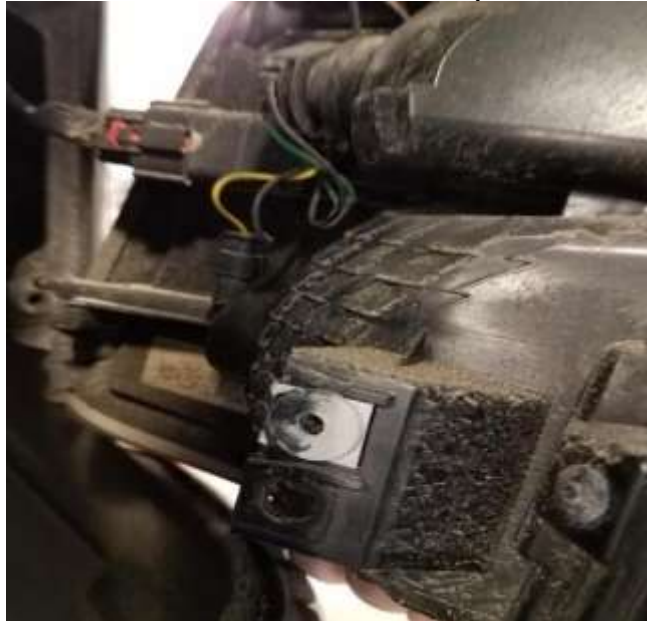
Washer applied to tail light screw clip

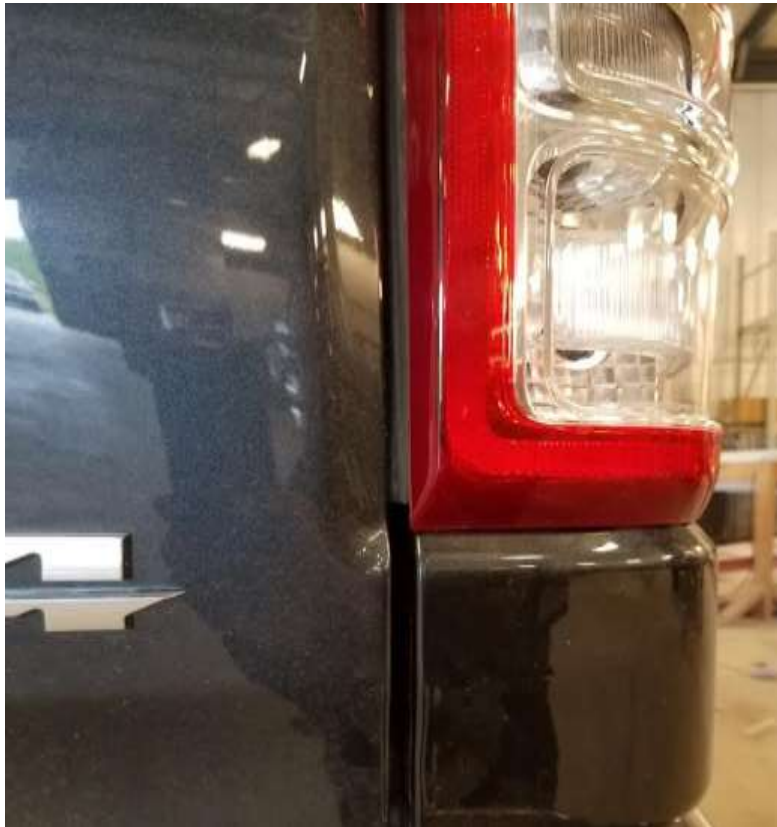
Tail light improved fit

Install tail lamp assembly. 08 - Electrical/8L - Lamps and Lighting/Lamps/Lighting - Exterior/LAMP, Tail Stop Turn/Removal and Installation
