STAR ONLINE PUBLICATION

Case Number: S2008000055

Symptom/Vehicle Issue: Battery Vent Tube Does Not Align With Some New Battery Installations

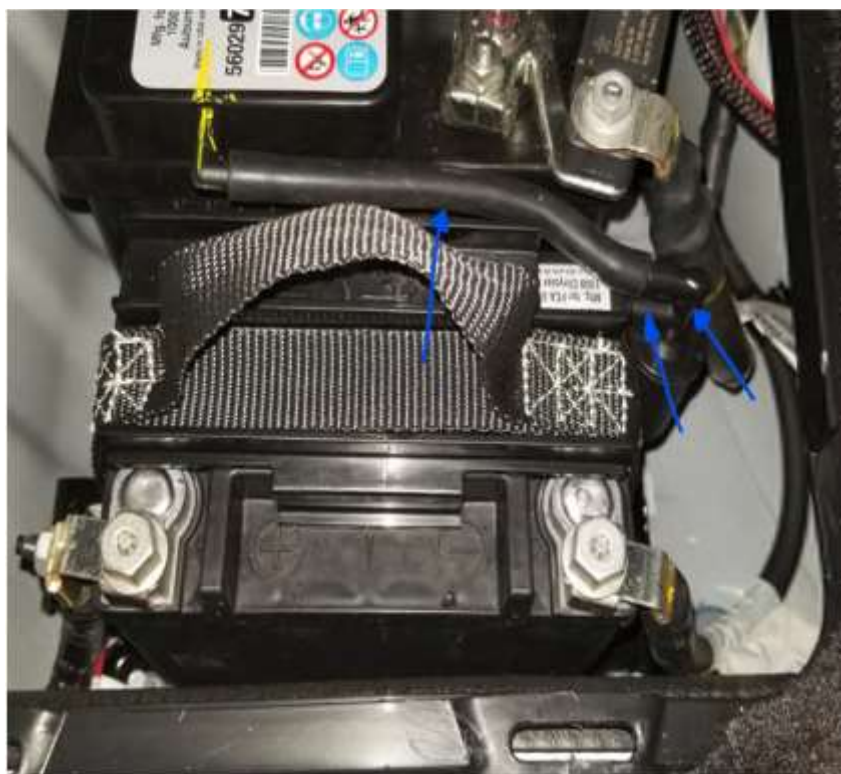
Technician observation: The replacement battery vent tube is not aligned with the original battery vent tube orientation.

Repair Procedure: The OEM elbow and vent tube does not connect with original vent port on auxiliary battery.
