STAR ONLINE PUBLICATION

Case Number: S2008000068

Symptom/Vehicle Issue: Intermittently The Stop/Start (ESS) System Is Inoperative

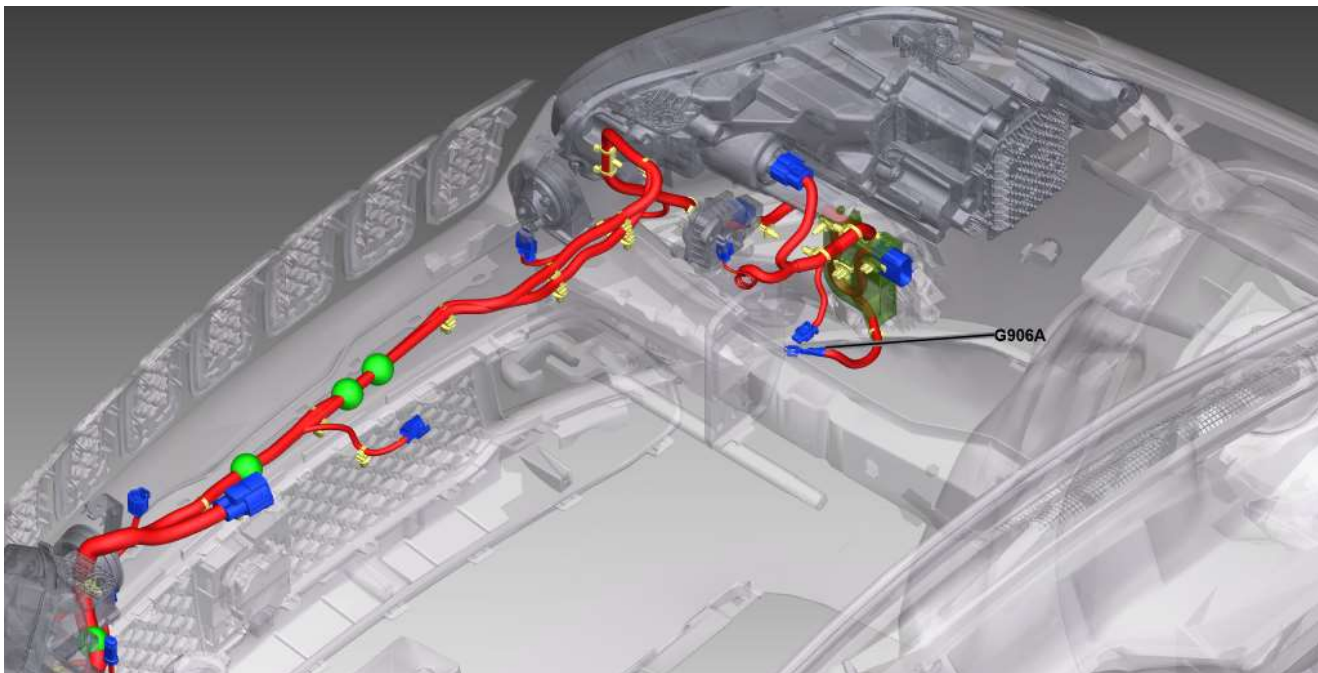
Discussion: A loose G906A ground may cause the Stop/Start (ESS) system to intermittently become inoperative.

Diagnosis: Inspect the G906A ground located in the engine bay on the passenger front frame horn. Physically inspect for a loose connection and potential corrosion at the ground location.

Repair: Clean and tighten the ground to secure the connection.
