## STAR ONLINE PUBLICATION

**Case Number:** S2008000072

**Symptom/Vehicle Issue:** No Crank, Extended Crank To Start, MIL Lamp On

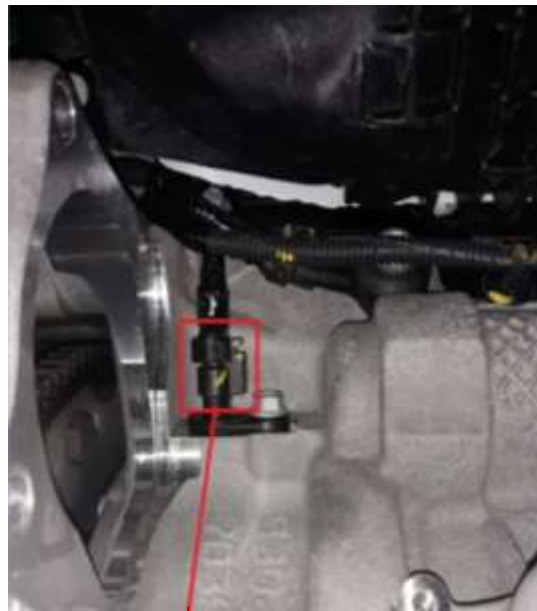
**Fig 1**

**Customer complaint/ technician observation:** Owner complains the vehicle has an intermittent no crank and or extended crank to start, check engine lamp on. Technician may not experience the condition; but vehicle has a stored DTC P0335 Crankshaft Position Sensor Circuit.

**Note:** The engine may still start even if either the CKP or CMP (crank position or cam position) fails. The PCM eventually sorts out engine position and can start the vehicle on just one of these two inputs. However, there is a delay in starting until the PCM can establish sync. A DTC is set and the MIL illuminates if either of the CKP or CMP Sensor signals are not present during engine cranking.

**Repair Procedure:** Inspect the crank position sensor connector, secure the connector. Use the push pull method to confirm the connector is securely locked in place. No parts required Fig 1, 2.
