STAR ONLINE PUBLICATION

Case Number: S2008000076

Symptom/Vehicle Issue: Exhaust Manifold Heat Shield Rub Through Of MDS Solenoid Wiring. P3449, P3441, P3425, And P3401 May Be Set In The PCM

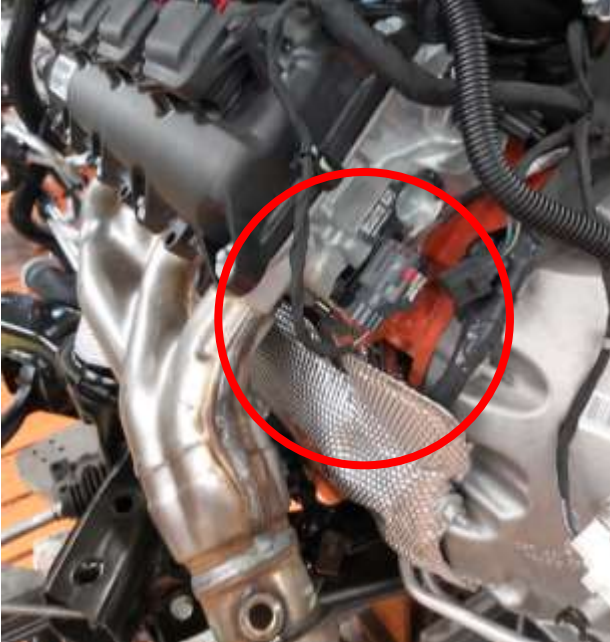
Rear of driver's side cylinder head

Discussion: The heat shield for the driver's side exhaust manifold can easily deform during assembly or repair. The heat shield is known to deform in such a way that it contacts the MDS solenoid wiring harness located at the rear of the driver's cylinder head.

Diagnosis: Inspect the clearance between the heat shield and the MDS solenoid wiring at the rear of the drivers cylinder head. Confirm that there is a minimum of 15mm of clearance between the edge of the heat shield and the wiring harness.

Repair: If there is less than 15mm of clearance. Obtain the desired clearance by bending or cutting away the heat shield from the wiring harness. Repair any wiring harness chaffing damage found.

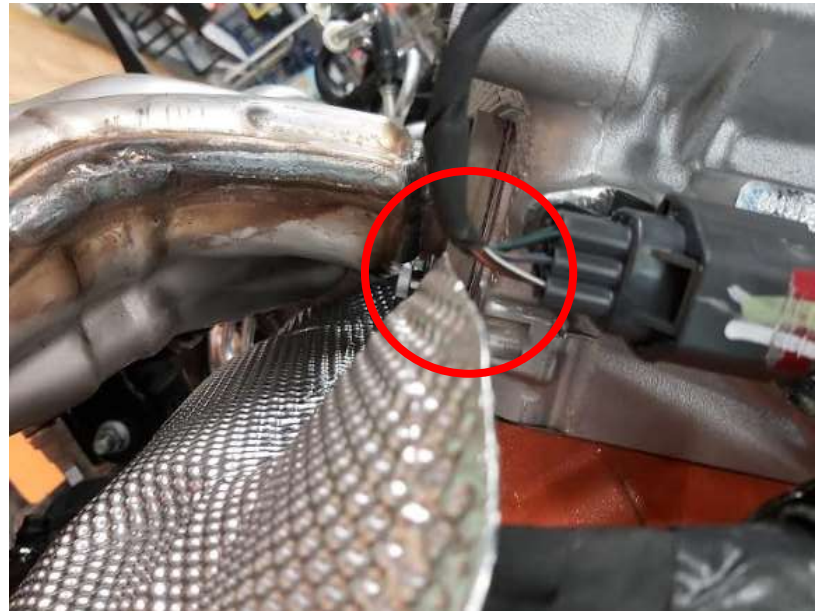
Wiring rub through point
