## STAR ONLINE PUBLICATION

**Case Number:** S2023000030

**Symptom/Vehicle Issue:** Squeak Noise Opening Or Closing Front Door

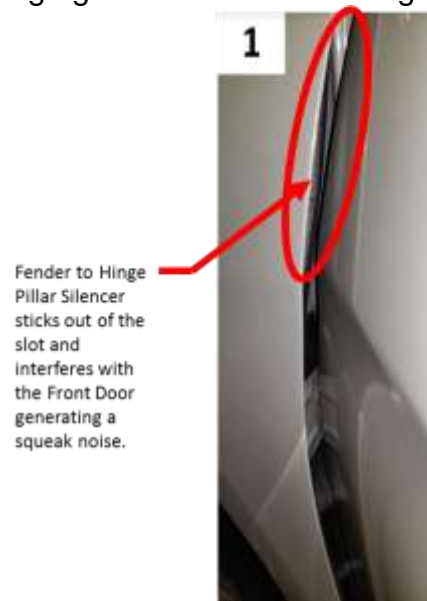
**Figure 1**

**Discussion:** Noise isolated to the upper area of front door near door hinge.

**Repair Procedure:** When performing the noise analysis, open and close the door and observe whether the front door is rubbing against the fender to hinge pillar silencer. See Figure 1.
