NUMBER: 09-008-20

Inspect Hydraulic Belt Tensioner

This bulletin involves inspecting the Julian date on the hydraulic belt tensioner for possible replacement.

2020 (DT) RAM 1500 Pickup

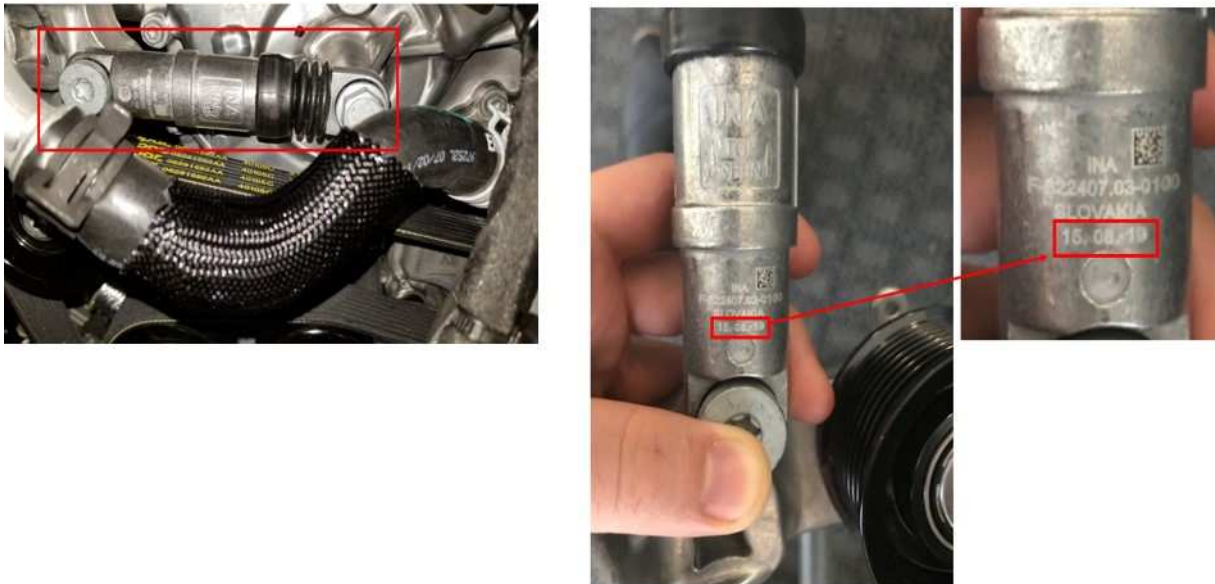
Fig. 1

NOTE: Only vehicles with this (15.08.19) Julian date code on the hydraulic belt tensioner should be replaced any other Julian date code is a good component.

2. Does the tensioner have this six digit stamped Julian date (15.08.19) on the front of the hydraulic belt tensioner (Fig. 1) ?
 - YES>>> Proceed to [Step 1](#) of the Repair Procedure.
 - NO>>> This bulletin has been completed, use inspect LOP (07-20-18-95) to close the active RRT, normal diagnosis maybe necessary for the MIL light if the Julian date code is not (15.08.19).

Location of (15.08.19) Julian Date Code

1. Replace the hydraulic belt tensioner. Refer to the detailed service procedures available in DealerCONNECT/Service Library under: Service Info>07 - Cooling / Accessory Drive / Tensioner, Belt / Removal and Installation (Fig. 2) .
2. Clear any DTCs that may have been set.
