**NUMBER:** 08-057-20

Navigation Feature Missing

2020 (M7) Jeep Compass

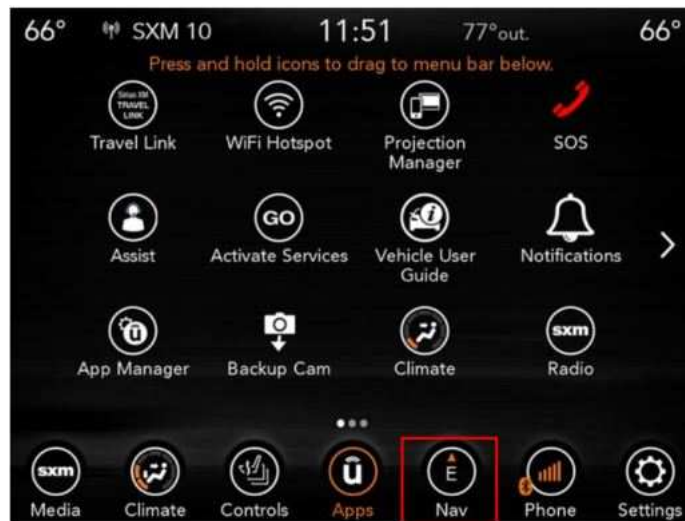
Fig. 1

1. Put the ignition in the “RUN” and turn on the radio, Check for a “Nav” icon on the bottom of the radio display, (Fig. 1) .

### Nav Icon Location on Display Screen

2. Was the “Nav” icon **missing** on the radio display screen?
  - YES>>> Proceed to [Step 1](#) of the Repair Procedure.
  - NO>>> This bulletin has been completed. Use inspection LOP (18-19-02-S1) to close this active RRT.

1. Using wiTECH, “Restore Vehicle Configuration”. This routine is available under the “Guided Diagnostics” tab found on the home, “Vehicle View”, page of wiTECH.
2. Perform a “Proxi Configuration Alignment” and follow all prompts:
  - a. Cycle the ignition OFF, unplug wiTECH pod and close the doors to let all modules go to sleep.
  - b. Reconnect wiTECH.
  - c. Cycle the ignition “ON” again.
3. Clear any DTC’s which may have been set during this repair procedure.
4. Is the “Nav” icon on the radio display screen?
  - YES>>> This bulletin has been completed.
  - NO>>> Normal diagnostic should be performed.
