**NUMBER:** 21-036-20

**DATE:** May 16, 2020

Transmission Case Oil Leak

2019 (RU) Chrysler Pacifica

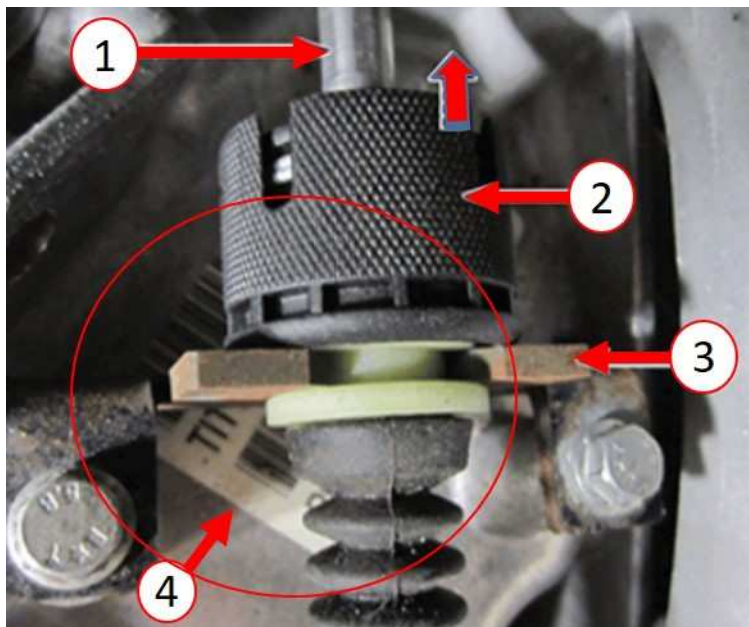
**Fig. 1**  
**(Reference Picture) for Transmission Tag Location**

1. Inspect the transmission tag located under the shifter cable, for the plant code and build date (Fig. 1) .

**NOTE:** It may be necessary to remove the Powertrain Control Module (PCM) and the two bolts holding the shifter cable, to view the transmission tag.

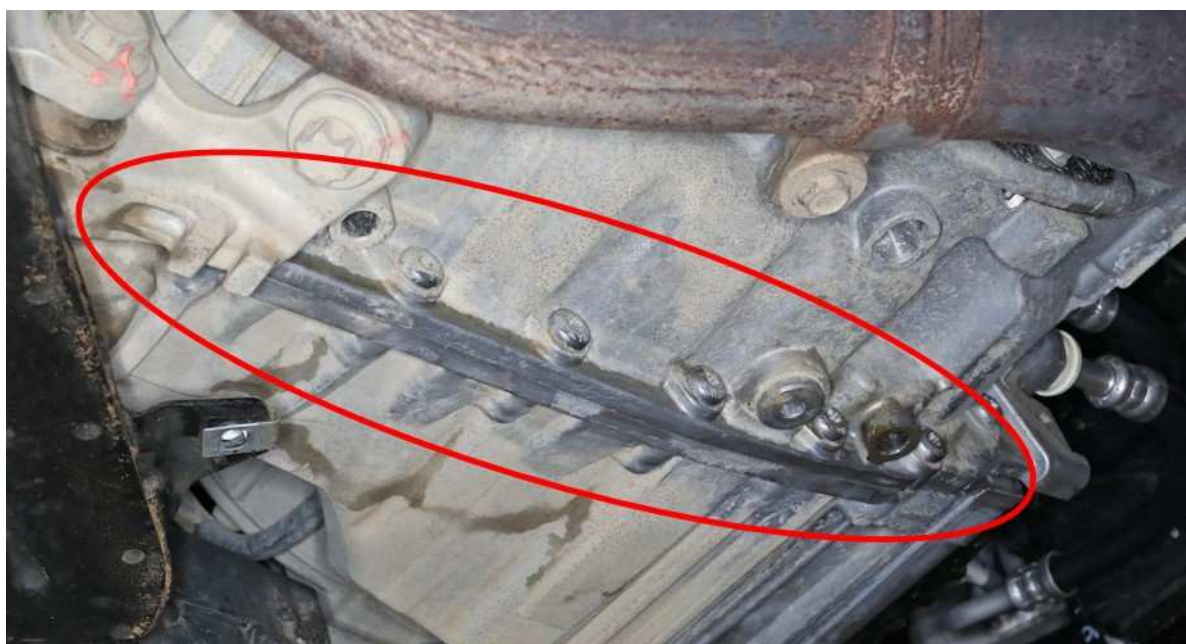
**Fig. 2**  
**(Reference Picture) Potential Leak Area at Case Split**

Customers may notice (possibly transmission) fluid leaking on the ground from the left front of the vehicle.

5. Start the vehicle and verify the transmission fluid temperature is above 50 °C (122 °F).
6. Verify the transmission fluid level and it is not leaking at the repair area (Fig. 2) , if a leak is still detected further diagnosis should be performed.

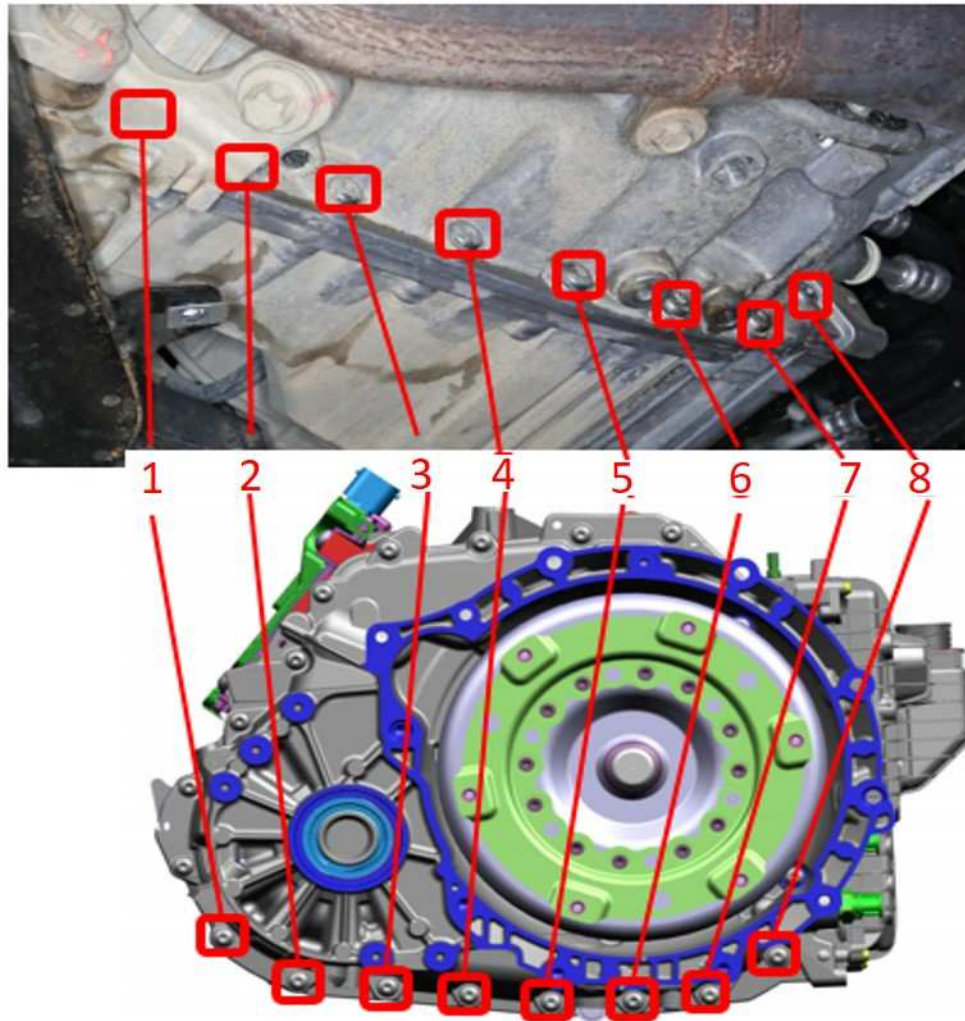
Fig. 4

(Reference Picture) Eight Bolts to be Torqued to Specifications at Potential Leak Area at the Case Split

2. Starting at bolt #8 and then working to bolt #1, torque bolts to 35 N·m (26 ft. lbs.) (Fig. 4) .

**CAUTION! Do not rotate the bolts counter clockwise.**
