**NUMBER:** 21-036-20 REV. A

**GROUP:** 21 - Transmission and Transfer Case

Transmission Case Oil Leak

2019 (RU) Chrysler Pacifica

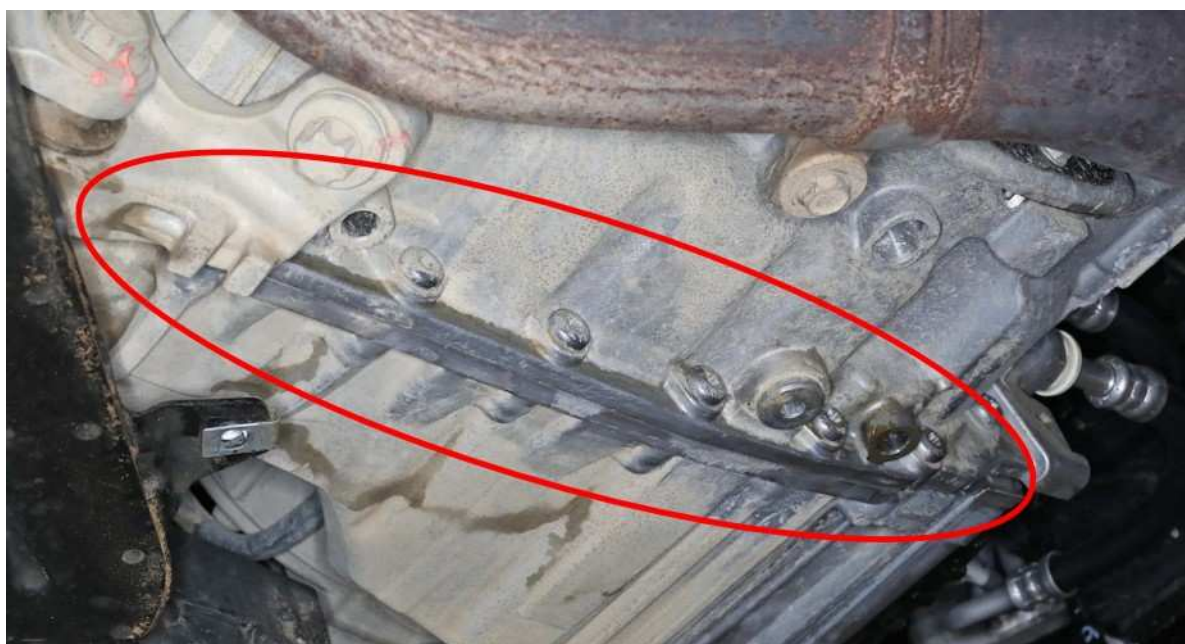
Fig. 2  
(Reference Picture) Potential Leak Area at Case Split

This bulletin involves tightening the lower transmission bolts to updated torque specifications to possibly eliminate a leak at the case split line of the transmission.

Customers may notice (possibly transmission) fluid leaking on the ground from the left front of the vehicle.

5. Start the vehicle and verify the transmission fluid temperature is above 50 °C (122 °F).
6. Verify the transmission fluid level and it is not leaking at the repair area (Fig. 2) , if a leak is still detected further diagnosis should be performed.

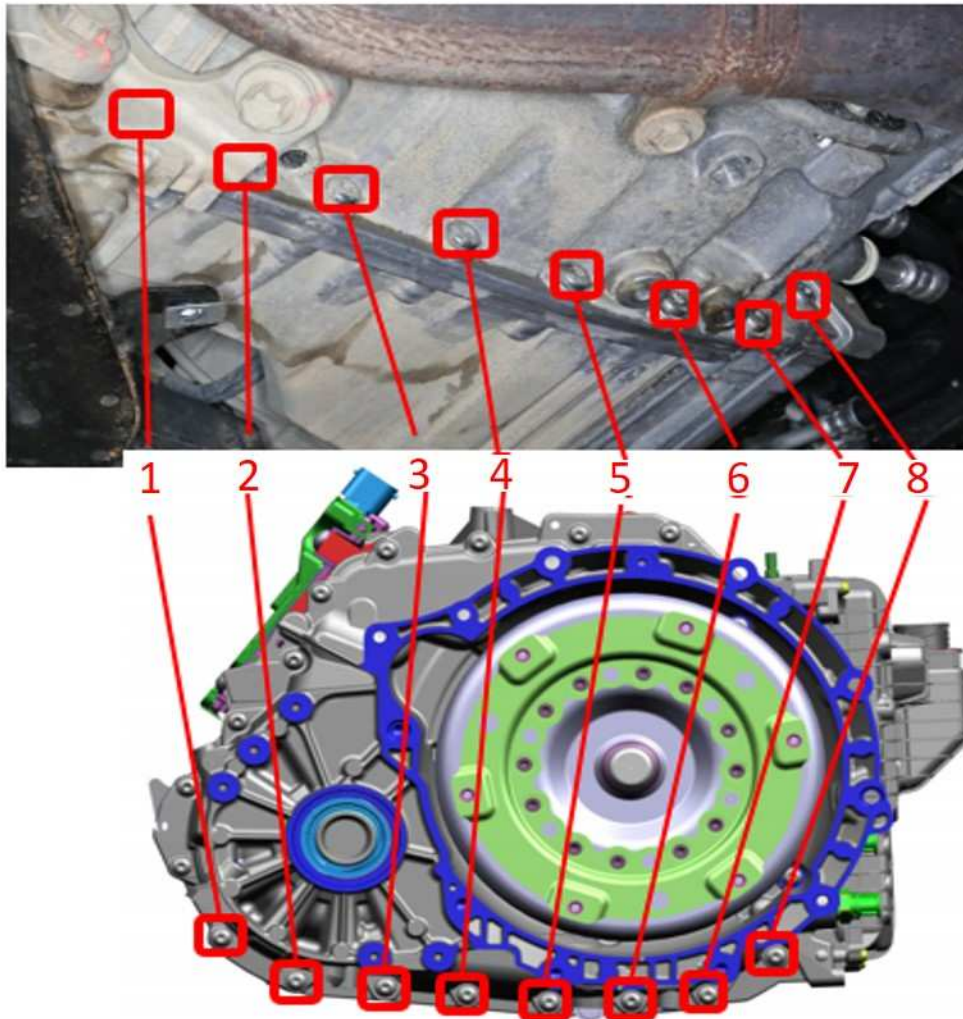
Fig. 4

(Reference Picture) Eight Bolts to be Torqued to Specifications at Potential Leak Area at the Case Split

2. Starting at bolt #8 and then working to bolt #1, torque bolts to 35 N·m (26 ft. lbs.) (Fig. 4) .

**CAUTION! Do not rotate the bolts counter clockwise.**
