NUMBER: 07-001-20 REV. B

Water Pump Inlet Tube Fastener Torque

2018 - 2020 (JL) Jeep Wrangler

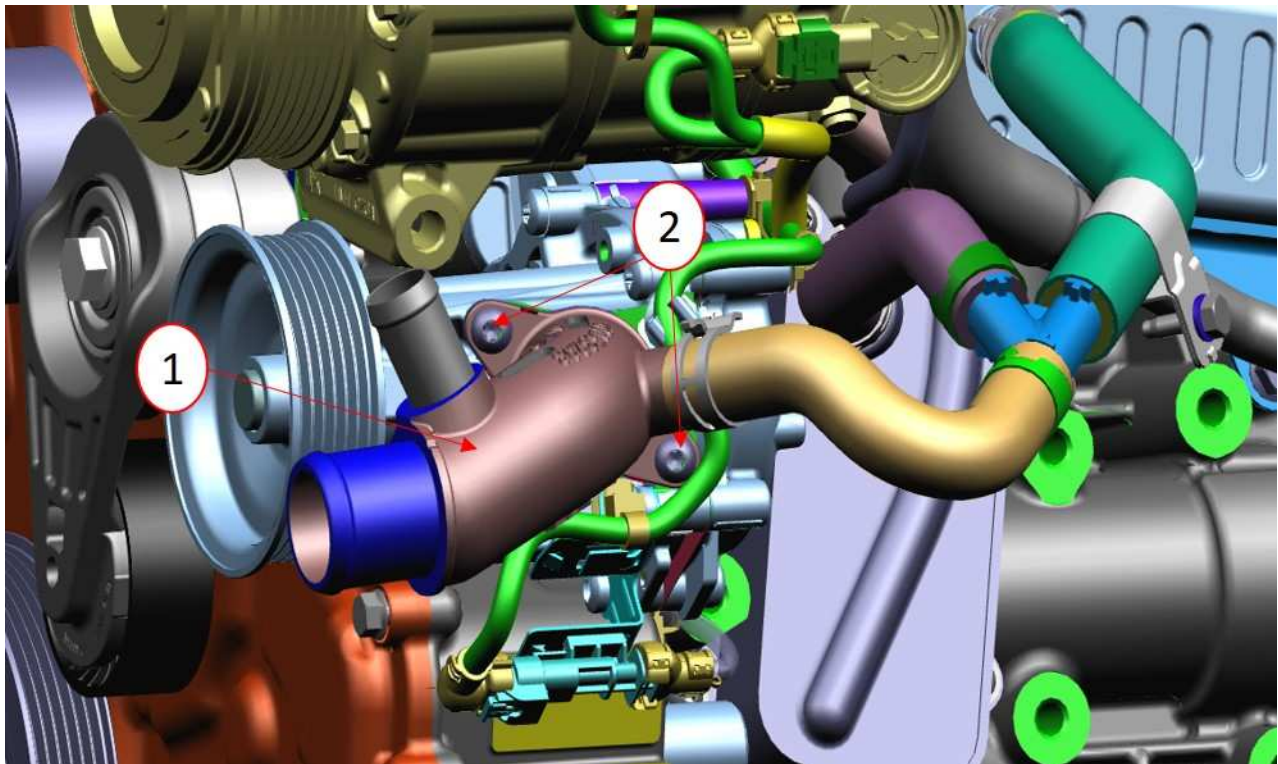
Fig. 1
Water Pump Inlet Tube Fasteners

1. Pressure check the coolant system. Refer to the detailed service procedures available in DealerCONNECT> Service Library under: Service Info>07 - Cooling / Diagnosis and Testing >Leak Testing>Pressure Tester Method.
2. Was coolant found to be leaking from the water pump inlet tube at the engine (Fig. 1) ?
 - YES>>> Proceed to [Step 1](#) of the Repair Procedure.
 - NO>>> Coolant was not leaking from this area. This Bulletin does not apply. Normal diagnosis should be performed.

1. Torque the water pump inlet tube fasteners to exactly 11 N·m (97 in. lbs) (Fig. 1) .

2. Pressure check the coolant system. Refer to the detailed service procedures available in DealerCONNECT>Service Library under: Service Info>07 - Cooling / Diagnosis and Testing >Leak Testing>Pressure Tester Method.
3. Is coolant still leaking from the water pump inlet tube at the engine (Fig. 1) ?
 - YES>>> Further diagnosis should be performed.
 - NO>>> This bulletin has been completed.
