# Technical Service Bulletin

| <b>Technical Service Bulletin:</b> TSB200117 | <b>Released Date:</b> 20-May-2020 |
| <b>FC227 Caused By Water Intrusion in Engine Intake Throttle Actuator Connector</b> | |

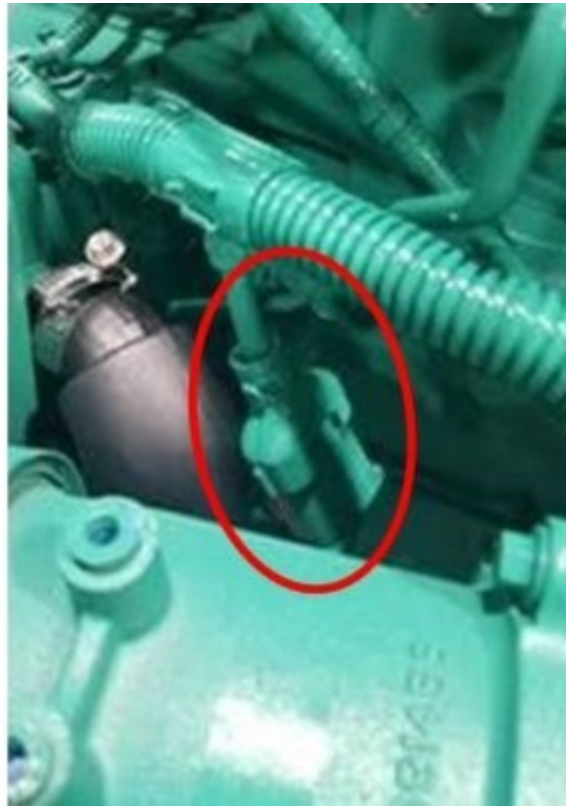
19r99664

- Engines built without an engine intake throttle actuator will have a cap on the wire harness near the intake. Incorrect orientation of the capped connector allows water to enter the electrical connector cap.

Figure 1, Location of Connector

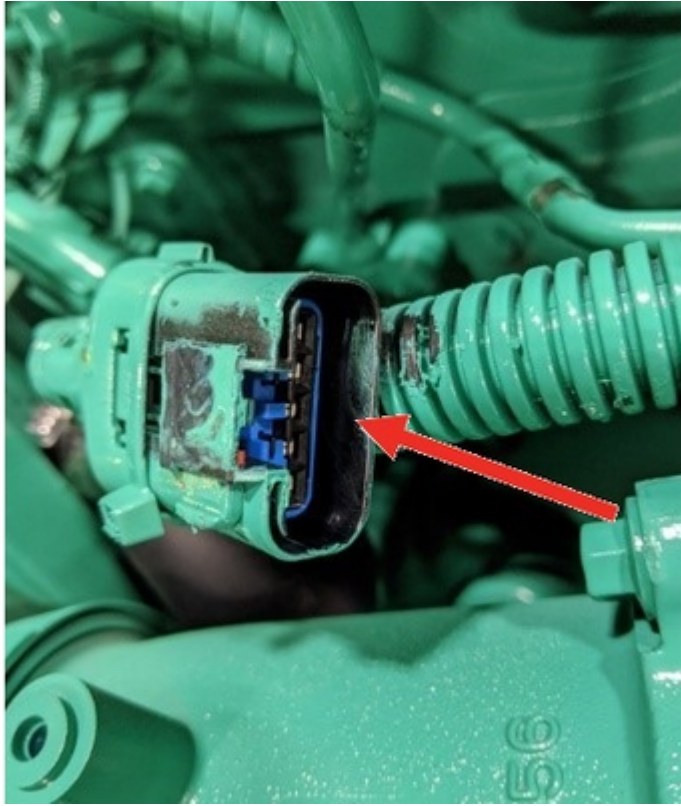
19r99665

Figure 2, Blow Out Excess Water

Remove the cap on the engine intake throttle actuator connector and use compressed air to blow out the excess water. Replace dry cap afterwards.

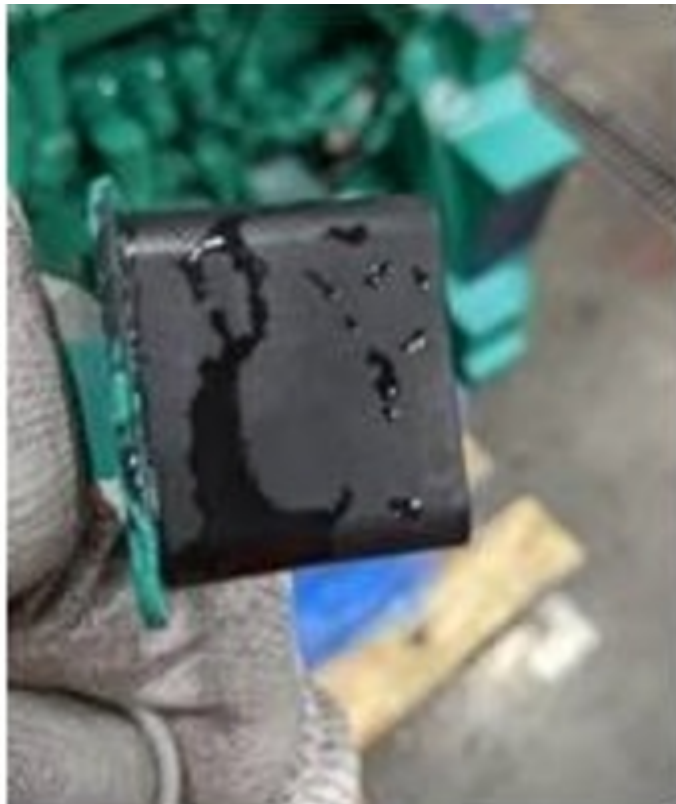
19r99666

Figure 3, Cap Found with Water

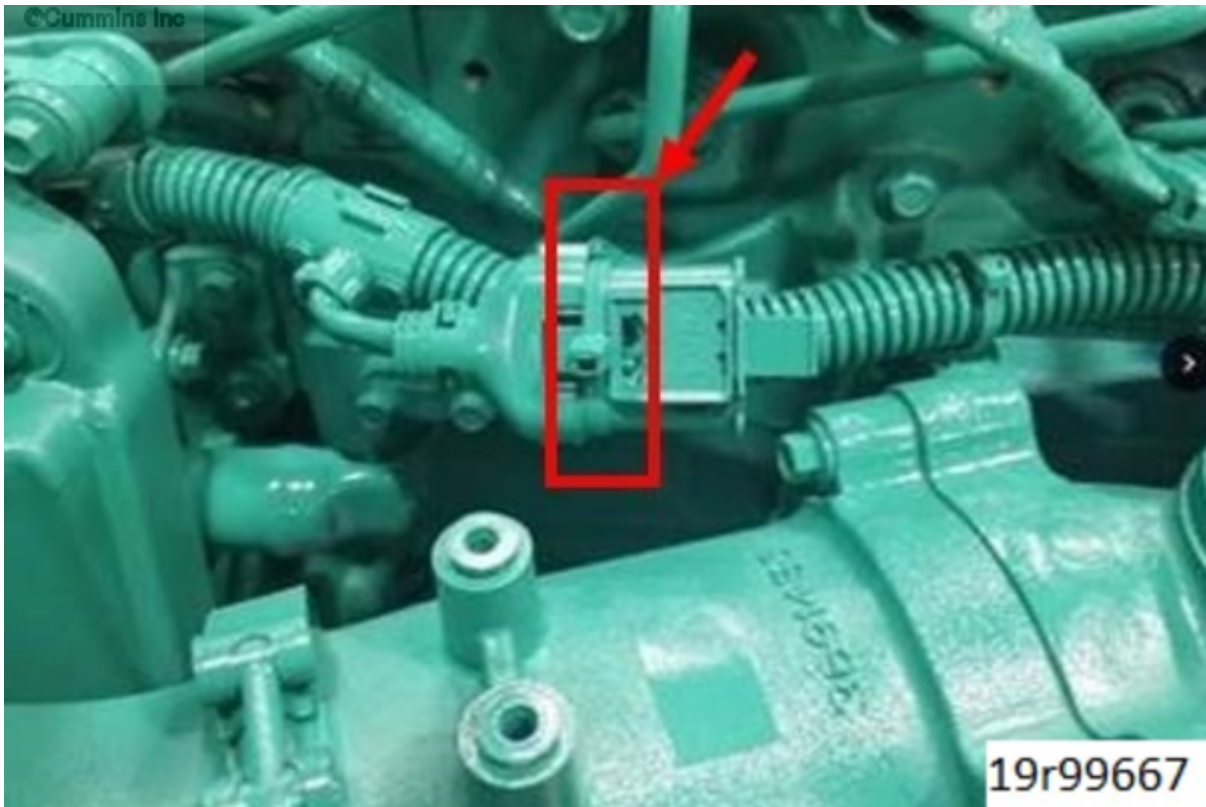
Figure 4, Correct Orientation of Connector

After connector has been blown out with compressed air, verify that the fault code goes inactive. The engine intake throttle actuator connector should then be zip tied horizontally to the engine harness as shown below.
