Service Bulletin

Bulletin No.: 16-NA-405

Subject: Poor Engine Performance in Extremely Cold Weather Conditions, PCV Bypass Hose and Charge Air Cooler Icing for LUV Engines, Malfunction Indicator Lamp (MIL) Illuminated - DTC P0299, P0236, P2227, P00C7 Set

Brand:	Model:	Model Year:		VIN:		Engine:	Transmission:
		from	to	from	to		
Buick	Encore	2013	2020	Refer to Parts Information section for breakpoints.		Equipped with 1.4L (RPO LUV)	
Chevrolet	Trax

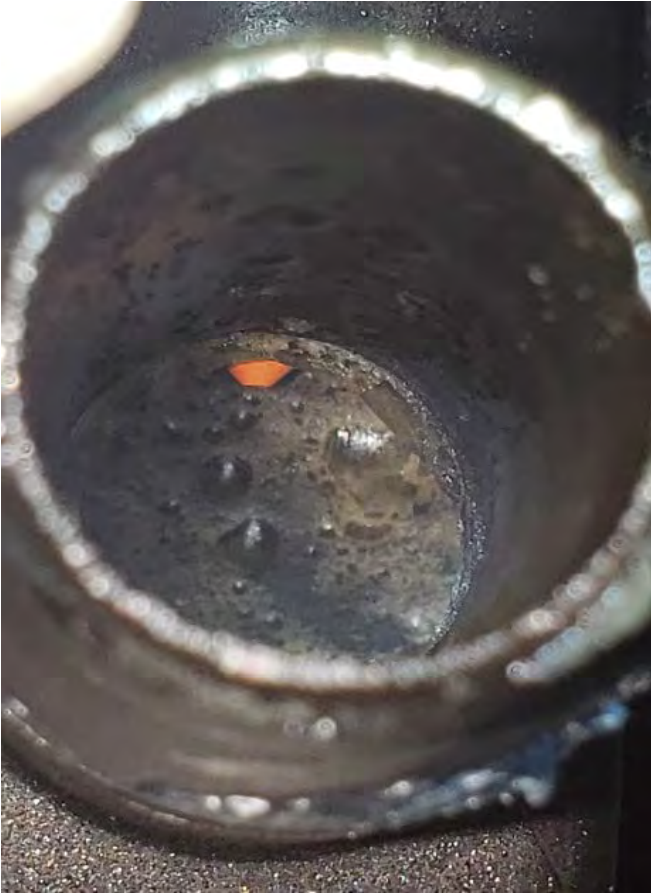
5286434

2. Inspect the vacuum ports of the intake manifold for ice accumulation.

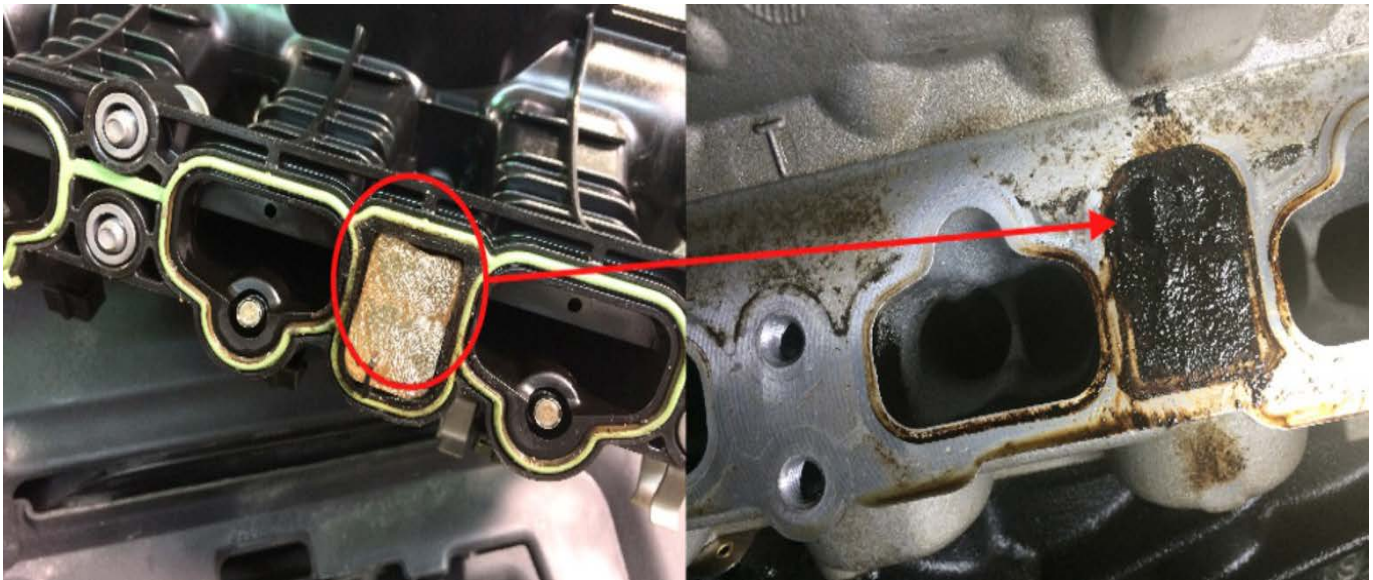
5286457

3. Inspect the PCV intake runner for ice build-up blocking the cylinder head as shown above.

4. Clean any ice/sludge/water/carbon out of the PCV pipes/hoses, the PCV nipple on the intake manifold, the PCV intake runners and the orifice between the #2 and #3 intake ports.

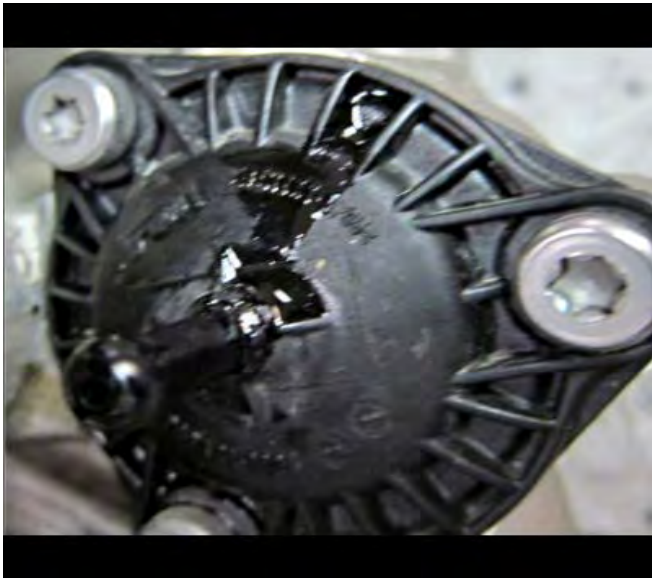
5590615

8. Inspect the charge air bypass valve for oil leaking from the vacuum side port.

- If oil is found leaking from the valve port, disassemble and clean the components. Refer to *Charge Air Bypass Valve Replacement* in SI.
 - Only if necessary, replace the components.
9. Install the valve.
 10. Install the intake manifold.

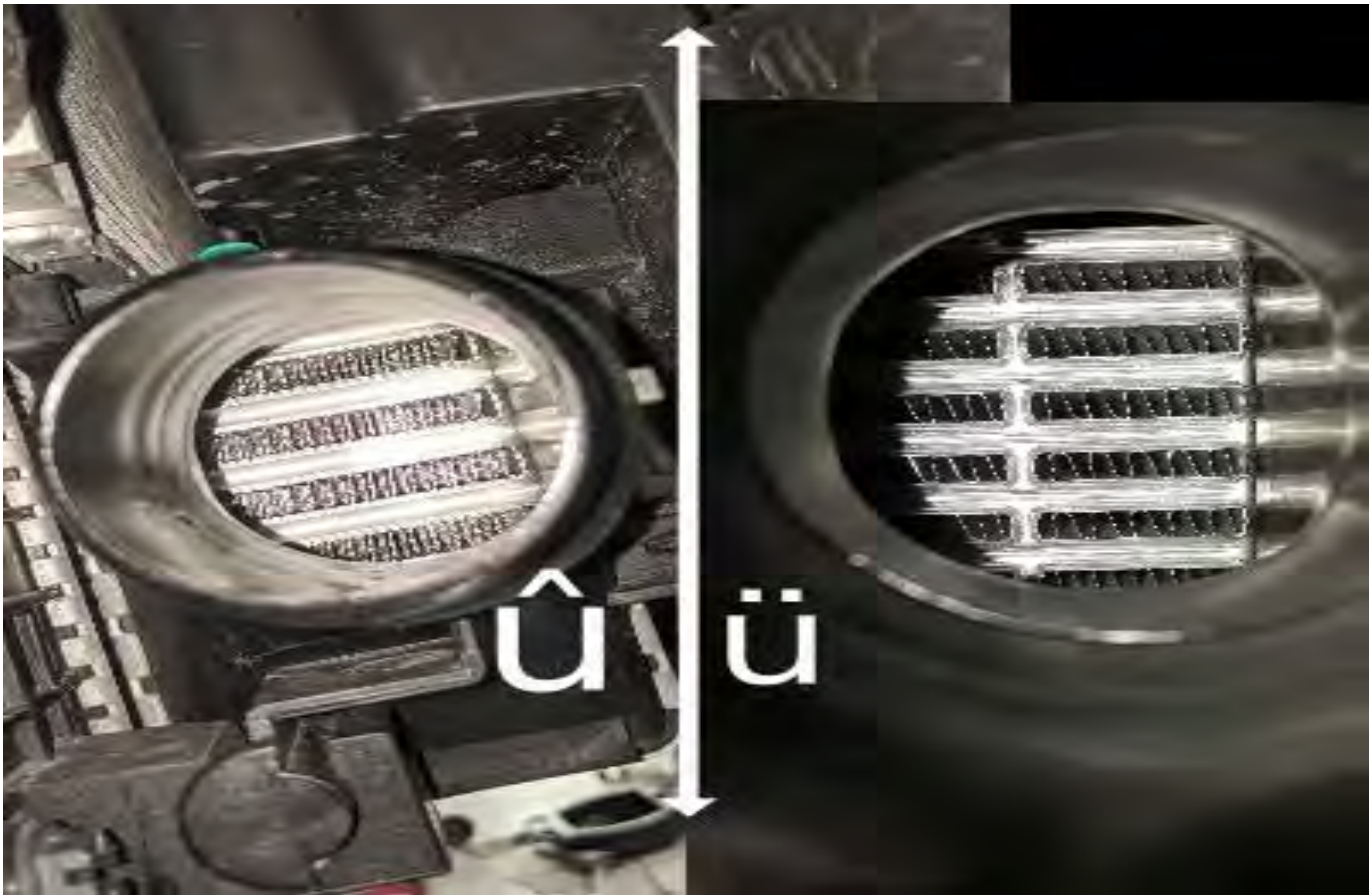
5500499

2. Inspect the charge air cooler through the inlet to determine if the vehicle has the new or old design.
 - If the charge air cooler is the old design (shown by X in the graphic), proceed to the Charge Air Cooler Replacement section below.
 - If the charge air cooler is the new design (shown by the check mark in the graphic – note the wider fin spacing and a division in the middle of the charge air cooler), no charge air cooler replacement is necessary.
3. Remove and clean the IAPT sensor.
4. Using care, remove the bands that secure the air hoses to the elbow duct.

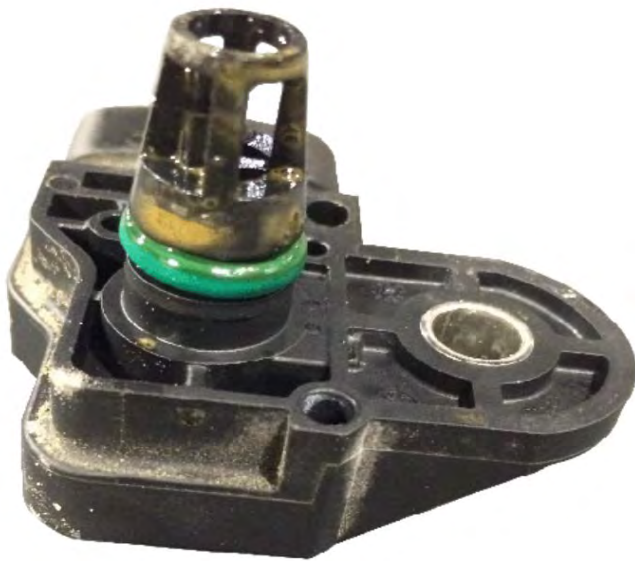
4910683

2. Inspect the IAPT sensor for any contaminates.

Important: Due to the sensitivity of the IAPT, **Do Not** use any chemical cleaners including water and **Do Not** use compressed air to remove contaminates.

3. Allow time for any ice build-up to melt by placing the sensor port down.
4. Clean the sensor with a clean towel.
5. Inspect the IAPT sensor for any contaminates.
6. Install the sensor into the elbow duct.
