Service Bulletin

Bulletin No.: 19-NA-153

Subject: Malfunction Indicator Lamp (MIL) Illuminated - DTC P0741 Set

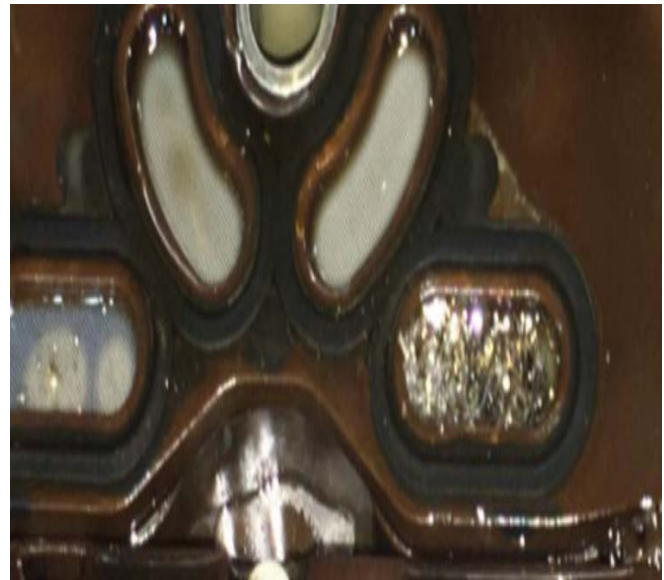
5360222

2. Remove the transmission oil pan.
3. Inspect the magnet in the pan for excessive metal accumulation.
 - If there was no signs of metal in the oil pan, install the pan and no further work is required.
 - If there was excessive metal shaving in the oil pan magnet, continue to step 4.
4. Remove the upper and lower valve body and clean thoroughly.
5. Inspect the TEHCM solenoid screen for debris:
 - If there was no signs of metal in the TEHCM, install the pan and no further work is required.
 - If there was excessive debris in the TEHCM, replace the TEHCM/solenoid valve body **Only** if there is debris on the screen as shown above and continue

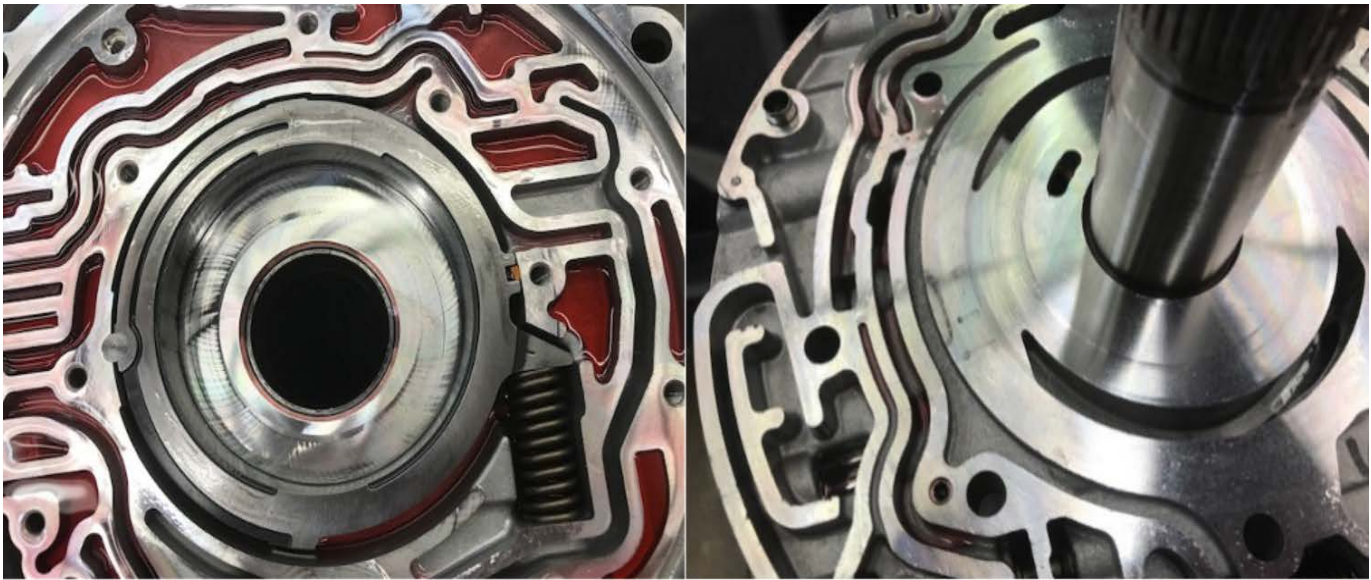
5360776

Do Not replace the pump if no signs of damage or excessive wear was not validated during inspection as shown above.

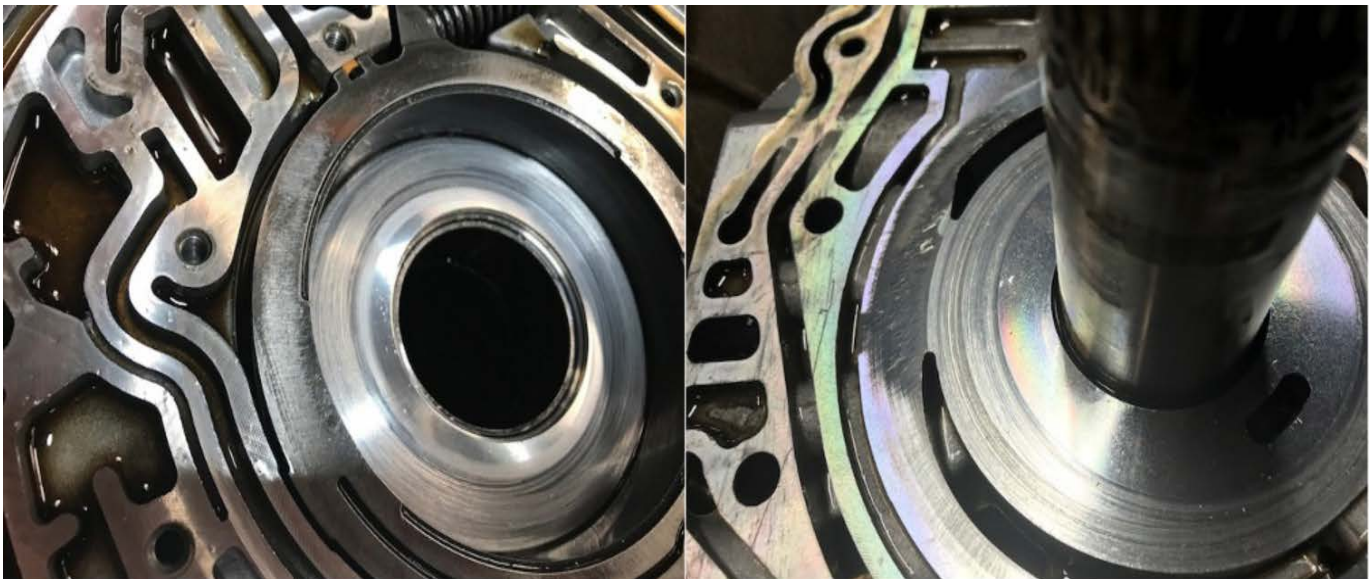
5360218

Note: Refer to the latest version of PI1447 for possible bushing/shaft scoring. Replace parts as necessary.

Perform an inspection of the transmission pump for signs of excessive wear as shown above.

Replace pump components as necessary.
