Service Bulletin

Bulletin No.: 19-NA-242

Subject: Information on High Voltage Battery Pack Refurbish Kit

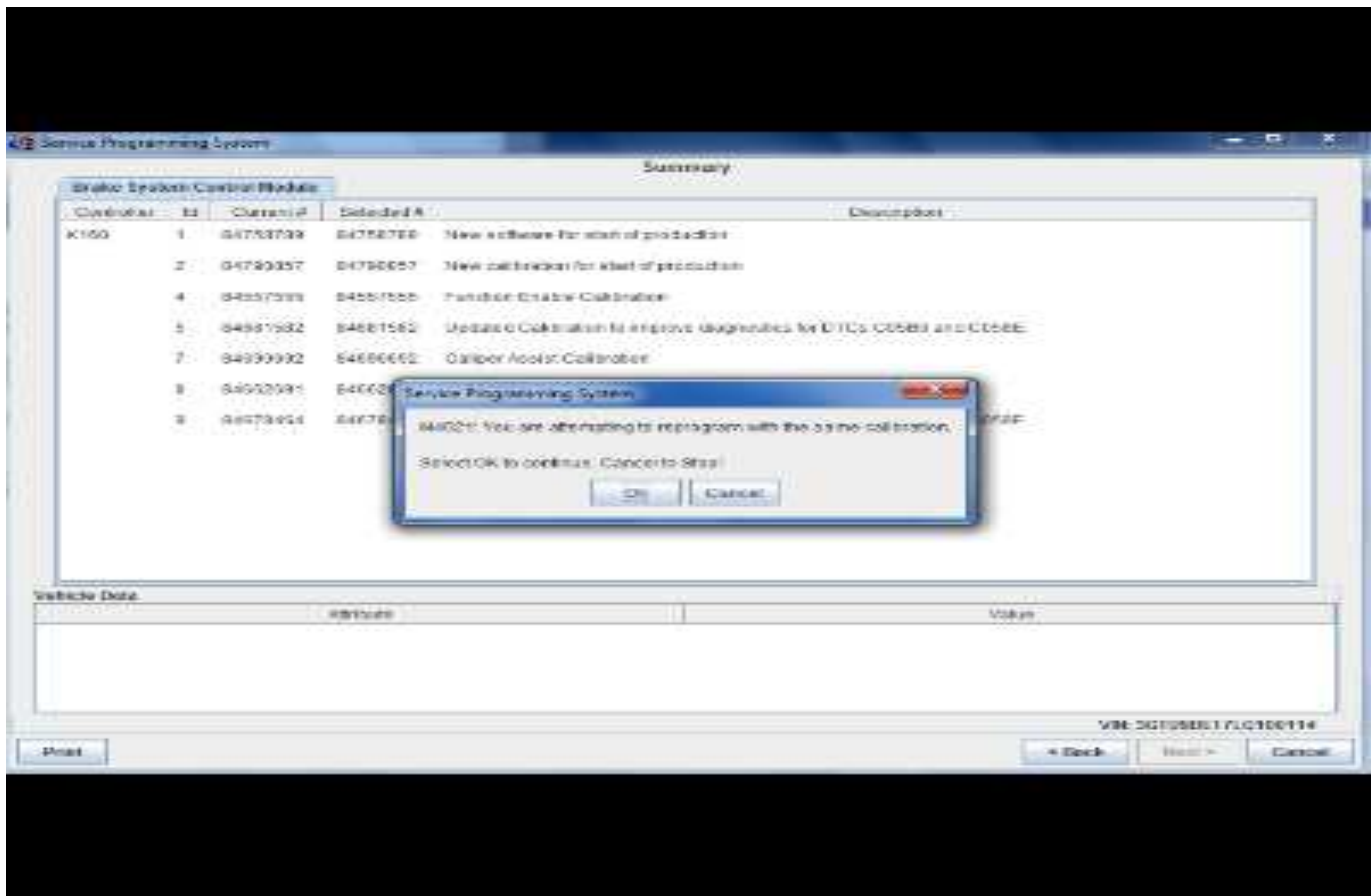
5431207

Important: TIS2WEB screen shown. Techline Connect screen is similar and will be included soon.

Important: If the Same Calibration/Software Warning is noted on the SPS screen, select OK and follow screen instructions. After a successful programming event, the WCC is located in the Service Programming

System dialogue box of the SPS Summary screen. No further action is required. Refer to the Warranty Information section of this bulletin.

1. Reprogram the HPCM2 for the 2011-2012 models. Refer to *Hybrid Powertrain Control Module 2 Programming and Setup* in SI. Modify as required (e.g., select x module from the controller screen). Then provide step-by-step instructions or refer to SI procedure.

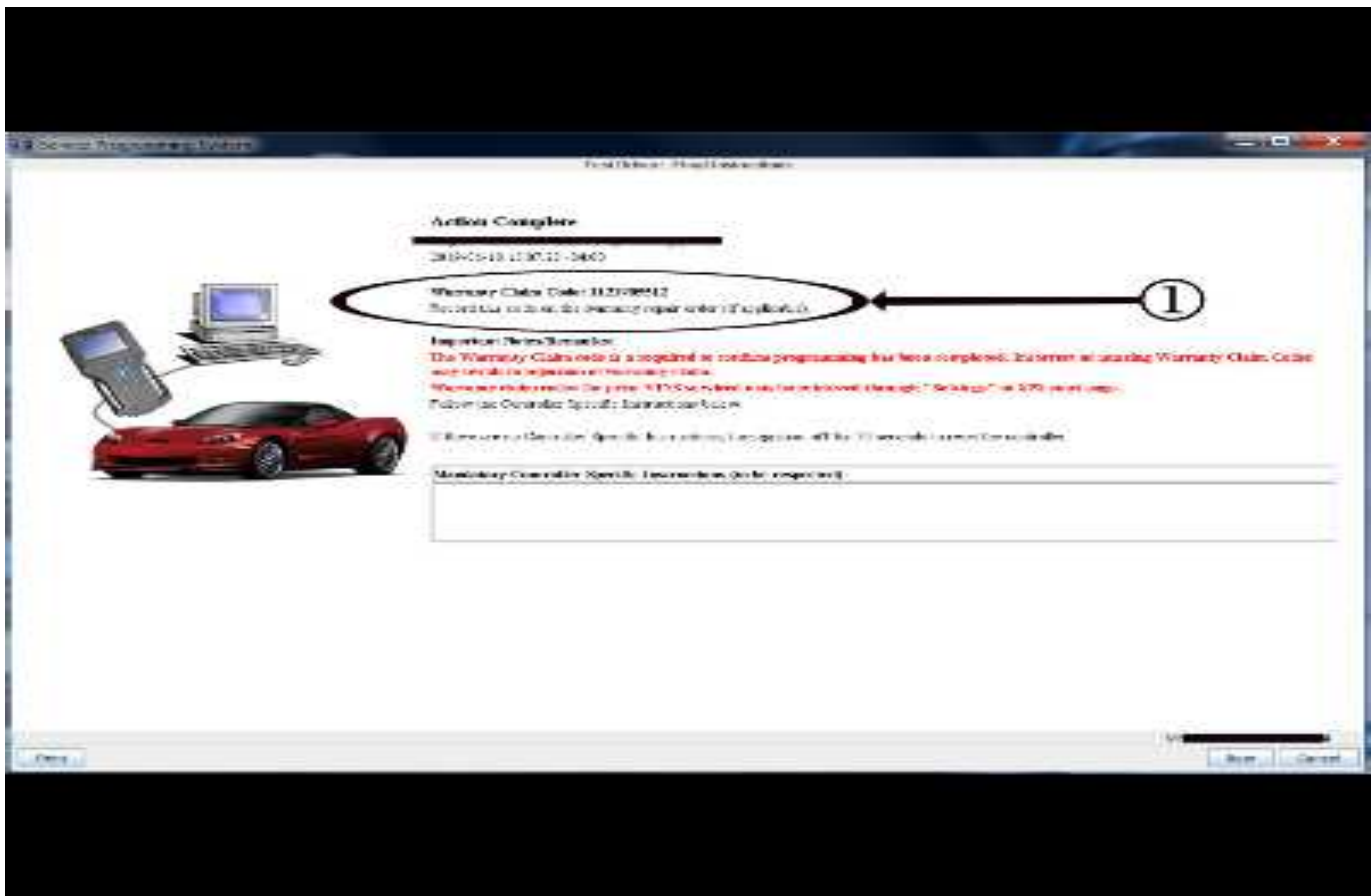
5431209

Important: TIS2WEB screen shown. Techline Connect screen is similar and will be included soon.

Important: To avoid warranty transaction rejections, you **MUST** record the warranty claim code provided on the SPS Warranty Claim Code (WCC) screen on the job card. Refer to callout 1 above for the location of the WCC on the SPS screen.

2. Record the SPS Warranty Claim Code on the job card for warranty transaction submission.
