Service Bulletin

Bulletin No.: 19-NA-243

Subject: Power Door Locks, Keyless Entry, Power Windows and Power Mirror Inoperative, Power Seats, Power Telescope Steering Column Inoperative and/or Moving On it's Own, Side Object Detection Inoperative and/or Unwanted Activation, Multiple DTCs Set

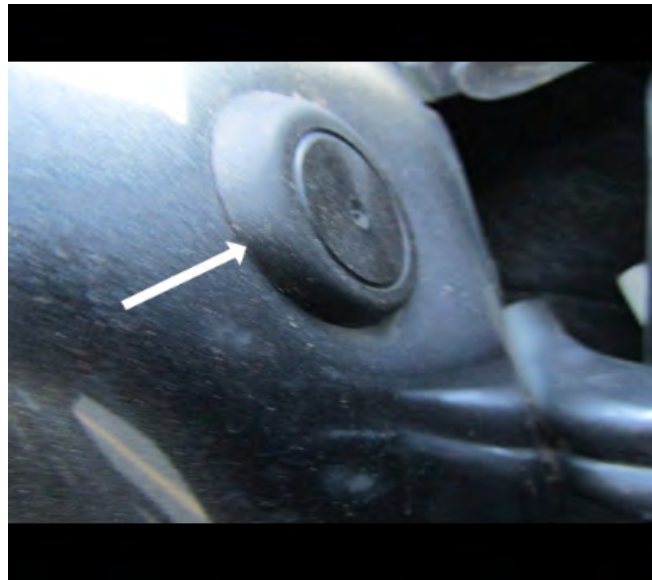
5429978

Involved Region or Country	United States, Canada, Mexico, Europe, Uzbekistan, Russia, Middle East, Israel, Palestine, Argentina (Mercosur), Brazil (Mercosur), Chile (West), Colombia (West), Ecuador (West), Paraguay (West), Peru (West), Uruguay (West), Japan, South Korea, Australia/New Zealand, Egypt, Africa
Condition	Some customers may comment on one or more of the following conditions: <ul style="list-style-type: none"> • Power door locks inoperative • Keyless entry inoperative • Power windows and power mirror inoperative • Power seats inoperative and/or moving on it's own • Power telescope steering column inoperative and/or moving on it's own • Side object detection inoperative and/or unwanted activation Technicians may find multiple DTC's set.
Cause	This condition may be caused by one of the following: <ul style="list-style-type: none"> • Water leaking past the body plug(s) located in the "A" hinge pillar above door harness to body connectors X500 and/or X600 causing corrosion in the connector. • The body plugs are missing.

Replace the body plugs with the revised part and repair the wiring as necessary. For repairing the wiring refer to *Wire to Wire Repair in SI*, also inspect connector X200 and X201 if water is found in connector X500 and/or X600.
