Service Bulletin

Bulletin No.: 19-NA-269

Subject: Radio Software Version U148 Over-the-Air Update

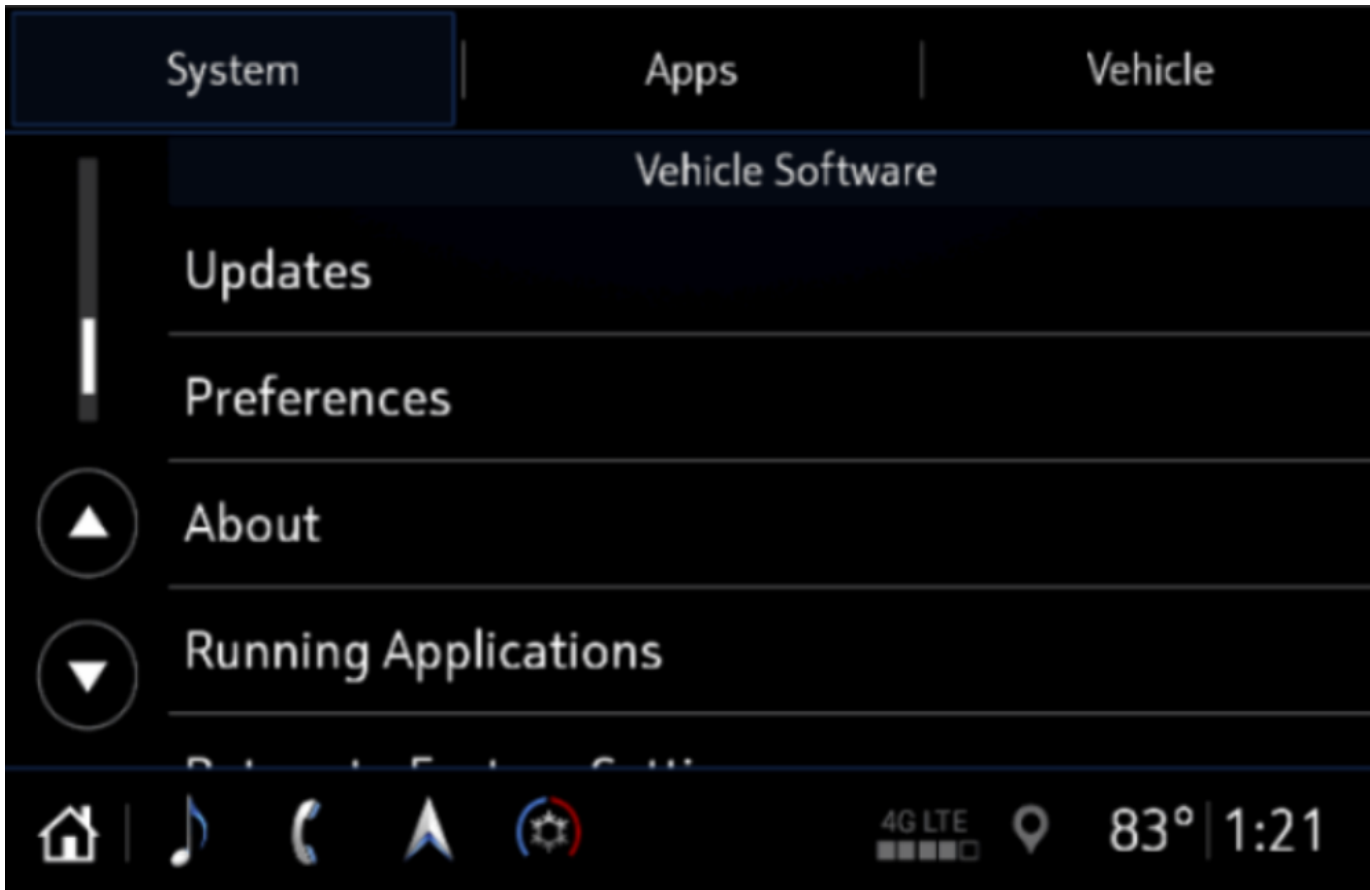
5313331

- If an update is shown under the “Updates” screen, proceed to the **Update Procedure Using Remote Vehicle Update** section of this document.

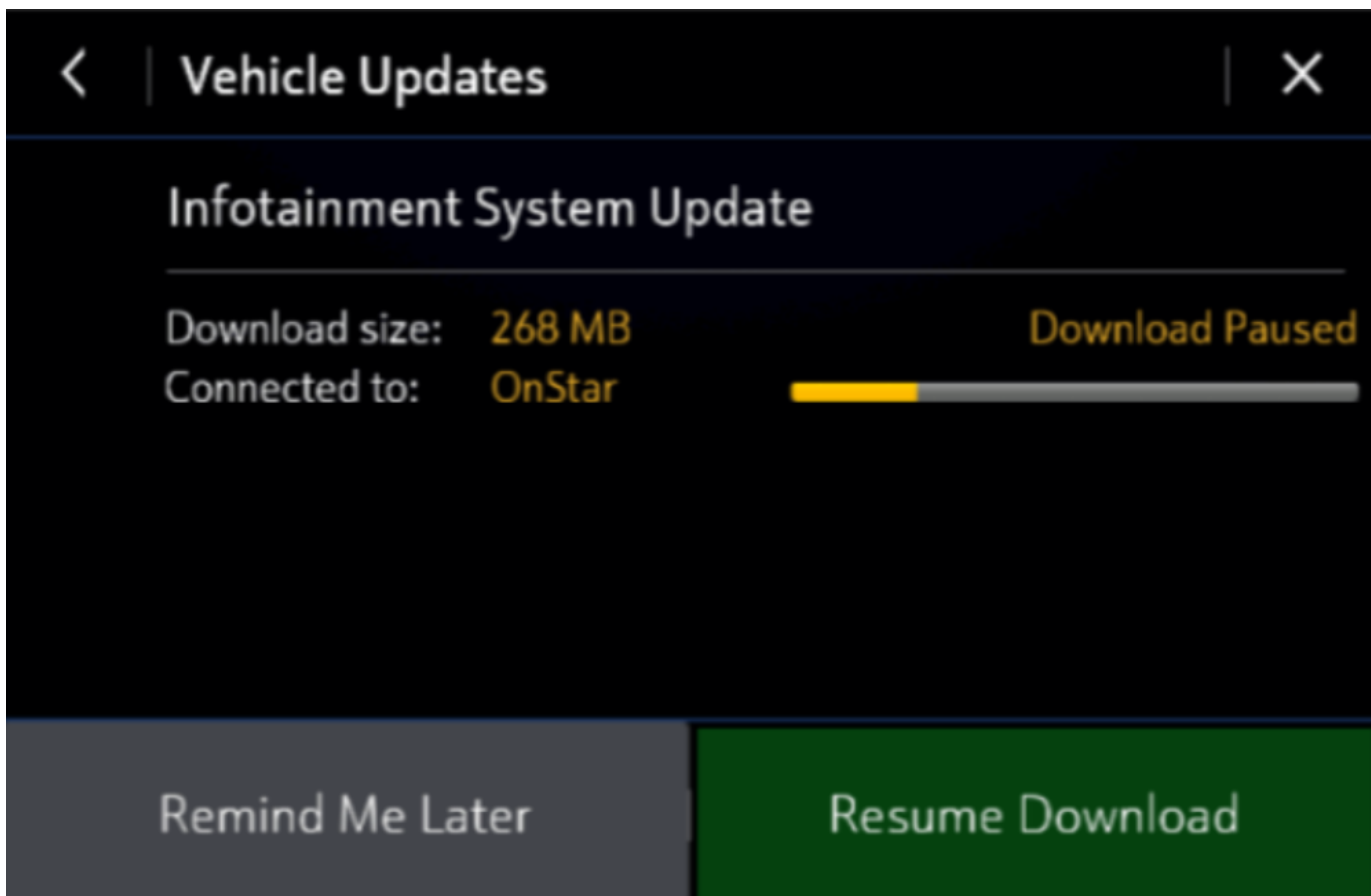
5313332

- If no update is shown (see “No Updates Available” image in next section), go to the “About” screen and verify the build number (i.e., U145, U146, etc.). If the build number is less than U148, proceed with the software update following the **Update Procedure Using TIS2WEB (USB Download)** section of this document.

Caution: If Vehicle Update screen shows "Infotainment System Update" (such as the screen above), do not use TIS2WEB or insert a USB stick. Use of the USB stick when the Remote Update has already been downloaded, installed, or paused during installation could result in program failures or module lockup condition. The update should be completed using the Remote Vehicle Update procedure, following prompts on the infotainment screen. Refer to Update Procedure Using Remote Vehicle Update after reading the remaining information in this section if the Remote Update has already been downloaded to the radio.

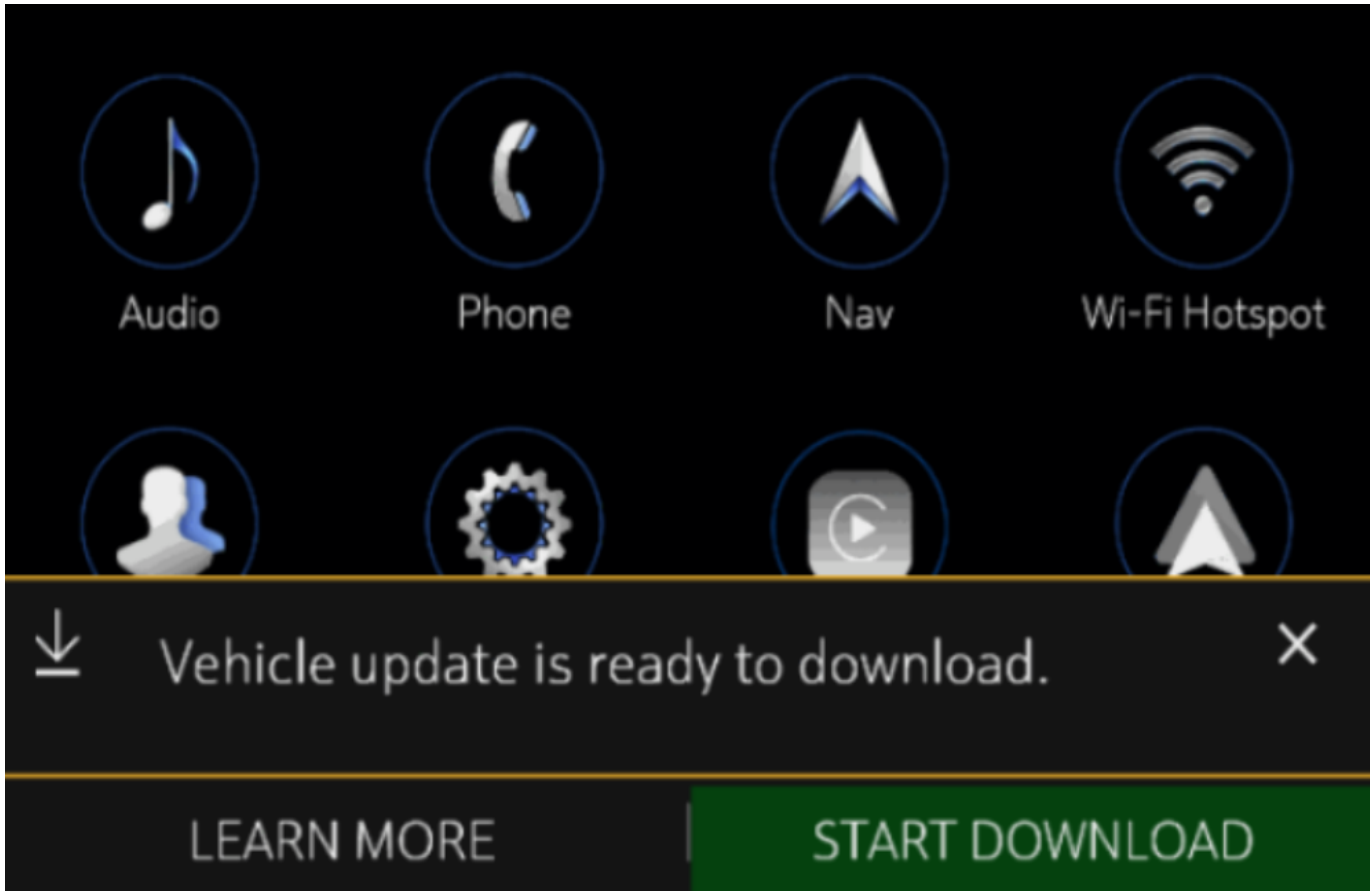
5313328

1. Verify if there is a remote package on the system, and check to see which of the below pop ups show.
 - If the remote vehicle update has not been downloaded, select "Start Download," wait for the download to complete and then follow the prompts to complete installation.

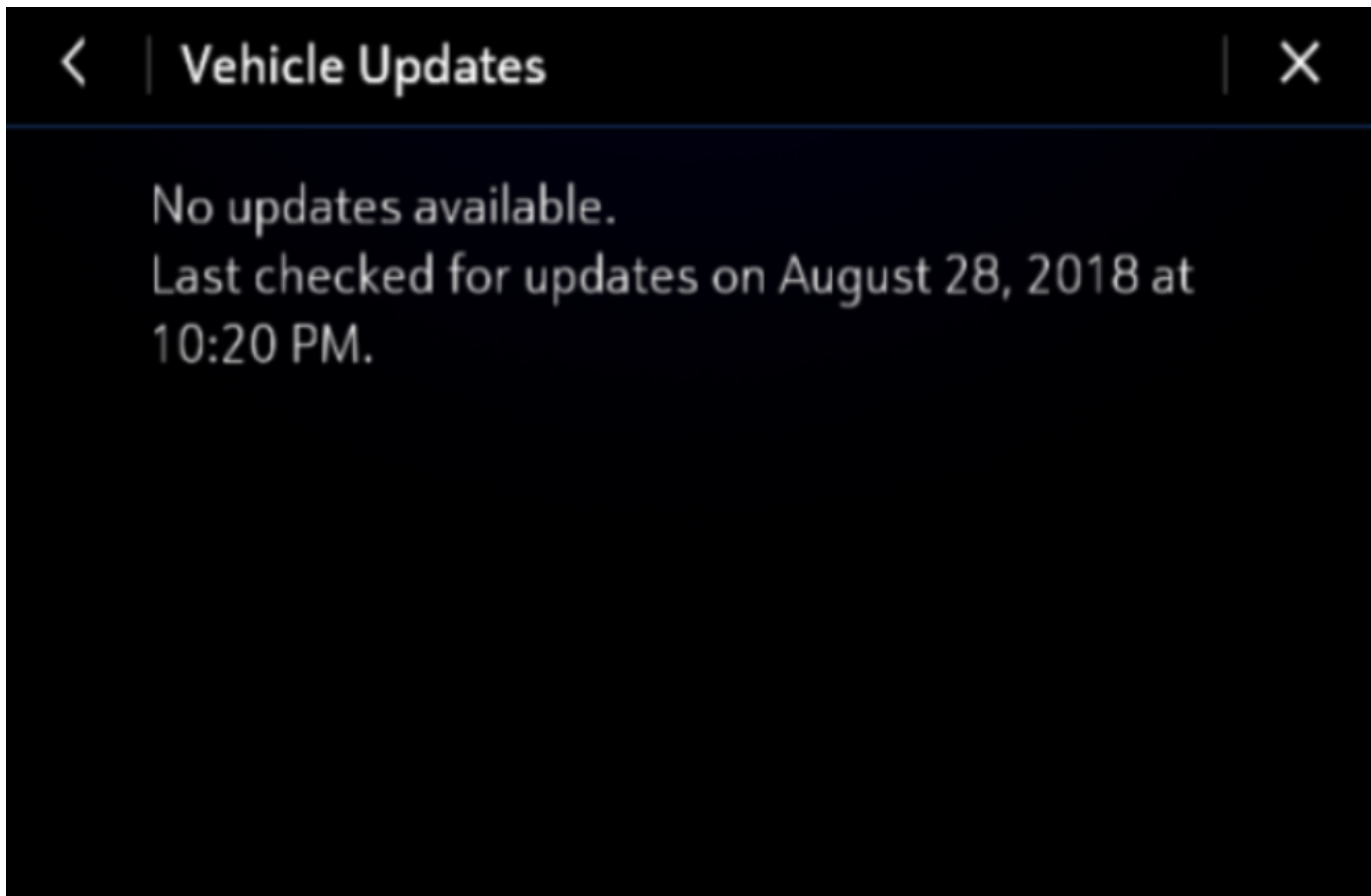
5313324

- If no "Start Download" or "Install Now" pop up is displayed, navigate to "Settings" -> "Updates." If there is a remote package on the system, it will display "Install Now" Or "Start Download." If the screen below is shown, then there is no remote update package on the system. Navigate to Settings -> About to verify the software version. If the build number is not U148 or greater, update via USB.

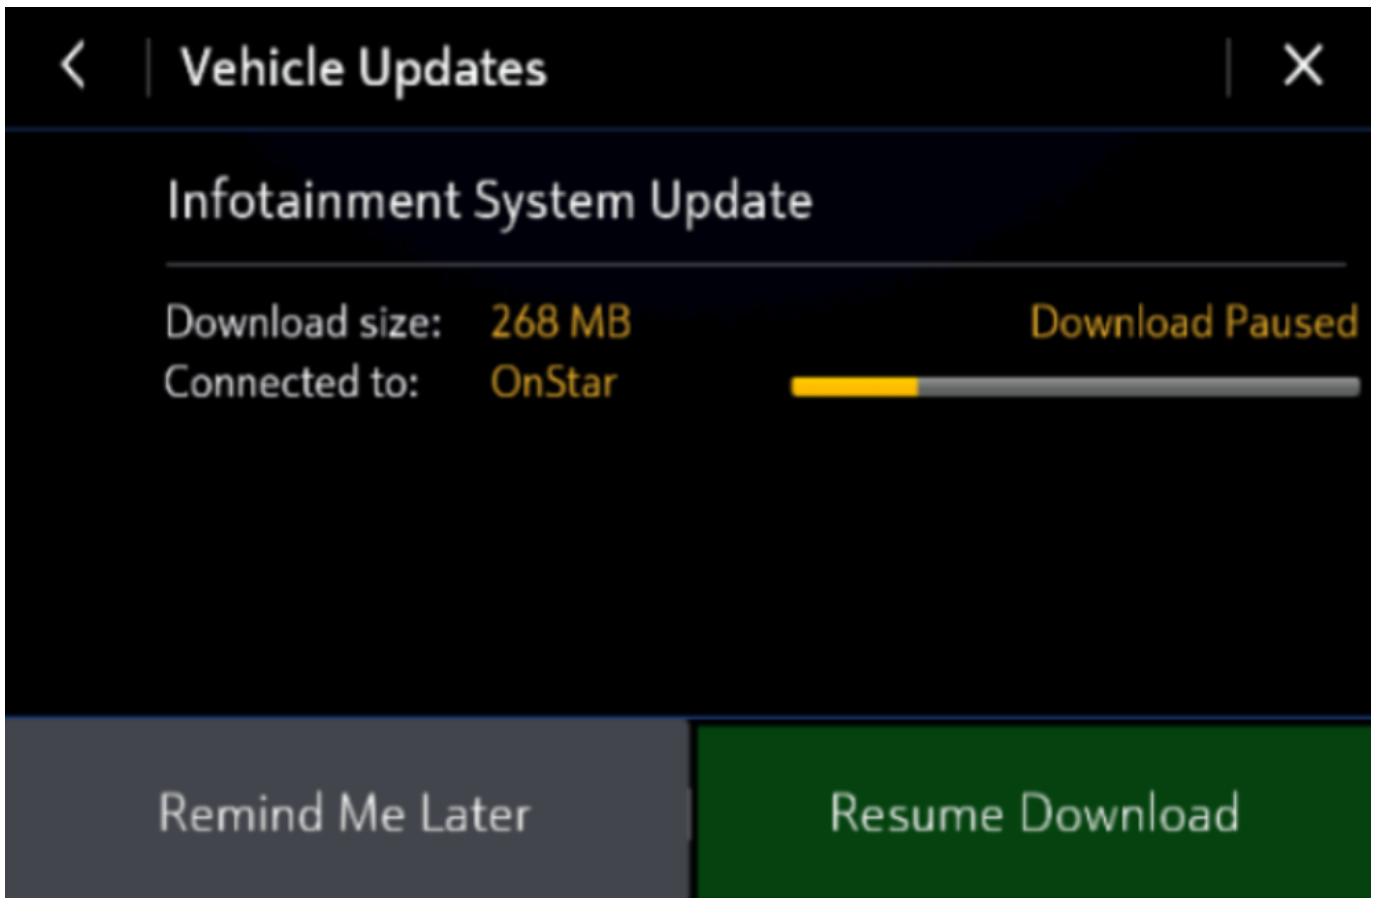
5313326

Scenario 2: Consistently Paused Download

If the above screen is shown and resuming the download repeatedly fails, a USB update will need to be performed. Turn the vehicle on, return to the home screen, and insert USB stick (see previous section). A pop up should be shown to "Install Now." Click "Install Now", verify the part number is correct and follow on screen prompts.

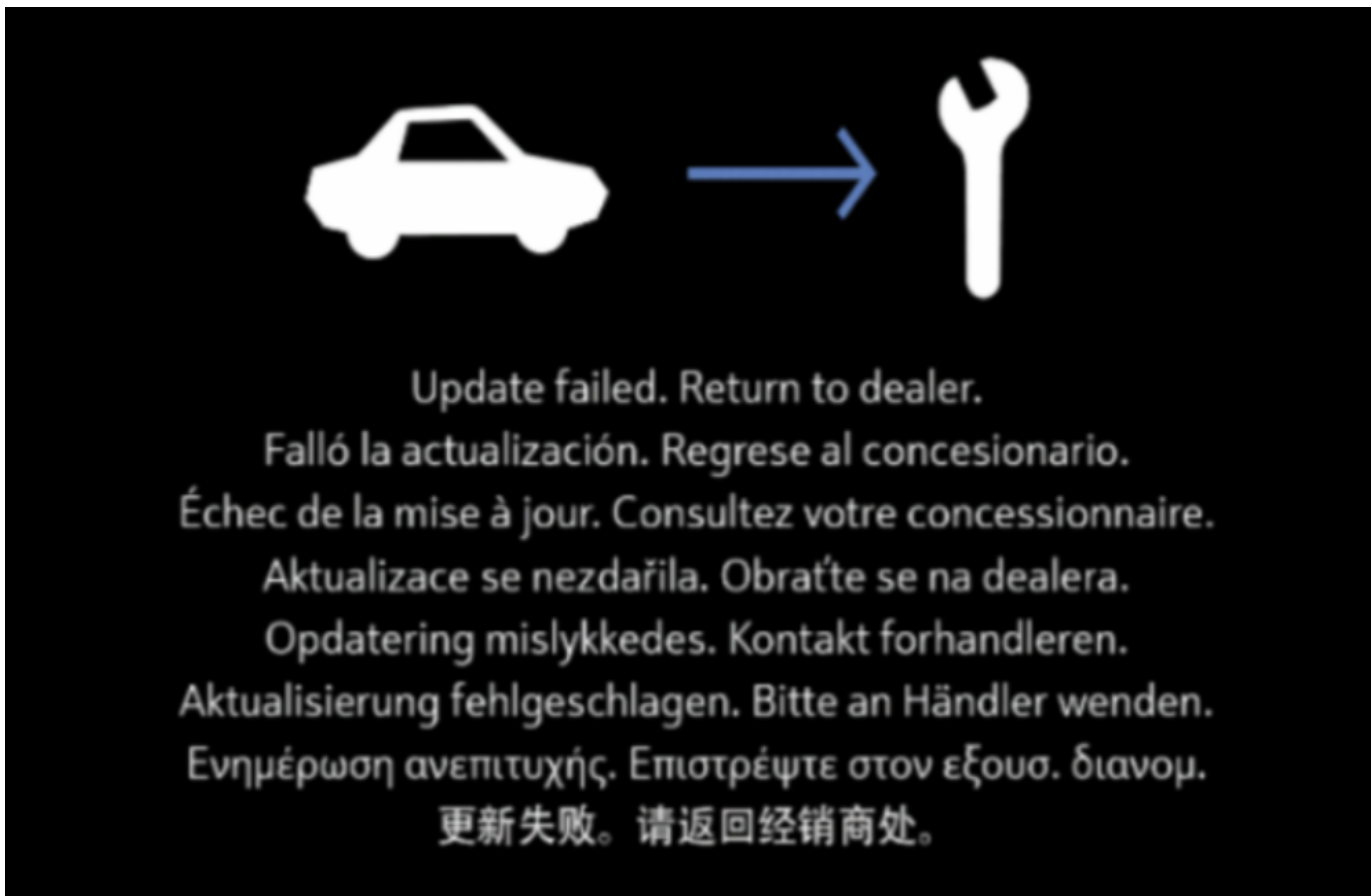
5313330

Scenario 3: Update Failed. Return to dealer screen.

1. If the above screen is shown, download the update through TIS2Web and insert USB stick into the radio **twice** (USB stick is not recognized on first insertion). A blue progress bar should come on the screen and update will proceed. If this screen above is shown when trying to update the radio through USB, reformat to FAT32 on your PC, and then try to download the update through TIS2WEB again.

2. After selecting USB File Transfer, if you are prompted by TIS2Web to select a software P/N, then follow the on-screen instruction to attempt to gather the software P/N from the A11 Radio using GDS2 scan tool. If GDS2 indicates the radio is not communicating, go back to TIS2Web, select A11 Radio, and select when radio displays “**Update failed. Return to dealer.**” to complete the USB File Transfer programming event.

3. If the screen above is shown again, contact Technical Assistance (TAC) for further assistance.
