Service Bulletin

Bulletin No.: 20-NA-010

Subject: Ticking/Tapping Noise Coming From the Front of Vehicle Near the Engine Cooling Fan Area

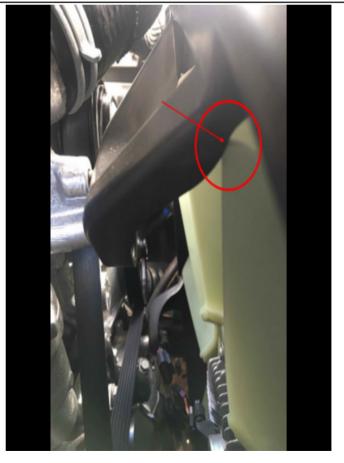
5485011

Involved Region or Country	North America, Middle East, Israel, Chile and Thailand	
	Some customers may comment that a tapping or ticking noise can be heard coming from the front of vehicle near the engine cooling fan area.

This condition may be caused by the engine fan blade contacting 1 or more of the 4 mounting tabs of the engine cooling fan shroud.

If contact between the fan blade and shroud is observed, replace the Fan Blade.
	, ' '
Correction	 Do not modify the fan blade or shroud and do not replace the Engine Cooling Fan Shroud. A new Fan blade service part has been released to correct this contact condition.
