Service Bulletin

Bulletin No.: 20-NA-036

Subject: Rear Camera Gridlines Incorrect, Misaligned, Offset, Incorrect Camera View after Replacing the Tailgate Handle or Entire Tailgate

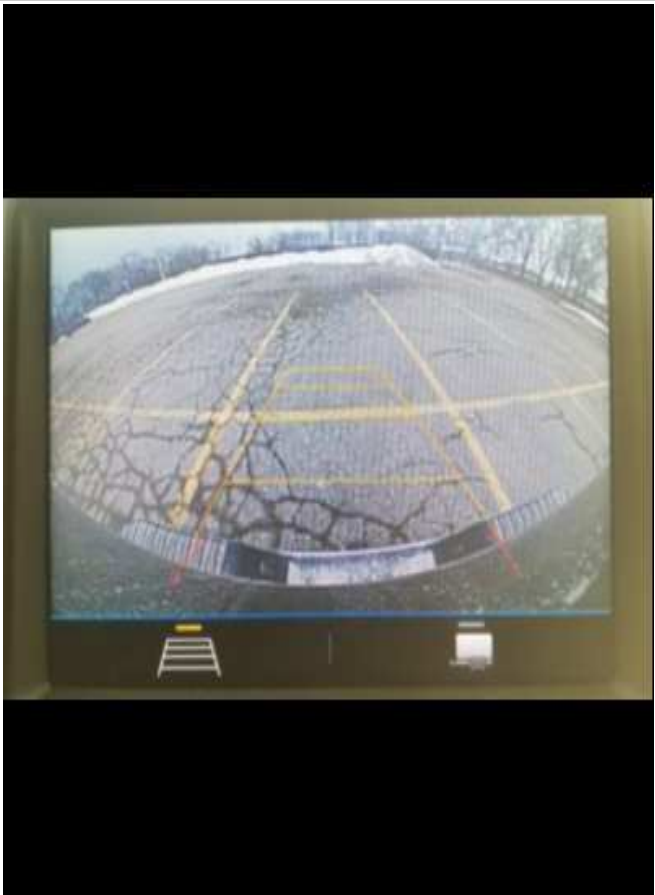
Involved Region or Country	North America, Middle East and Israel.
Additional Options (RPOs)	QK1, QT2/QT3, and UVC. Equipped with Radio IOR.
Condition	<p>Some customers may comment on a misaligned, offset, or incorrect rear camera view after replacing the tailgate handle or entire tailgate.</p> <p>Old Handle and New Calibration</p>   <p>New Handle and Old Calibration</p> <p>5525772</p>

</div> <div data-bbox="1419 1052 1484 1071">5525777</div>
Cause	The cause of the condition may be that the rear camera angle is different from original position in the replacement tailgate handle.
Correction	Reprogram the radio with correct software for the new tailgate handle, refer to <i>A11 Radio: Programming and Setup</i> in SI. Dealer will have to contact Techline for the correct calibration. Old Handle and Old Calibration

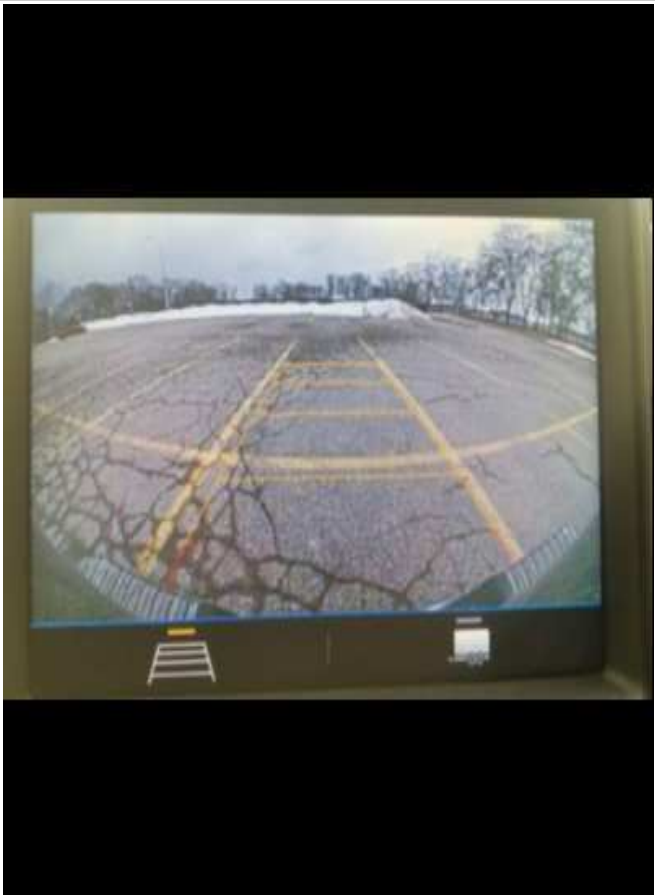
5525771

New Handle and New Calibration
