Service Bulletin

Bulletin No.: 20-NA-073

Date: June, 2020

Subject: Loss of Brake Assist, Various Messages Displayed in Driver Information Center (DIC), Brake Pedal Travel and Apply May Feel Different, One or More of the Following DTCs May be Set P0606 with C0021, C05D2, C0595, C2A3B, C0024, C053D.

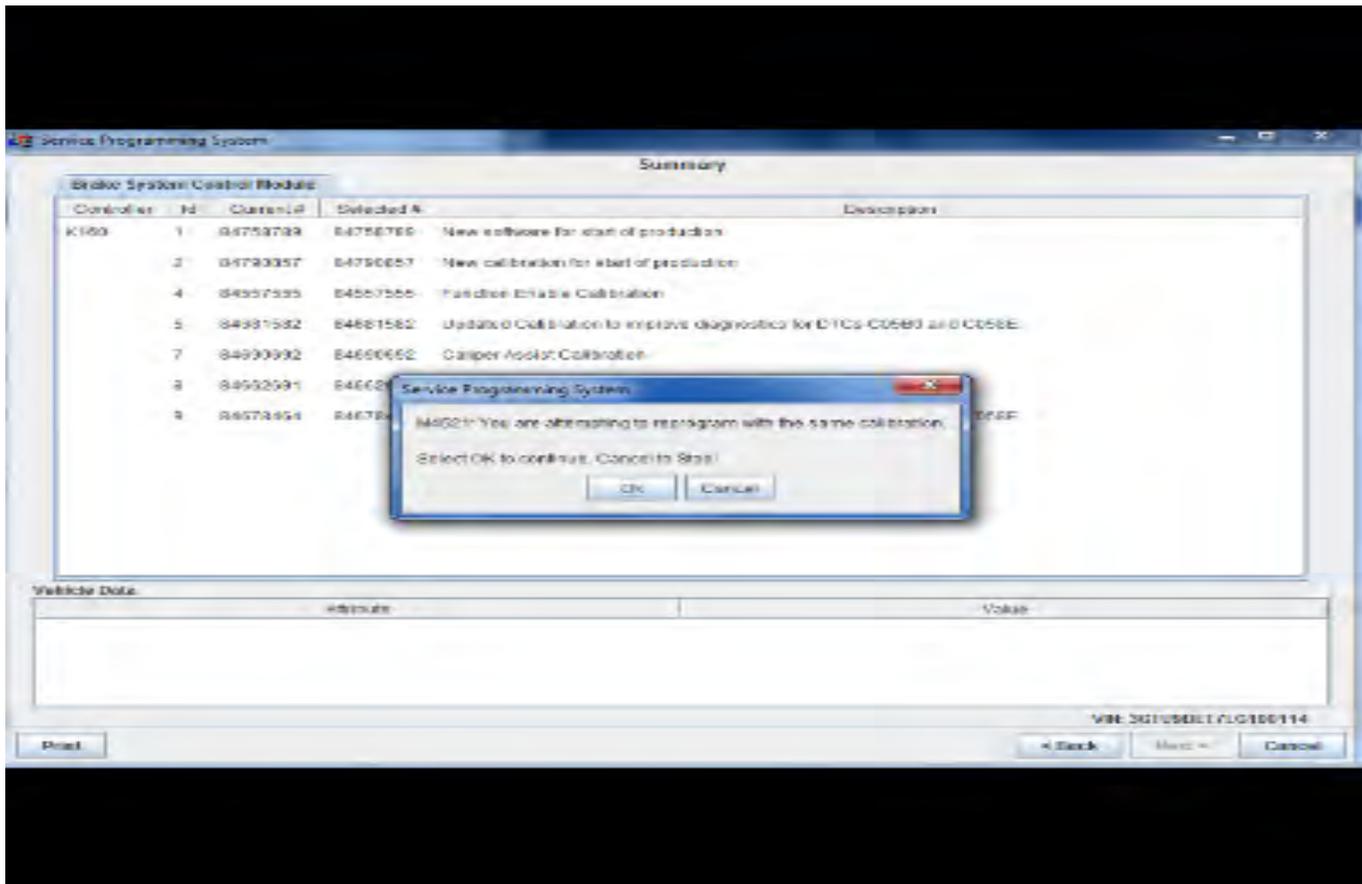
Important: TIS2WEB screen shown. Techline Connect screen is similar and will be included in the near future.

Important: If the Same Calibration/Software Warning is noted on the SPS screen, select OK and follow screen instructions. After a successful programming event, the WCC is located in the Service Programming System dialogue box of the SPS Summary screen. No further action is required. Refer to the Warranty Information section of this bulletin.

1. Reprogram the Brake System Control Module.
Refer to *K160 Brake System Control Module Programming and Setup* in SI. Then provide step-by-step instructions or refer to SI procedure.

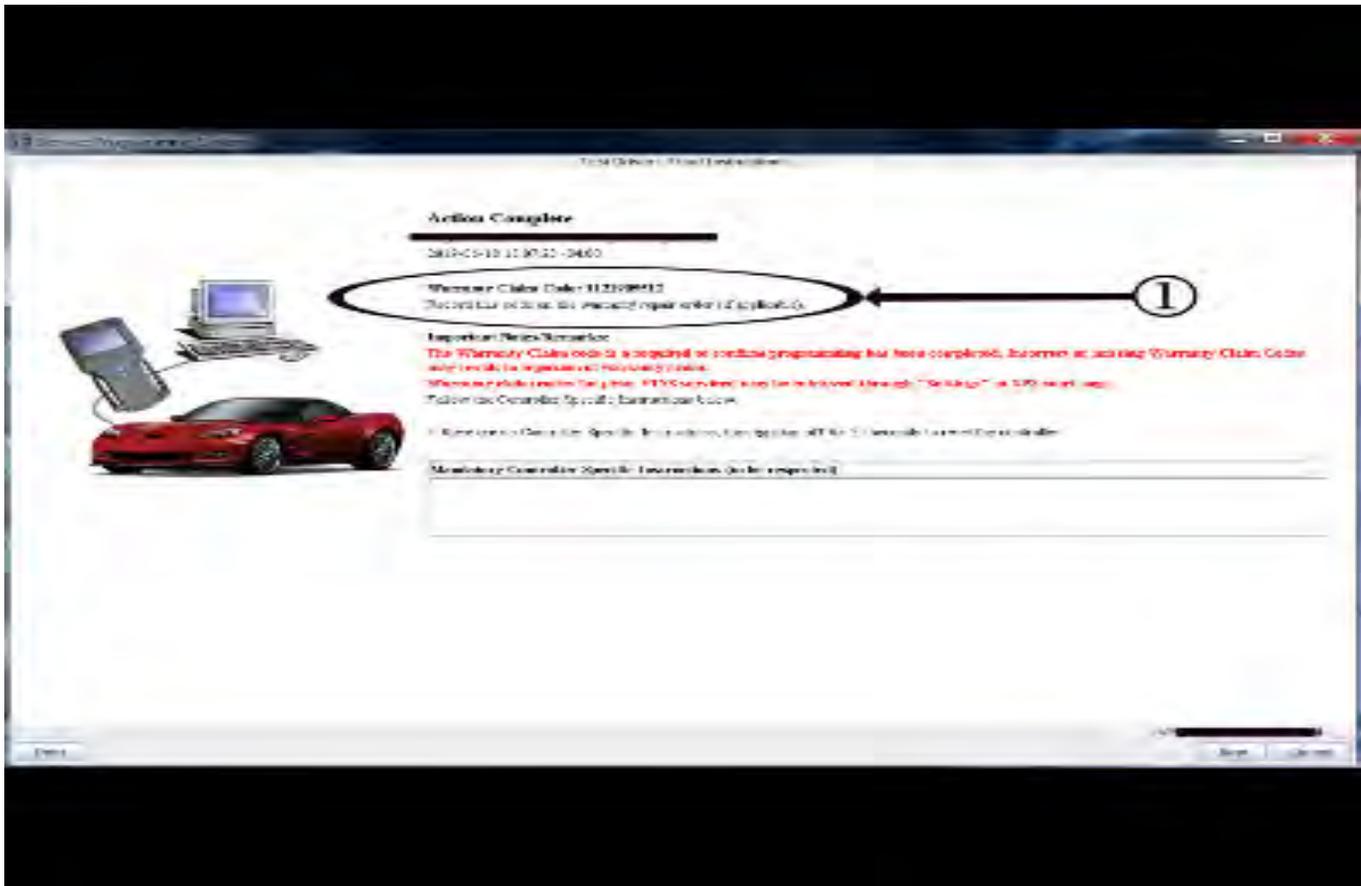
5431209

Important: TIS2WEB screen shown. Techline Connect screen is similar and will be included in the near future.

Important: To avoid warranty transaction rejections, you **MUST** record the warranty claim code provided on the SPS Warranty Claim Code (WCC) screen on the job card. Refer to callout 1 above for the location of the WCC on the SPS screen.

2. Record the SPS Warranty Claim Code on the job card for warranty transaction submission.
