Service Bulletin

Bulletin No.: 20-NA-096

Subject: Glow Plug Control Module Update

Brand:	Model:	Model Year:		VIN:		Engine:	Transmission:
		from	to	from	to		
Chevrolet	Silverado 2500HD/ 3500HD	2020	2020			L5P	All
	Silverado 4500HD/ 5500HD/ 6500HD	2020	2020			L5D	
GMC	Sierra 2500HD/ 3500HD	2020	2020			L5P

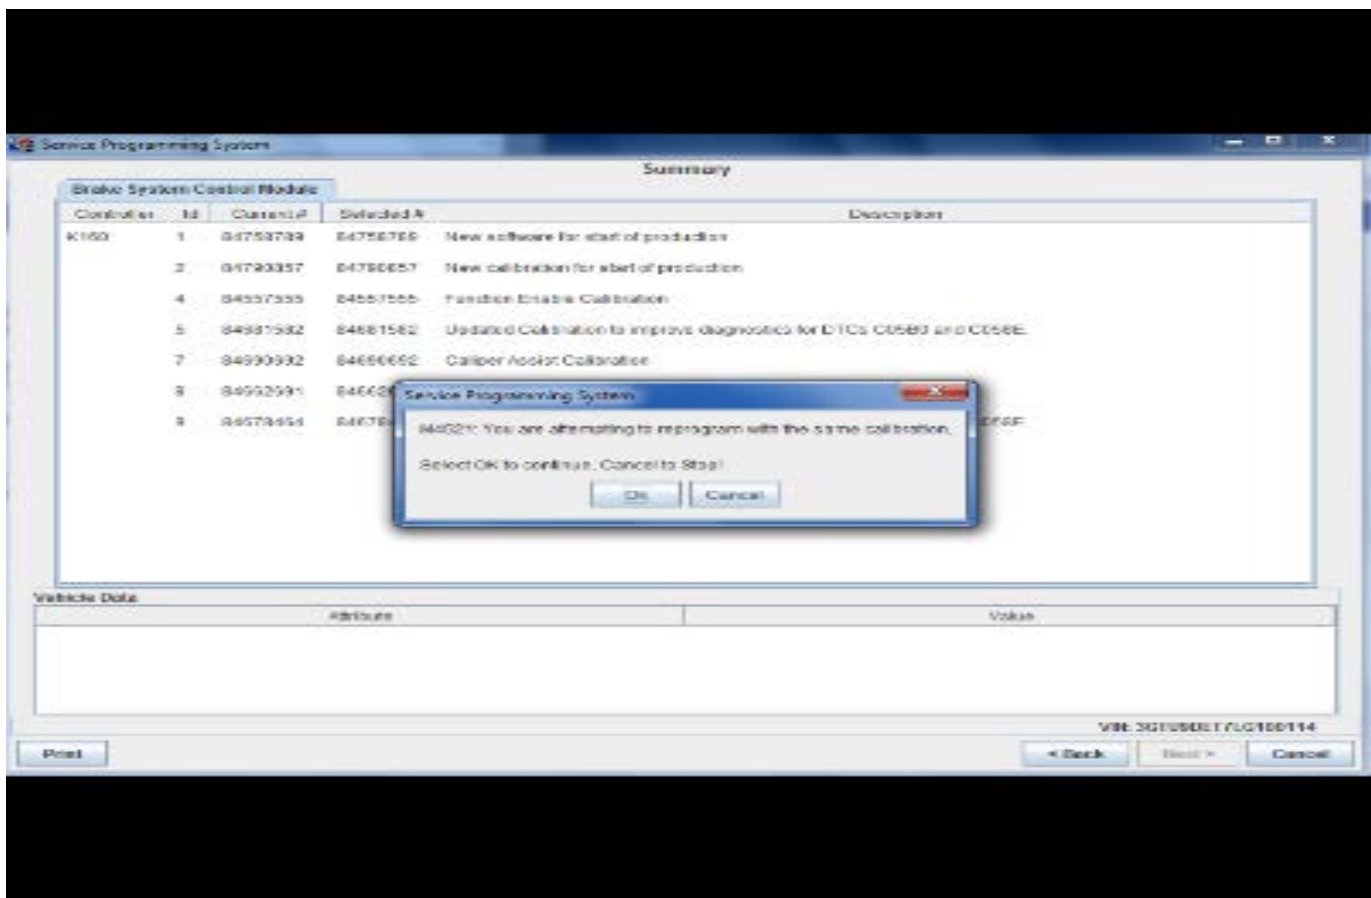
5431207

Important: TIS2WEB screen shown. Techline Connect screen is similar and will be included soon.

Important: If the Same Calibration/Software Warning is noted on the SPS screen, select OK and follow screen instructions. After a successful programming event, the WCC is located in the Service Programming

System dialogue box of the SPS Summary screen. No further action is required. Refer to the Warranty section of the bulletin.

1. Reprogram the Glow Plug Control Module. Refer to *K34 Glow Plug Control Module: Programming and Setup* in SI.
