Service Bulletin

Bulletin No.: 20-NA-099

Subject: Park Assist Not Available to Turn On or Off and Possible Driver Information Center (DIC) Illuminated with DTC U0159 Set

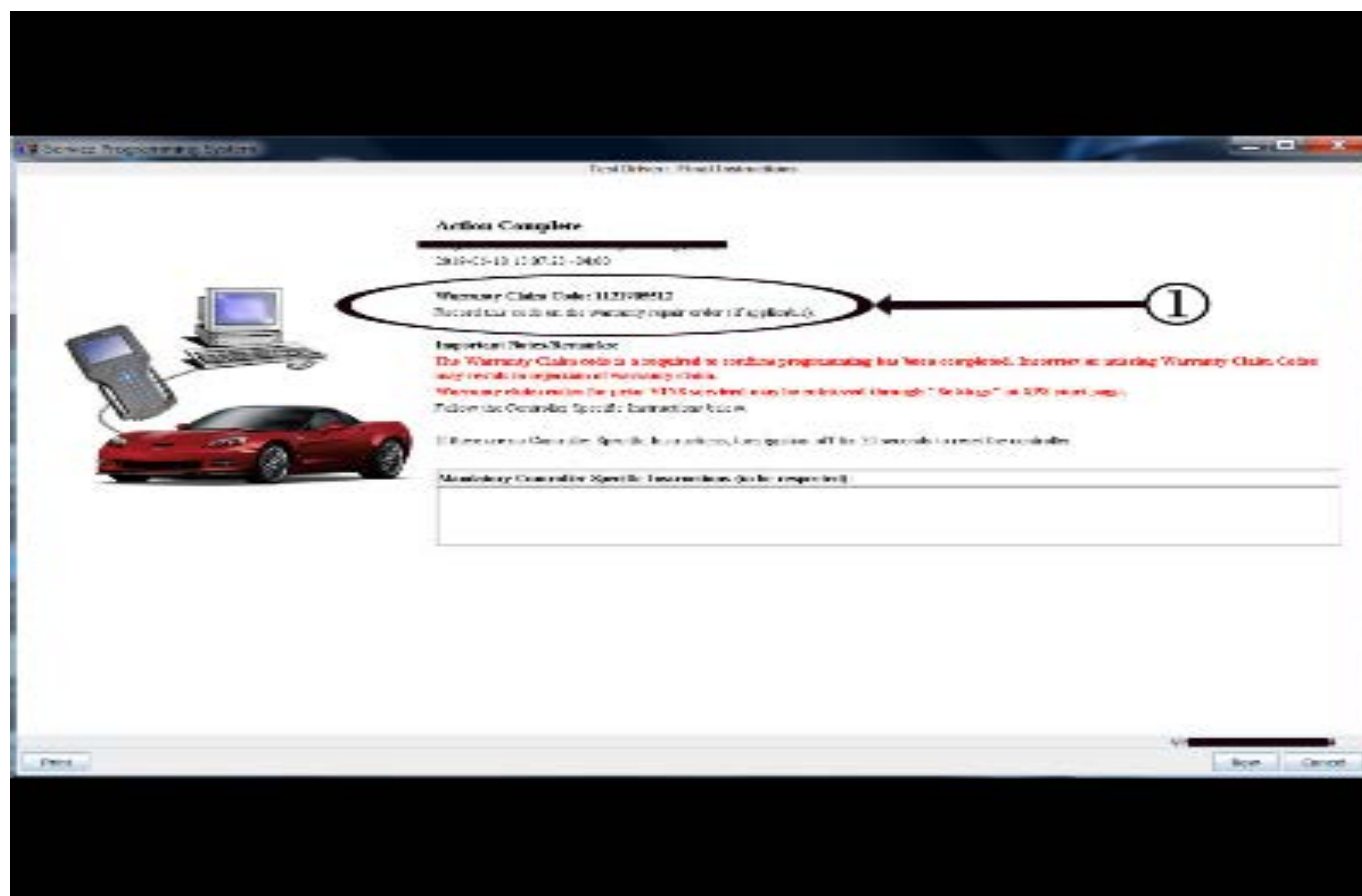
5431209

Important: To avoid warranty transaction rejections, you **MUST** record the warranty claim code provided on the SPS Warranty Claim Code (WCC) screen on the job card. Refer to callout 1 above for the location of the WCC on the SPS screen.

- Record the SPS Warranty Claim Code on the job card for warranty transaction submission.
