Service Bulletin

Bulletin No.: 20-NA-113

Subject: Action Required Steering Assist is Reduced Drive with Care Or Service Power Steering Message And Or Current Power Steering Control Module DTCs

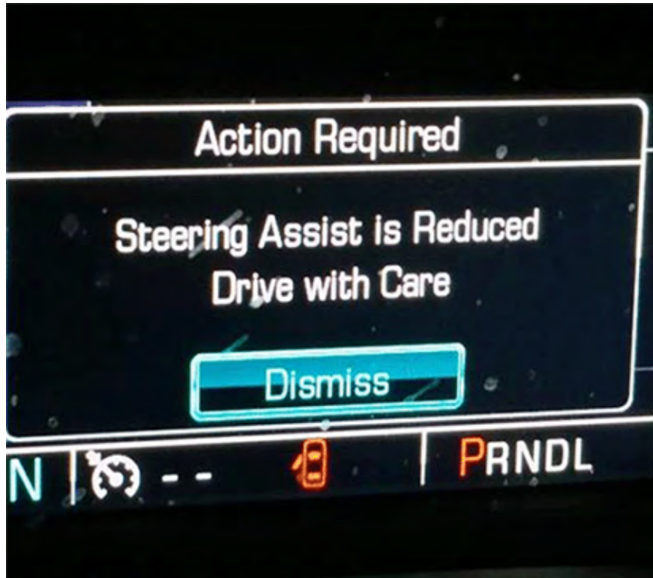
- Customer brings the vehicle in for an "Action Required Steering Assist is Reduced Drive with Care" message that is displayed each ignition cycle. See DIC message below.

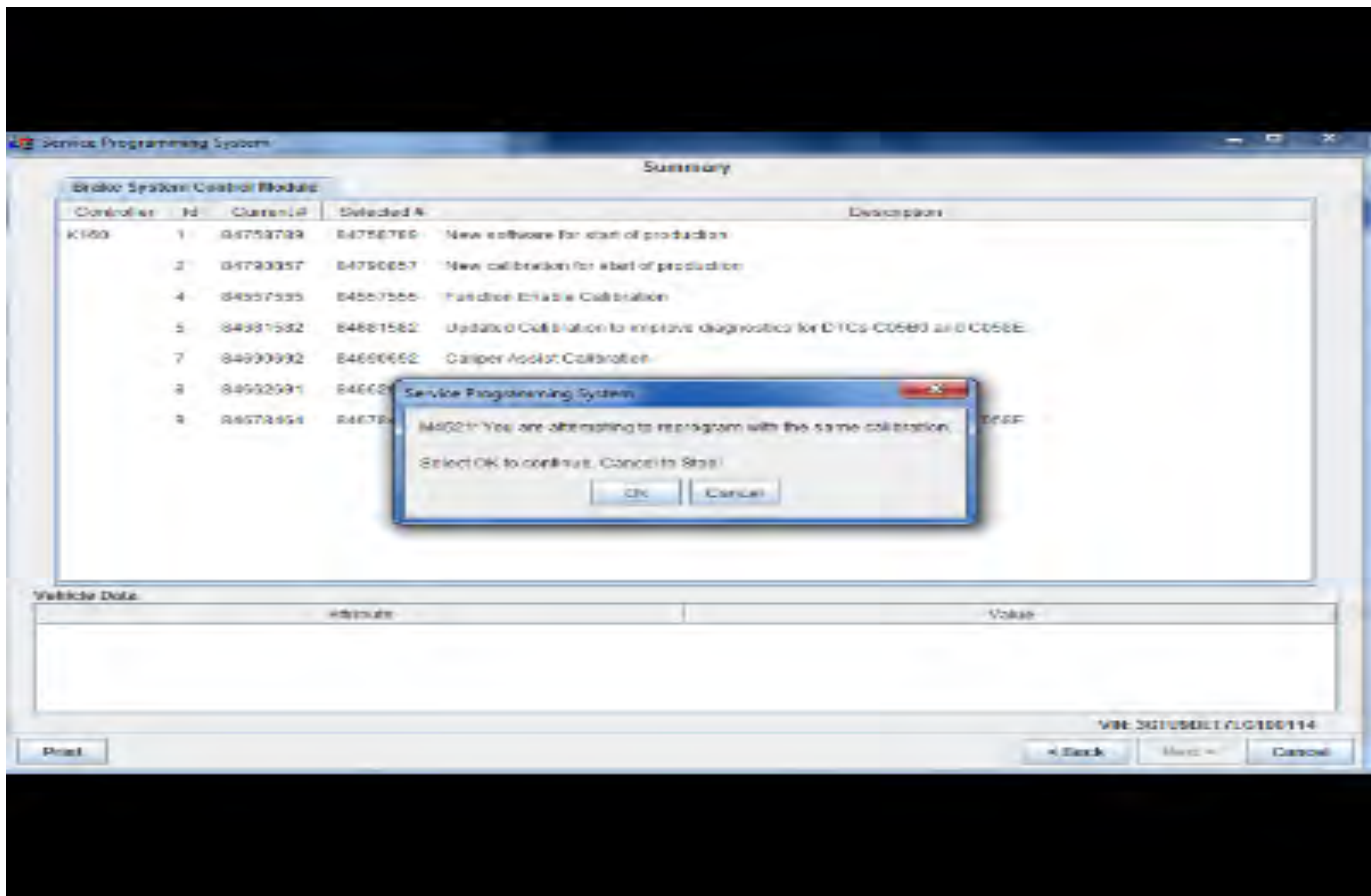
5431207

Important: If the Same Calibration/Software Warning is noted on the SPS screen, select OK and follow screen instructions. After a successful programming event, the WCC is located in the Service Programming

1. Reprogram the Power Steering Control Module. Refer to *K43 Power Steering Control Module: Programming and Setup* in SI.

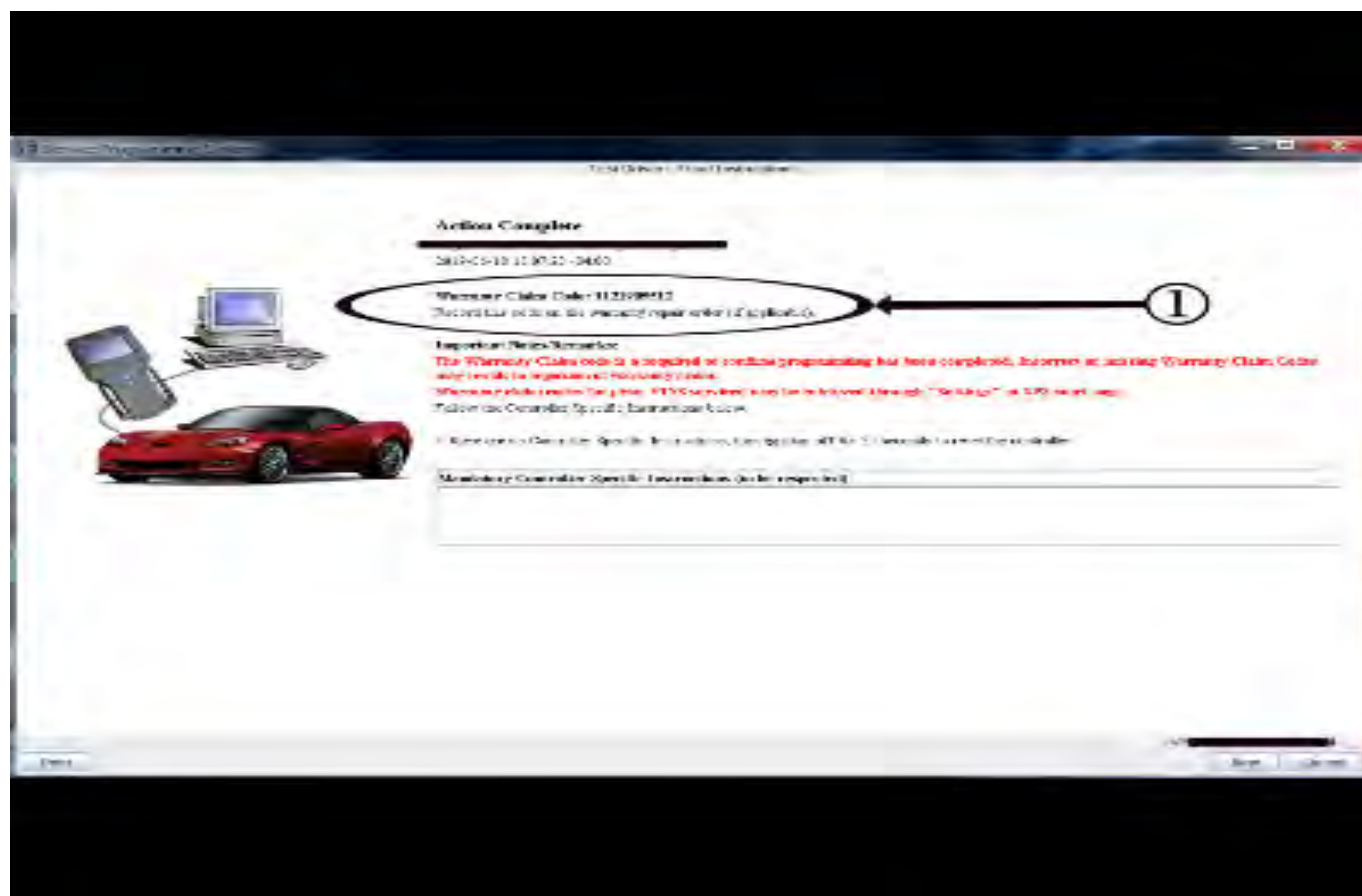
5431209

Important: To avoid warranty transaction rejections, you **MUST** record the warranty claim code provided on the SPS Warranty Claim Code (WCC) screen on the job card. Refer to callout 1 above for the location of the WCC on the SPS screen

2. Record SPS Warranty Claim Code on job card for warranty transaction submission.
