Subject: Engineering Information – Oil Leaking From Oil Pan

Brand:	Model:	Model Year:		VIN:		Engine:	Transmission:
		from	to	from	to		
Chevrolet	Silverado 1500	2020	2020	-	-	Equipped with 2.7L Engine (RPO L3B)	-
GMC	Sierra 1500

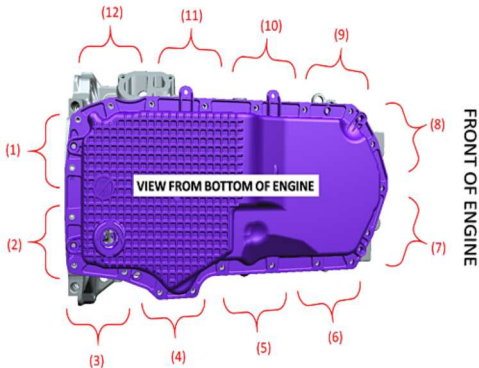
5. Make an assessment on which leak "zone" 1–12, as shown in the picture above, that the oil is originating from.

1. Visually inspect oil pan to identify traces of residual oil collection, and trace the leak path to the highest point (check if this is the oil pan to LCE joint).
2. If leak seems to be from oil pan to LCE joint, wipe excess oil and add engine dye.
3. Put additional miles on vehicle, and re-inspect with a black light to confirm that source of leak is in fact the oil pan to LCE joint.
4. If dye is detected, take clear snapshots of leak location / path at the oil pan to LCE joint.
