Technical Service Bulletin

39 Four-wheel drive malfunction message, DTC C05ED00 stored in the all-wheel drive control module

39 20 32 2051558/3 June 17, 2020. Supersedes Technical Service Bulletin Group 39 number 20-27 dated March 20, 2020 for reasons listed below.

Model(s)	Year	VIN Range	Vehicle-Specific Equipment
A4, A4 allroad	2017 – 2018	All	Quattro Ultra
A5, A5 Cabriolet. A5 Sportback, and Q5	2018	All	Quattro Ultra

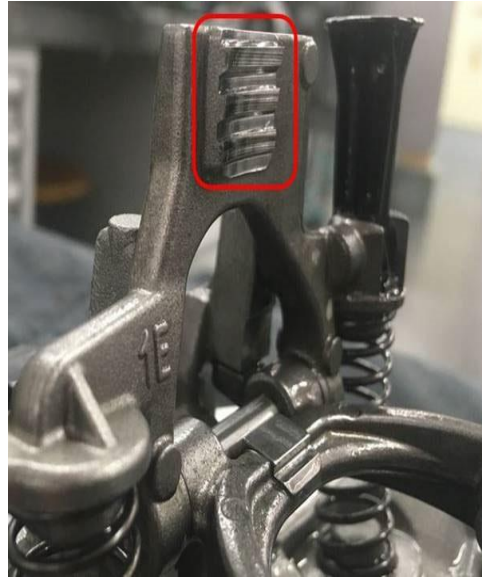
Figure 1. Worn/faulty shift fork.

Quattro Ultra shift fork inside the rear differential is worn/faulty (Figure 1).

Complete the ODIS test plan for the **DTC C05ED00** (4WD/AWD Clutch "B" Stuck Engaged) completely according to Guided Fault Finding to rule out other reasons for the restricted function and to avoid an unnecessary parts replacement:

- If the result of the test plan leads to a repair, follow the Guided Fault Finding repair advice and this TSB does not apply.
 - If the result of the test plan finds no defect, perform a short test drive. If the same DTC returns after the test drive with the same symptom, the shift fork inside the rear differential is at fault and must be replaced. Perform the repair as follows. Do **not** replace the complete differential.
1. Drain the oil of the rear differential according to the repair manual.
 2. Remove the rear differential per the repair manual.
