Front Bumper Cover Gap at Fender

Service Category Vehicle Exterior

Section Exterior Panels/Trim

YEAR(S)	MODEL(S)	ADDITIONAL INFORMATION
2014 - 2020	4Runner

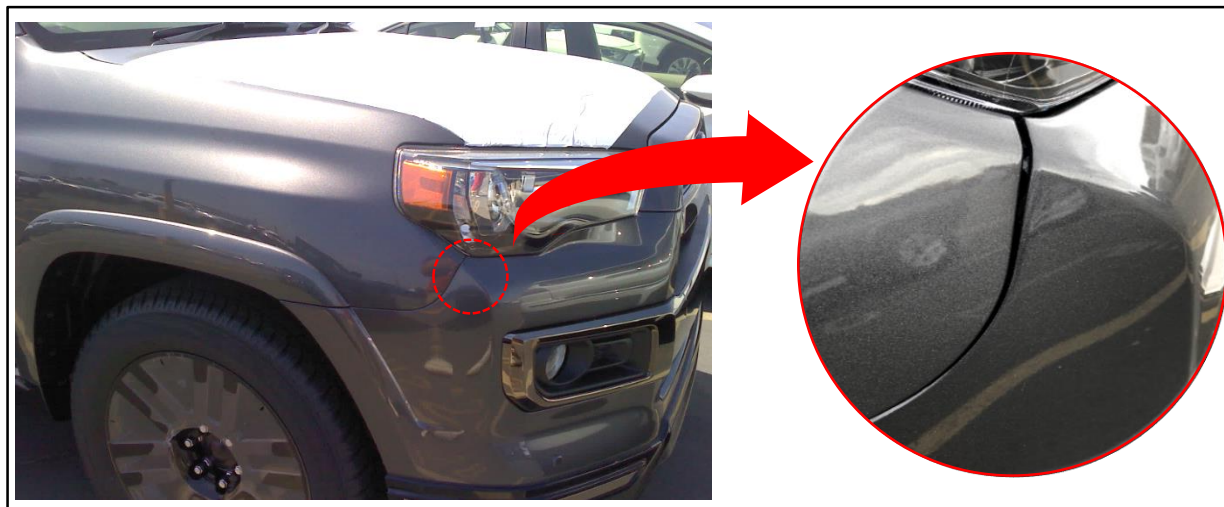
Figure 1.

- Confirm the condition exists.
Does the vehicle exhibit a gap due to disengagement of the front bumper cover clips and the fender retainer near the headlamp assembly?
 - YES** — Continue to step 2.
 - NO** — This bulletin does NOT apply. Continue diagnosis using the applicable Repair Manual.

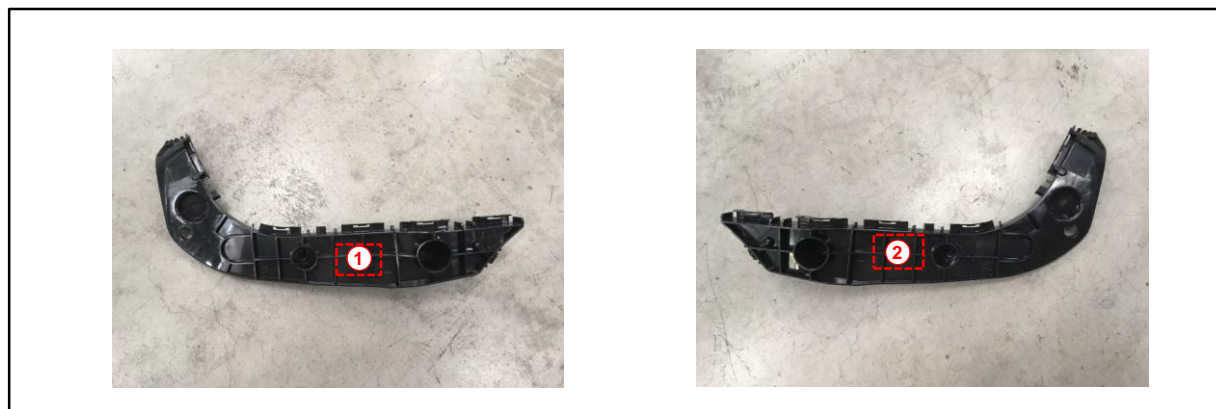
Figure 2. Retainers

1	Left-hand Side Retainer (Part No. 52116-35153)	2	Right-hand Side Retainer (Part No. 52115-35153)
---	--	---	---

2. Remove the front bumper cover.
Refer to TIS, applicable model and model year Repair Manual:
 - [2014](#) / [2015](#) / [2016](#) / [2017](#) / [2018](#) / [2019](#) / [2020](#) 4Runner:
Vehicle Exterior – Exterior Panels/Trim – “Exterior Panels/Trim: Front Bumper: Removal”
3. Remove the old retainers and Install the NEW retainers.

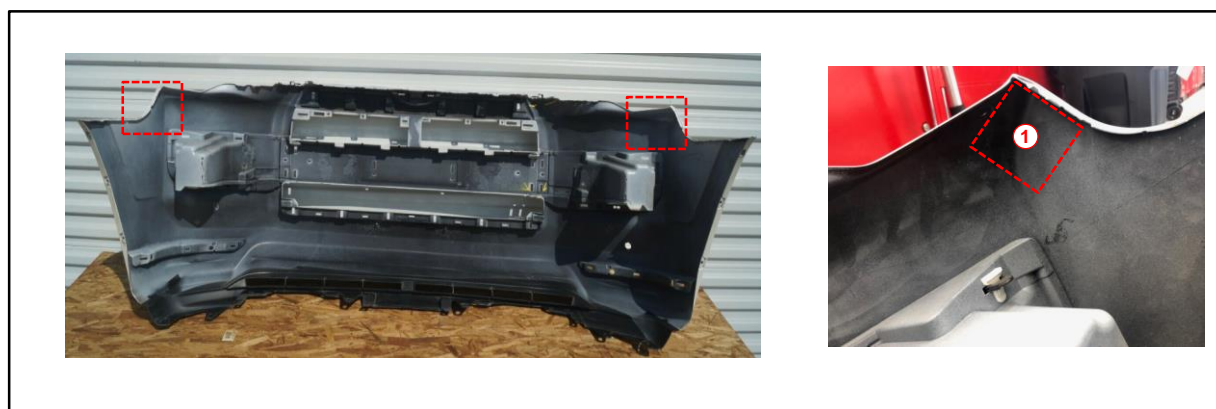
Figure 3. Primer Application and Dual Lock™ Fastener Installation Areas on the Front Bumper Cover

1	Along the Side Wall
---	---------------------

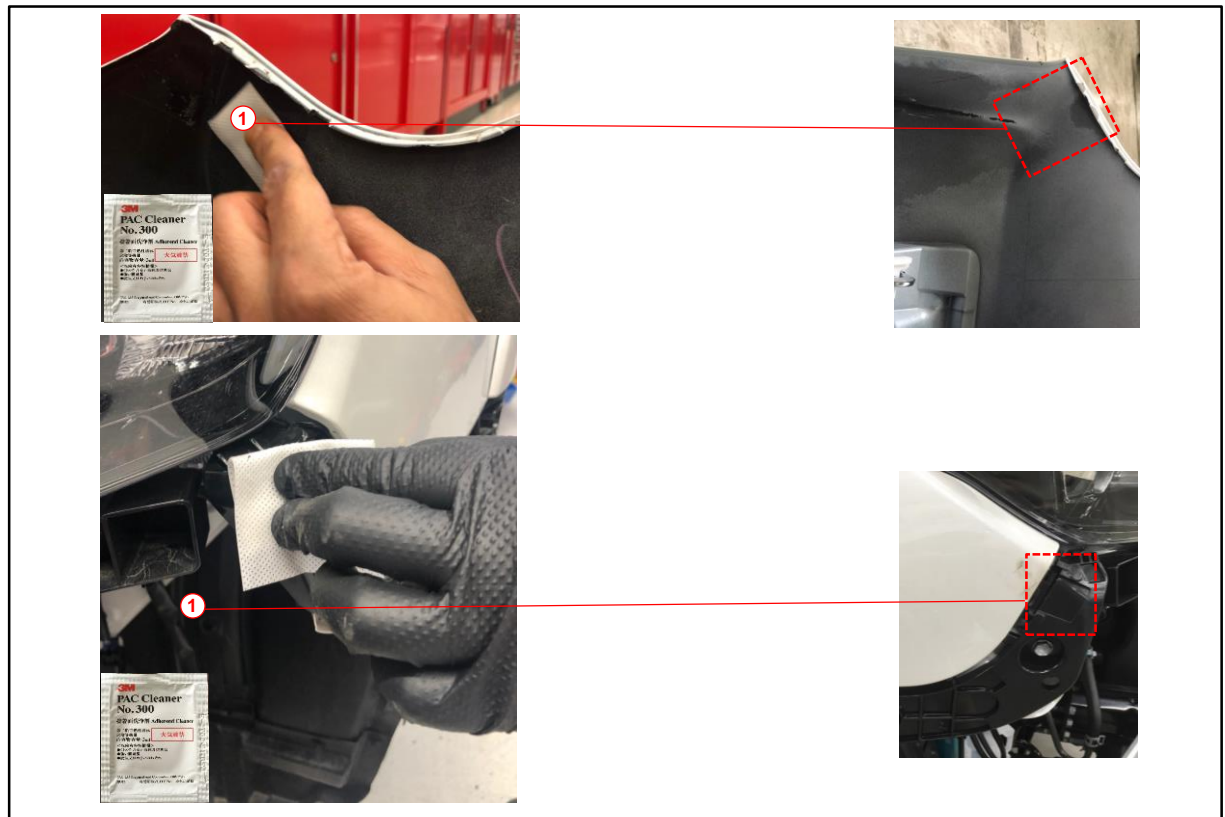
Figure 4. Front Bumper Cover and Retainer Cleaning Surfaces

| 1 | Clean Using 3M™ PAC Cleaner No. 300 |

4. Clean ALL front bumper cover and retainer surfaces where the Dual Lock™ Fasteners will be installed, using 3M™ PAC Cleaner No. 300.

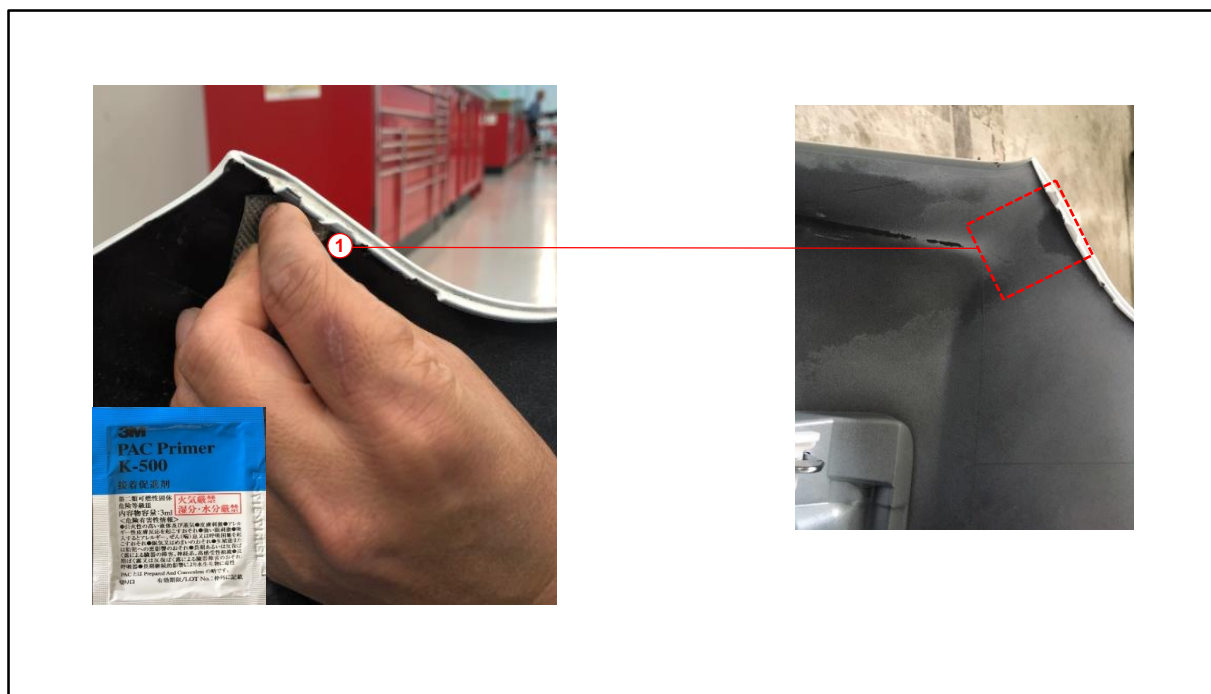
Figure 5.

1 Apply 3M™ PAC Primer K-500

5. Apply 3M™ PAC Primer K-500 to the surface on each side of the front bumper cover where the Dual Lock™ Fasteners will be installed and allow it to dry for AT LEAST two minutes.

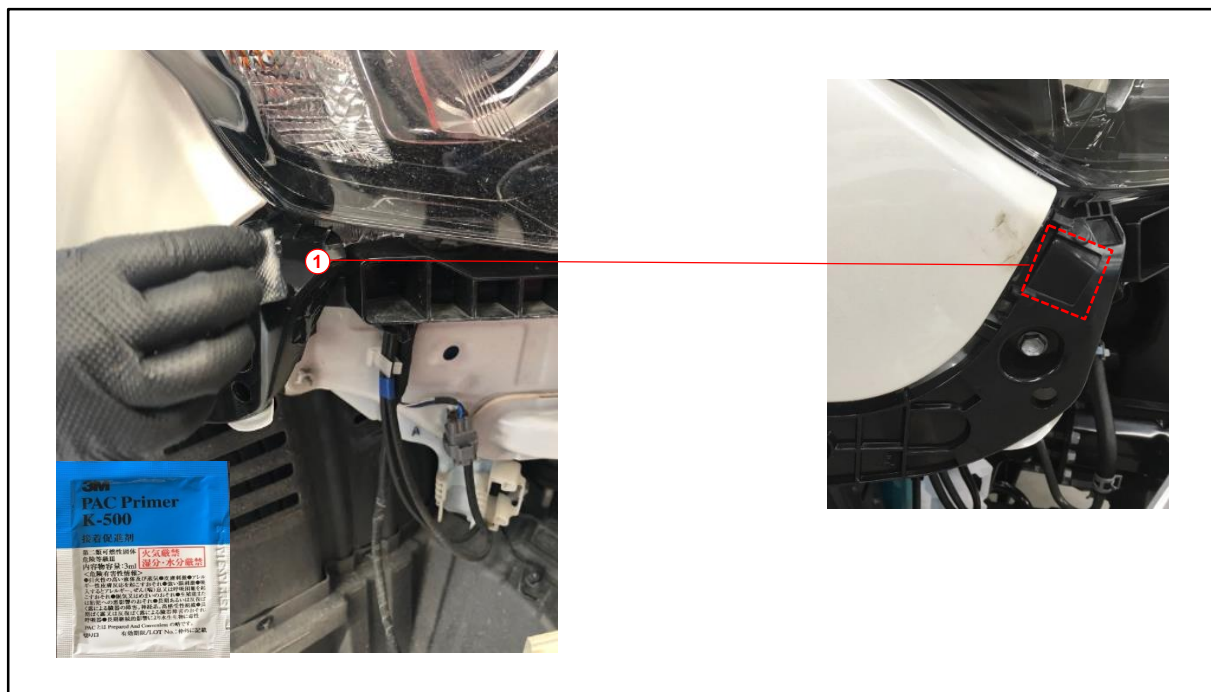
Figure 6.

| 1 | Apply 3M™ PAC Primer K-500 |

6. Apply 3M™ PAC Primer K-500 to the retainer surface on each side where the Dual Lock™ Fasteners will be installed and allow it to dry for AT LEAST two minutes.

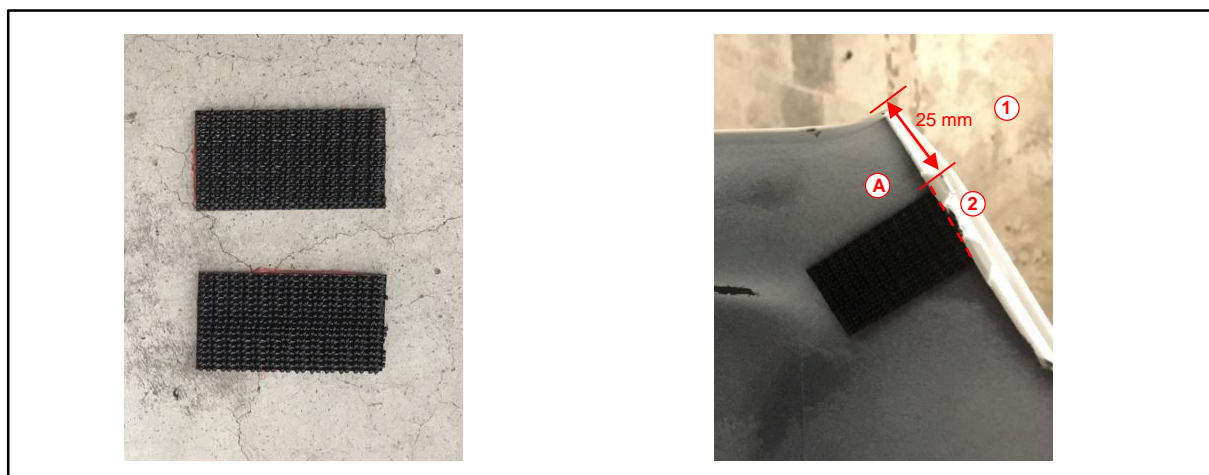
Figure 7.

A	Front Bumper Cover Side Wall
1	Apply Along the Shape
2	Apply Along the Line

7. Apply the larger Dual Lock™ Fasteners (35 mm x 20 mm) to each side of the front bumper cover.

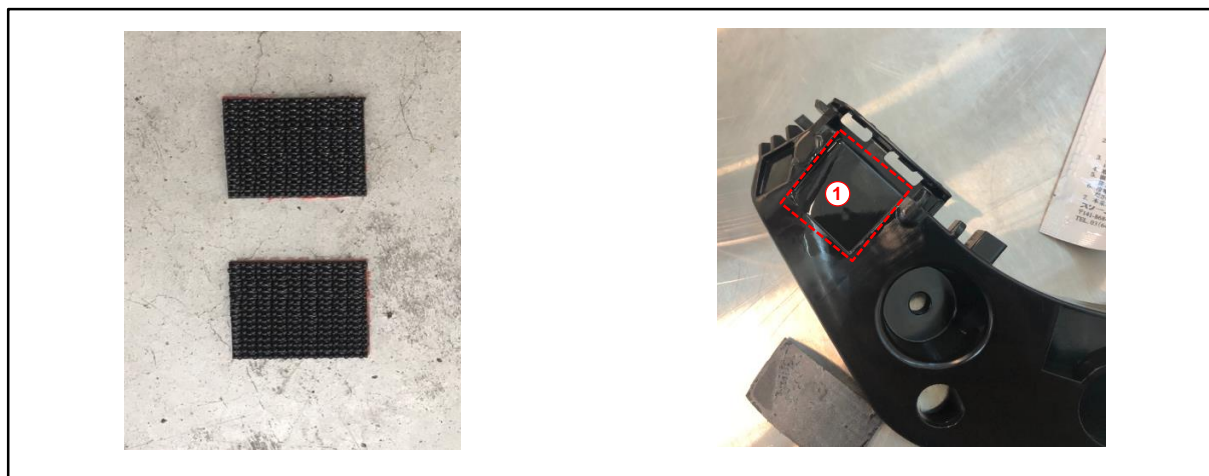
Figure 8.

1	Cut-out Area on the New Retainer
----------	----------------------------------

8. Apply the smaller Dual Lock™ Fasteners (25 mm x 20 mm) to both side retainers. Paste the Dual Lock™ Fasteners inside the cut-out area.

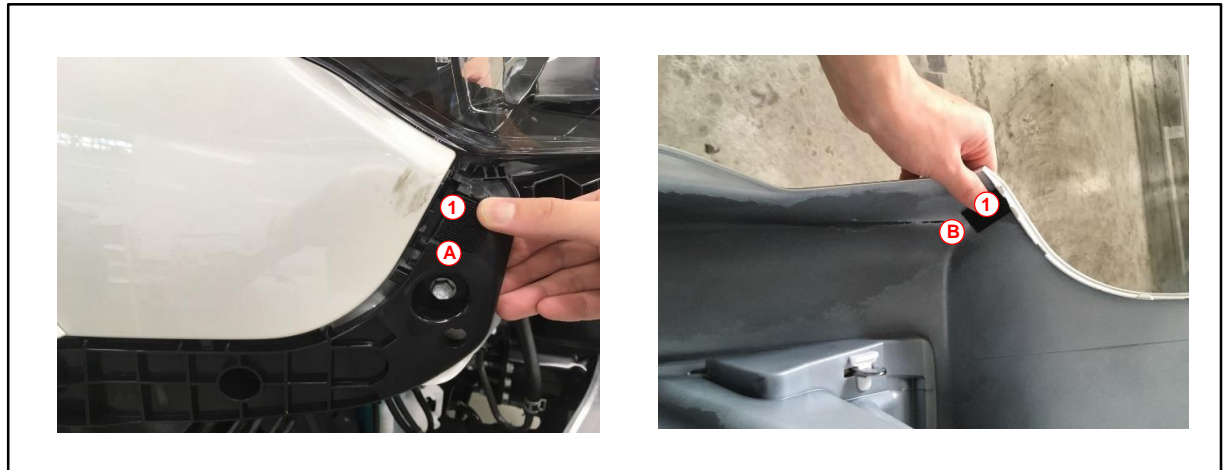
Figure 9.

A	Retainer
1	Press

B	Front Bumper Cover Side Wall
1	Press

9. Confirm proper Dual Lock™ Fastener adhesion by pressing on ALL Dual Lock™ Fasteners.

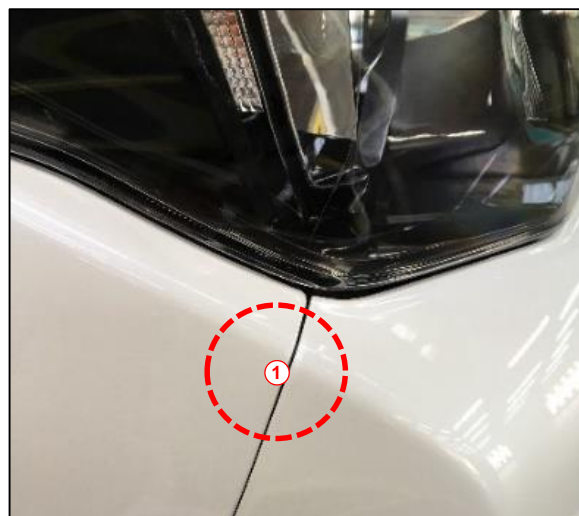
Figure 11.

1	Press
---	-------

12. Press on the area where the fasteners are installed to ensure the Dual Lock™ Fasteners are properly engaged AFTER the front bumper cover installation has been completed.
